PHYSICAL NEEDS ASSESSMENT

THE PANORAMIC
1321 MISSION STREET
SAN FRANCISCO, CA 94103

AUGUST 25, 2021

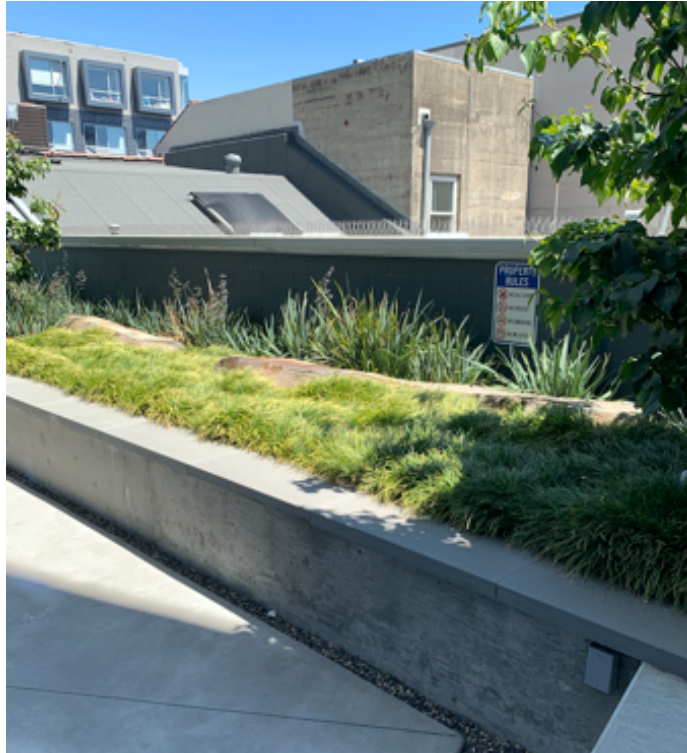
Landscaping consists of plants installed in planters at the roof deck and at the 2nd level courtyard. The landscaping includes automatic irrigation controls which are located at the roof and 2nd levels. The landscaped areas are well-maintained.

Second floor courtyard planted area

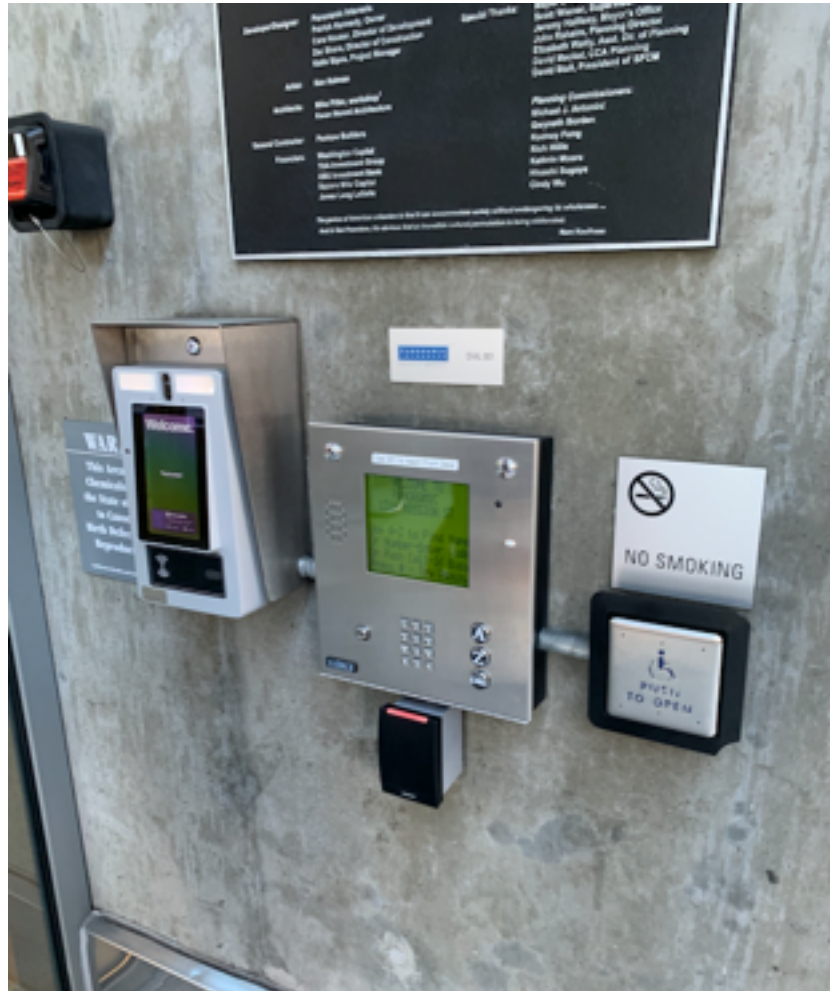
Main entry call system

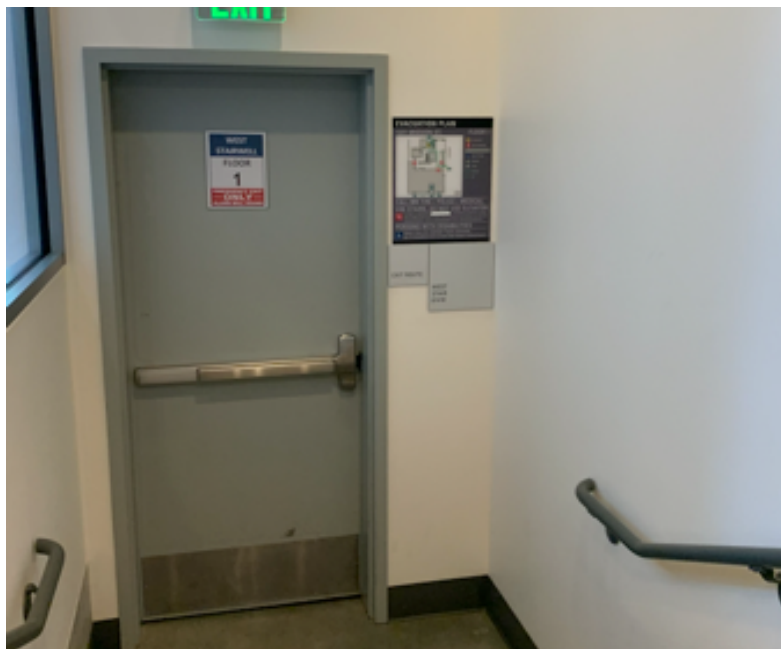
Exit door (west) and evacuation signage. This door leads to Washburn Alley.

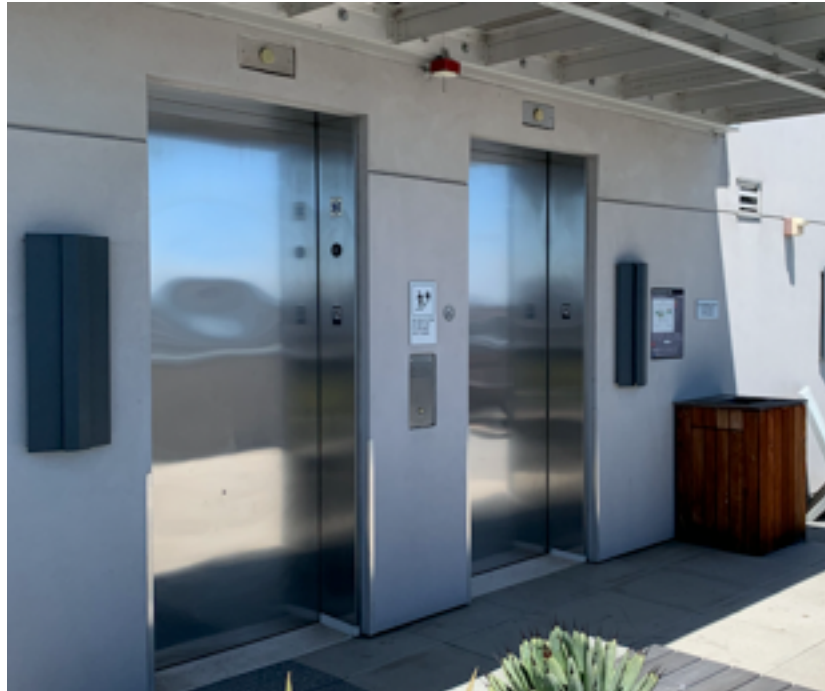
Lighting at elevators at the roof deck

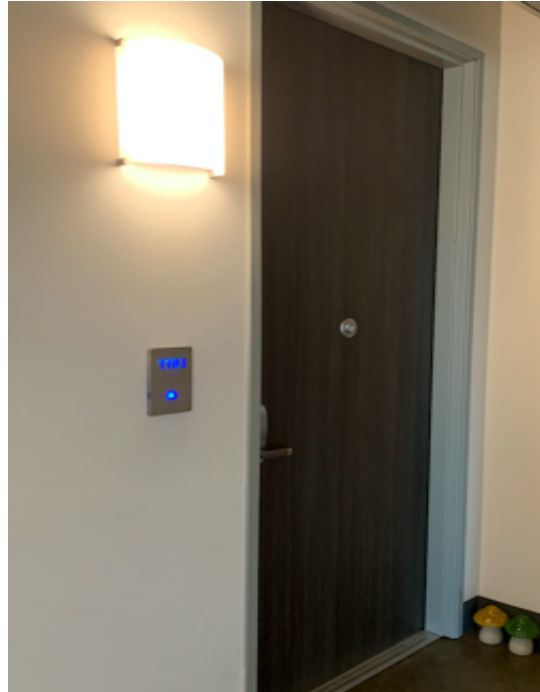
Hallway lighting at the residential floors includes LED sconces at the elevator lobby, combination illuminated door number and doorbell lights, and sconces at the entry doors. Hallway lighting appeared to be in good condition.

Entry door lighting and doorbell

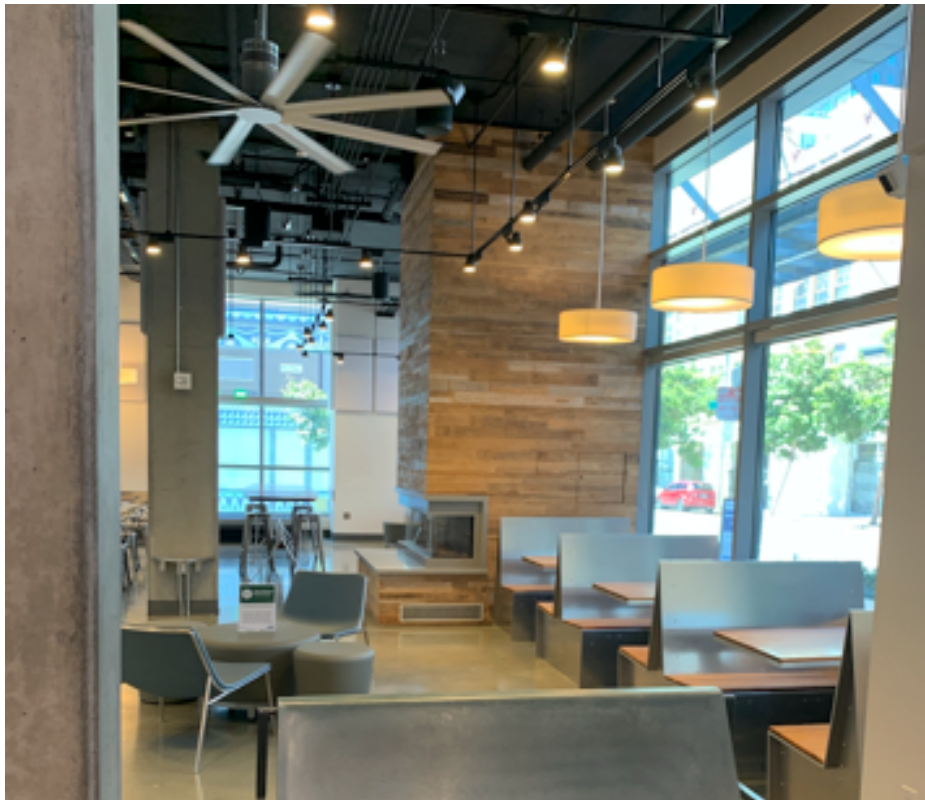
Ground floor lighting includes decorative pendant lighting, and wall-mounted lighting, as well as compact fluorescent downlighting. Ground floor lighting is in good condition.

Pendant and track lighting at ground floor lounge

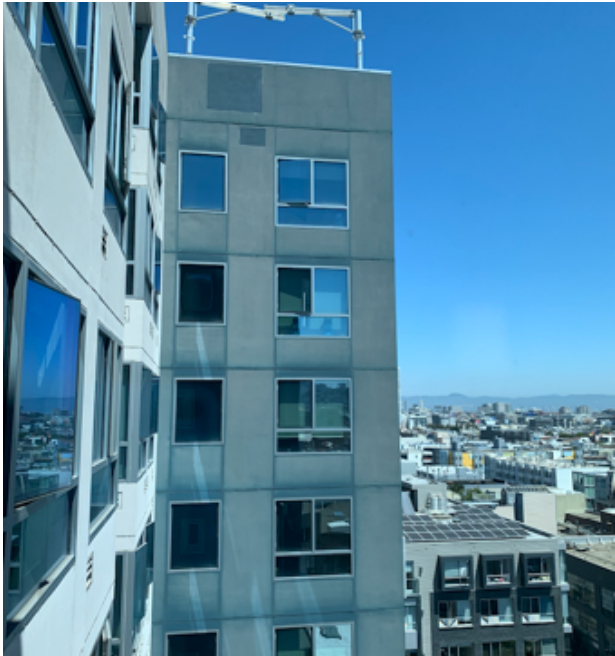
Exterior siding – the south and west-facing exterior walls where EIFS is installed are showing moderate fading. The Owner's representative indicated that they are in the process of replacing or repairing the prematurely faded siding areas.

West facing side of south building section – EIFS panels faded

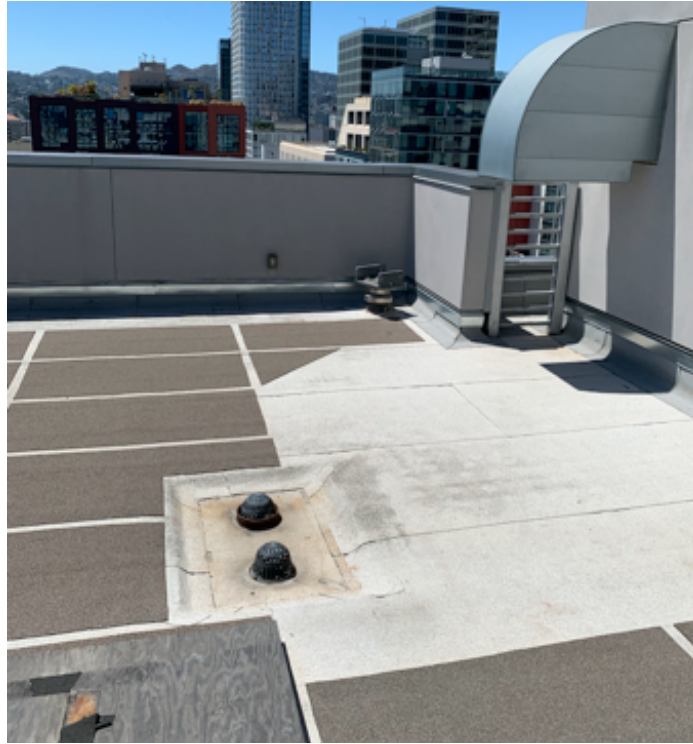
Roof walking pads

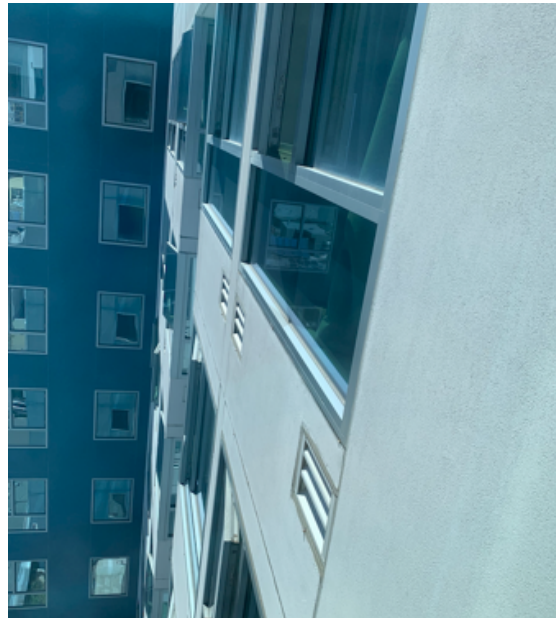
All windows at the building are original. All storefronts are original. Windows schedules are shown on Sheet A10.03 of the reviewed plan set. All windows are dual paned with metal framing and are in varying fixed and operable configurations. No issues were noted or reported with windows or windows/storefront systems.

Windows at 10th Floor

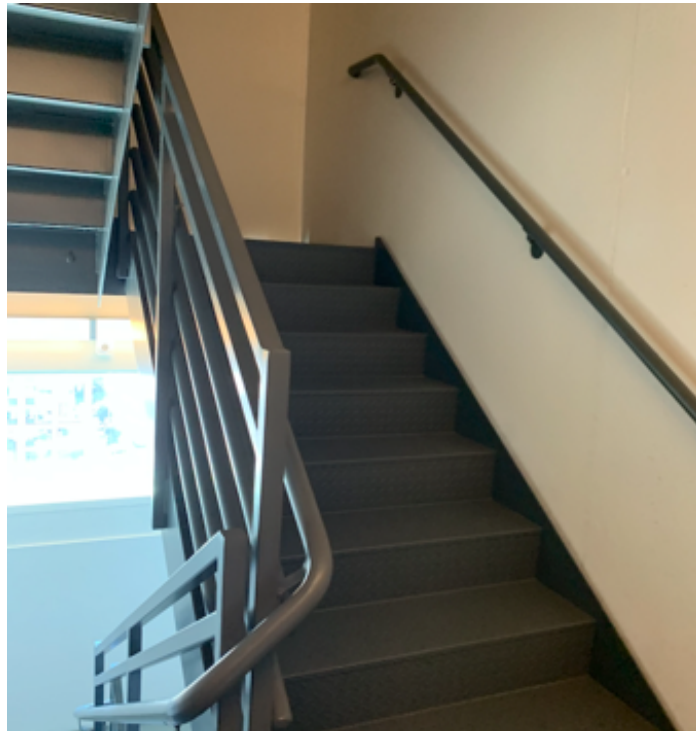
are finished with a rubberized coating. Stair landings include a 4" topping slab over foam fill. Observed stairs and landings were in very good condition.

Stairs

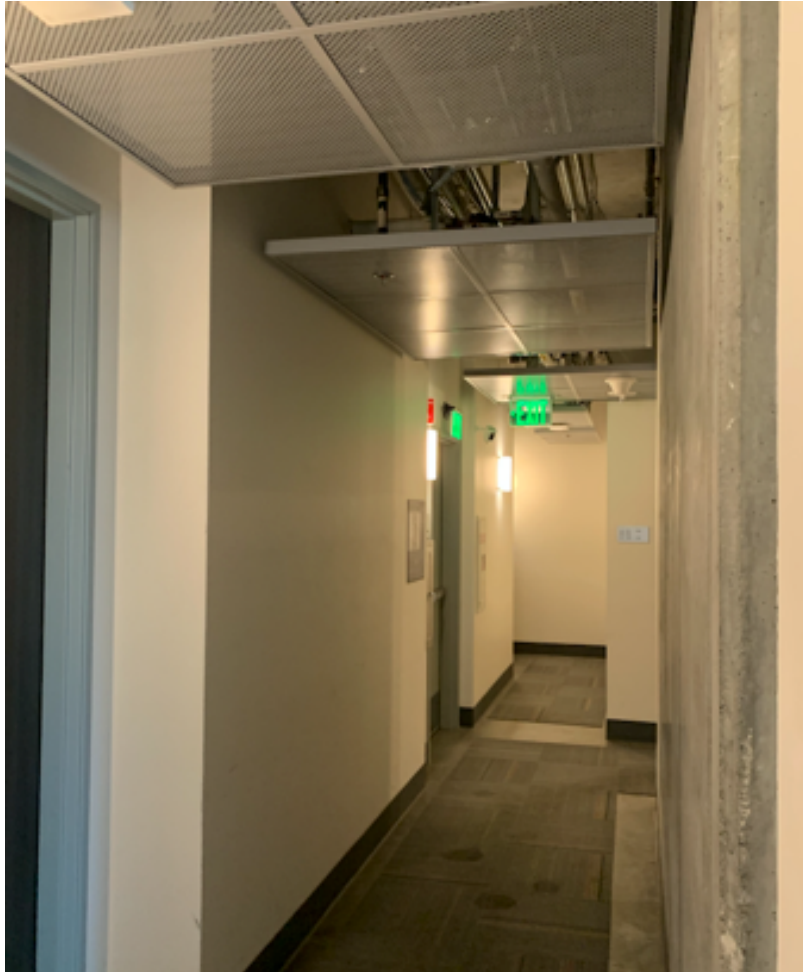
Hallways surfaces are finished concrete. Walking mats are installed on the hallways. No issues were noted or reported regarding hallway flooring. Hallway walls are painted, and lighting is achieved via wall mounted sconces. Hallway ceilings are finished with a dropped metal raceway that occludes the ceiling mounted piping and wiring.

Typical hallway

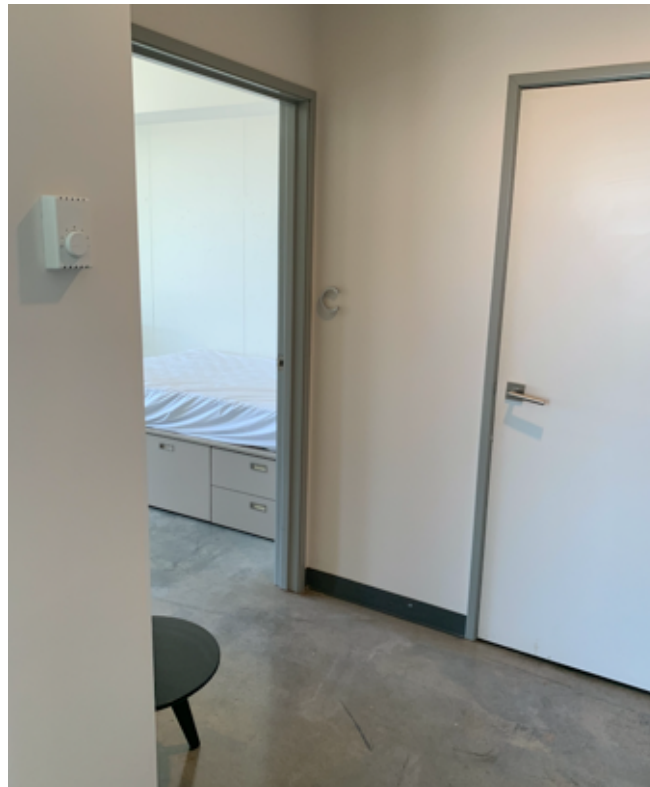
All flooring is finished concrete (applied via troweling, and then sealed) in all rooms of the units. The flooring was in good condition in the observed units. Some floors showed moderate scratches in the finish coating, but it is assumed that floors are addressed when units are turned.

Flooring in three-bedroom suite hallway

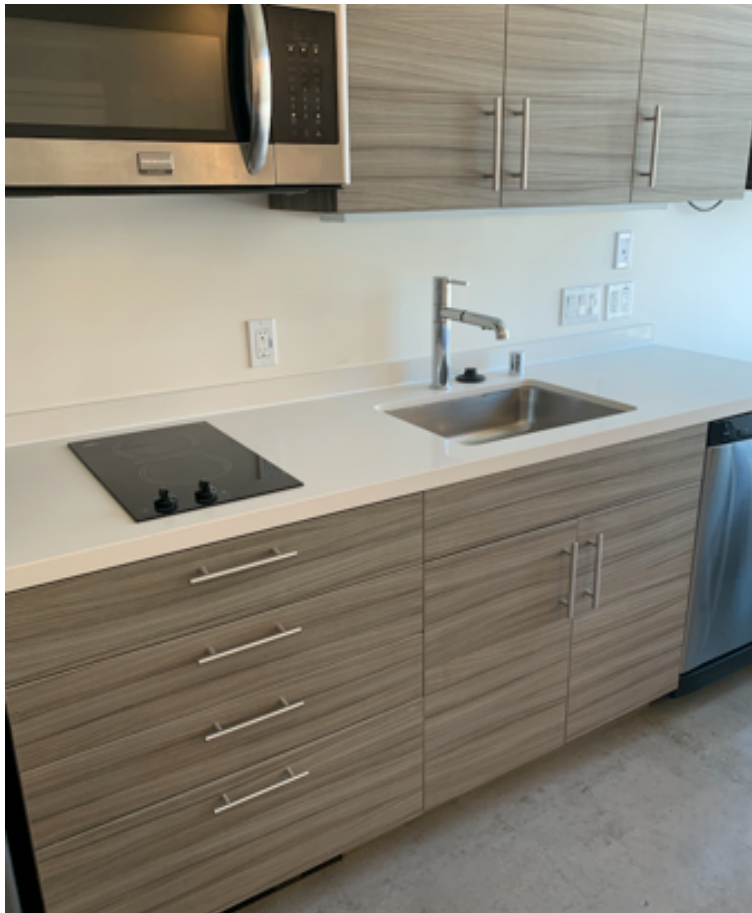
Cabinet are laminated wood or pressed wood with wood grain look on the doors and frames. Shelving is laminated wood. The observed cabinets were in good condition.

Countertops are solid surface and all observed counters were in good condition.

Unit 805 kitchen – studio unit

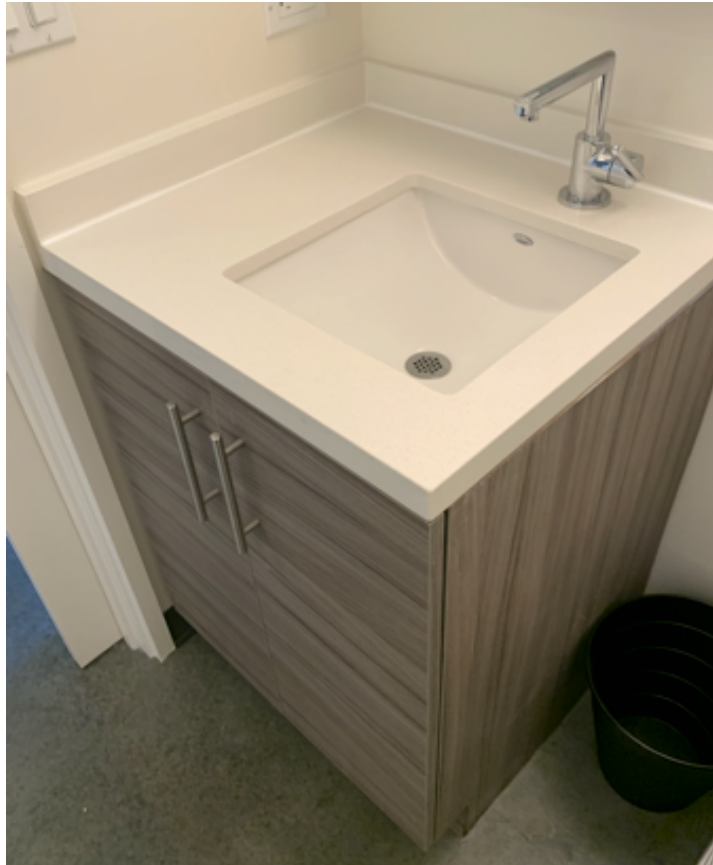
The bathroom sinks are typically single bowl sink set into a solid surface countertop, over a vanity cabinet. Sinks and vanity cabinets were found to be in good condition.

Typical bathroom sink and cabinet

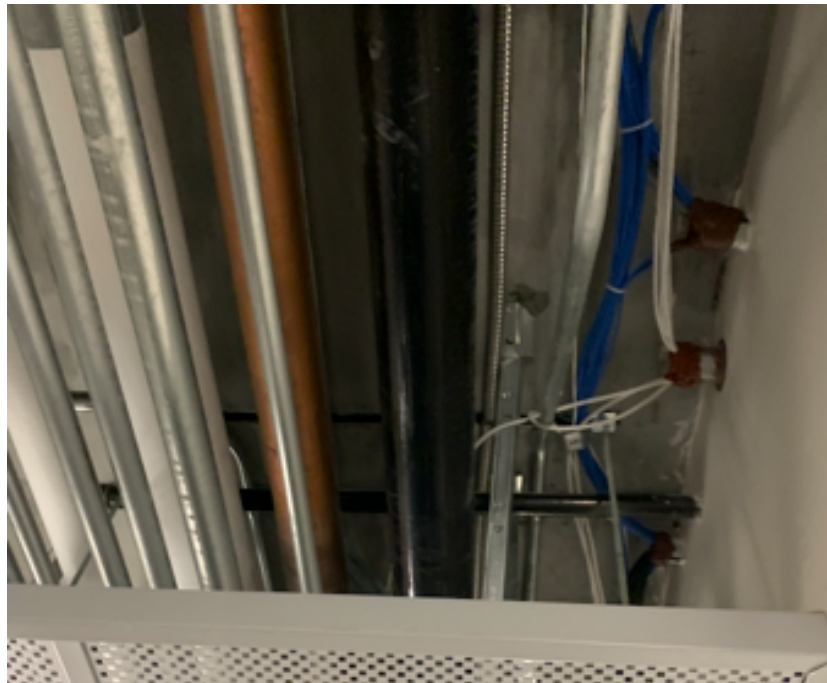
Supply and waste lines for the property include the observed materials only. Other material types may be present, but were not observable. Copper was observed for supply and cast iron for waste. Vent piping types were sheet metal other materials.

No active leaks were observed or reported at the time of the inspections.

Building piping as seen at hallway ceiling - copper water supply, cast iron waste

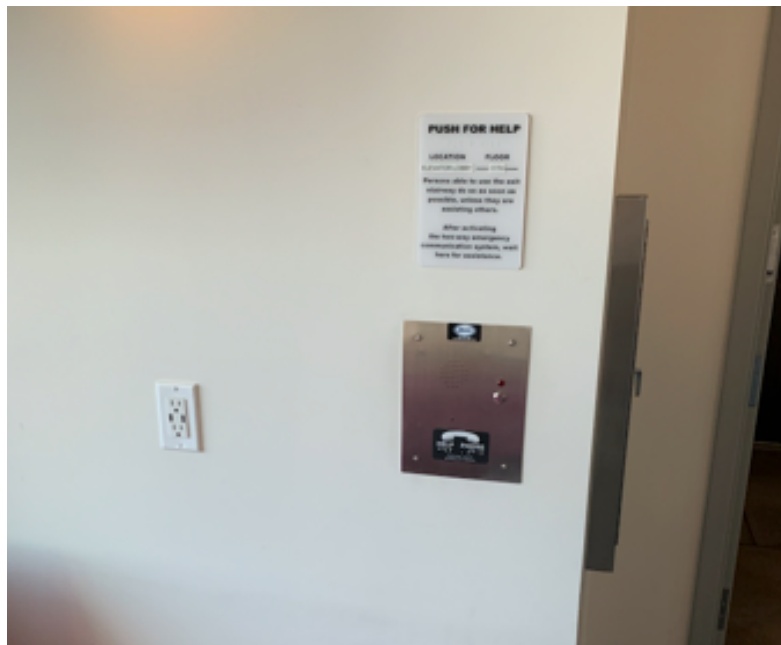
Area of rescue are located at each residential floor near the elevators. The ERRCS system is located at the areas of rescue on each floor.

Area of rescue and call panel

All fire life and safety equipment must be maintained in good working order and must comply with prevailing building and fire codes at all times.
