Eula Hotel
3055 - 3061 16th Street
San Francisco, CA

Observation and Assessment Report

July 2, 2021

Saida + Sullivan Design Partners, Inc
ZFA Structural Engineers

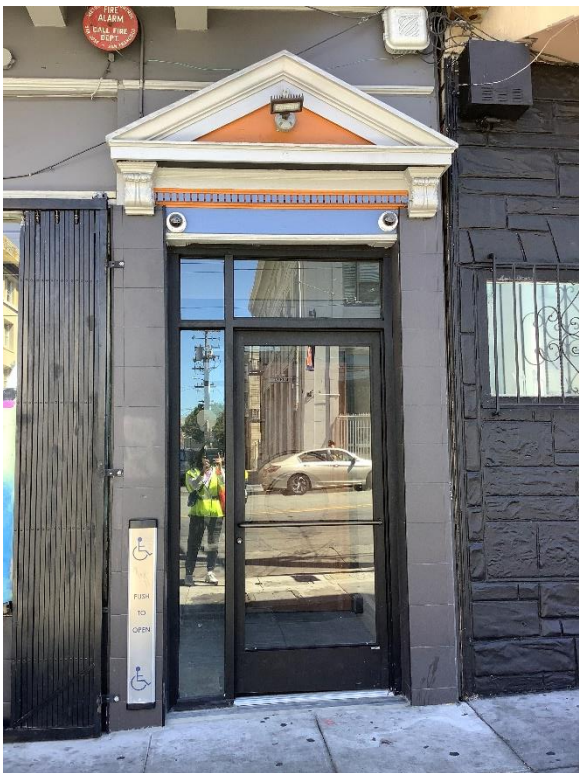
Pedestrian access is provided from the public sidewalk along 16th Street. Entries to the residential vestibule and the commercial use are both located on the 1st floor. ADA hi-lo door actuator was observed at the residential entrance.

Residential Entrance, Hi-Lo Door Actuator, Lighting

Comments: San Francisco Information Sheet (NO. DA-05), if approved by San Francisco Building Department, allows for the use of powered door operators in lieu of both the required maximum opening force and the maneuvering clearances adjoining the exterior and interior of doors and gates within existing buildings which are required to be made accessible to persons with disabilities. The ADA hi-lo door actuator that was observed can satisfy the DA-05 requirement so the specific residential entrance can be accessible to persons with disabilities. However, the small residential vestibule behind the residential entry door is too small to allow for a wheelchair to turnaround, and the vestibule only leads to a stair up that provides access to the 2nd and 3rd floors which is not an accessible path of travel. The small residential entry vestibule can be enlarged into some of the current commercial space, and also provide an accessible route into that space from the residential vestibule.

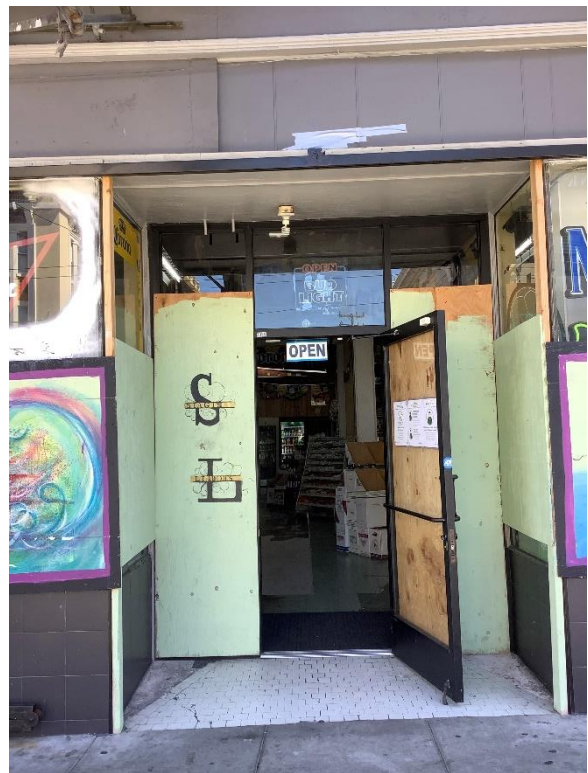
Entry to the commercial space (3055 16th Street) from the public right of way has a visually flat exterior vestibule before the entry door and could potentially become an accessible entrance.

Commercial Space Entrance, Lighting

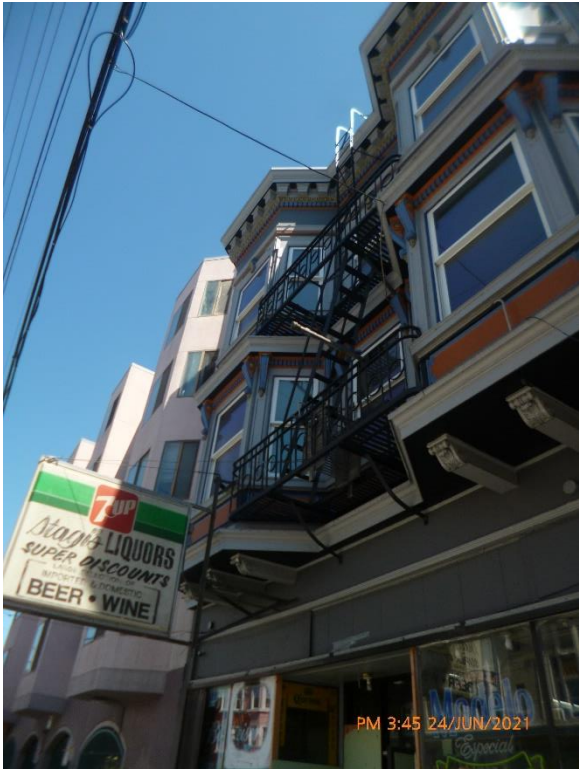
Building Front Façade

Comments: The exterior walls appear to be in good condition.

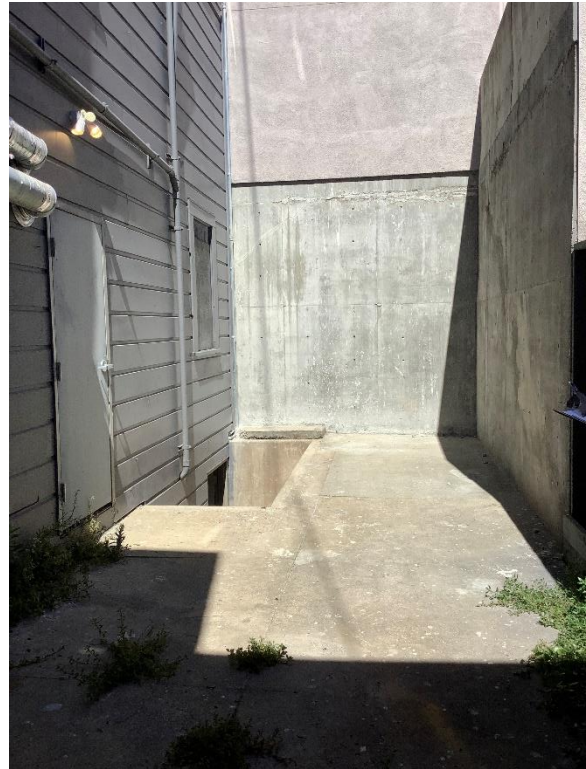
Rear Patio, Stair to Basement, and Door to Residential Stair

Landscaping	<p>No landscaping was observed.</p>
Outdoor Gathering	<p>A small rear yard was observed that is approximately 300 s.f. gross area. It is accessed from a concrete stair up from the basement, and also from the residential hotel rear exit stair. The entire rear yard has a concrete slab and is confined by the walls of neighboring buildings. There are no handrails or a guardrail around the stair down to the basement.</p> <p>Comments: The stair from the basement needs a handrail, guardrail, and warning stripes on the treads to increase safety. A new door with a vision lite should be installed at the residential stair door located here. Further study is needed to explore the feasibility of creating access to the rear yard from the first floor commercial space (future community space). This rear yard can definitely be enhanced to provide a quiet space for reading, eating, and small gatherings. Please see further notes on this space and the attached concept board for improvement ideas which include: various ground surfaces, drought tolerant plantings, illumination, colors and/ or individual planting treatments on walls, furniture for intimate to small group gathering, and carefully placed mirrors to perceptually extend the “garden”.</p>

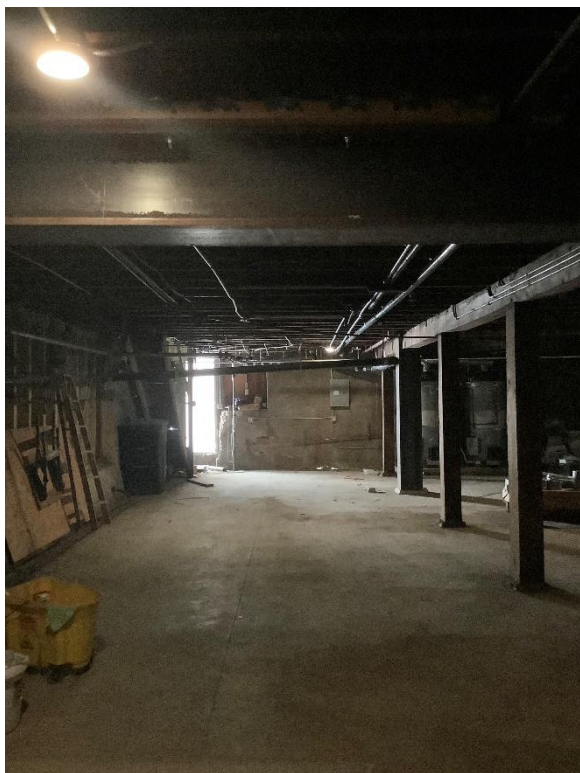
Basement

One small louver on the basement rear door was observed. There was no other basement ventilation observed.

Comments: The condition of the basement exhaust system was not evaluated in this report. A separate MEP investigation is required if an evaluation is desired by the owner.

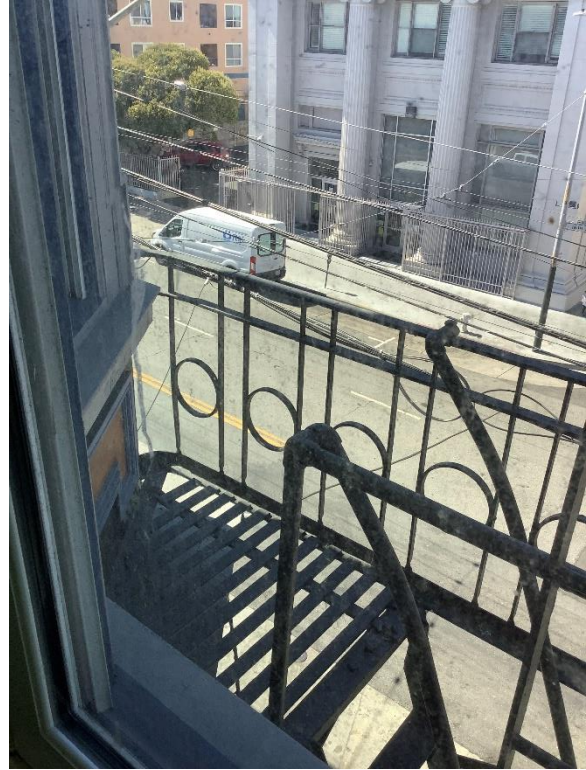
- Windows** The windows in residential units, common kitchen, and circulation are either wood framed single-hung or vinyl sing-hung windows. Skylight was observed on the 3rd floor roof.
Comments: All windows appear to be new and in good condition.

- Fire Escape** An existing metal fire escape is located on the front façade (north side) of the building with a ladder down from the roof level.
Comments: Owner should verify that fire escapes have been inspected and are in good working order.

Window and Fire Escape

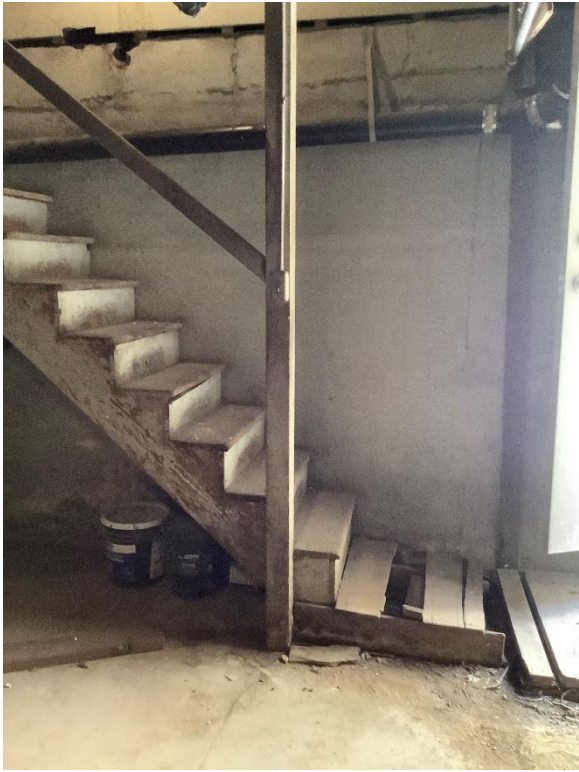
Comments: The narrow wooden staircase to the basement was in very poor/ unsafe condition and needs to be replaced and widened to be more functional. It

Basement Wooden Staircase

is very dark in the basement, adding some light fixtures should be considered. The basement space is not utilized and could be looked at for some storage opportunities (ie. bicycles).

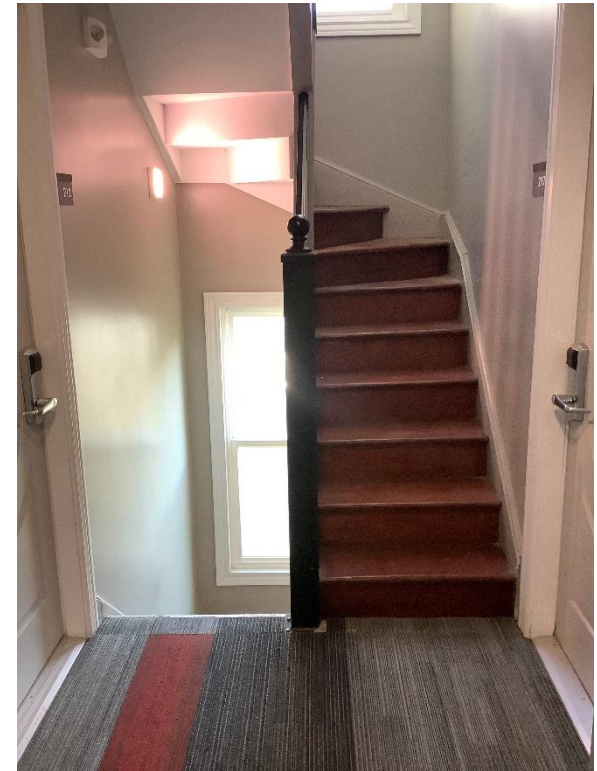
Comments: The stairs appear to be in good condition and maintained from the original construction. As mentioned prior, the concrete stair will need a handrail and guardrail for safety. Compliance with the California Existing Building Code should be reviewed. Further study is needed to determine number of exits and exit access doorways per the Change of Use and future layout of the first floor.

Rear Exit Stairs

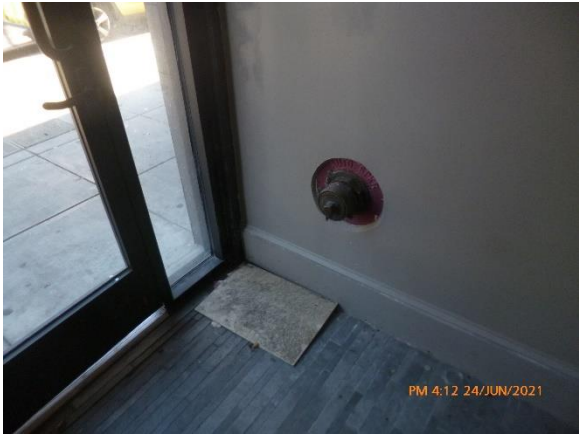
Access to the residential vestibule is located at along 16th Street. An existing fire department connection (FDC) was observed protruding from the residential vestibule wall.

Comments: The residential vestibule finishes appear to be new and in good condition. Hardware for the wood door inside the residential vestibule was missing. Recommend FDC to be addressed with a cane rail or other treatment for sight impaired visitors or residents.

Residential Vestibule and Existing FDC

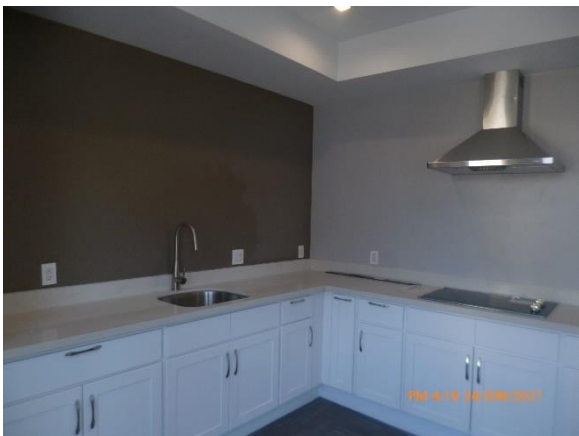
Comments: The interior finishes and appliances are in very good condition as interior renovations appear to be close to completion. Adding a wall-mounted fire extinguisher is recommended to increase fire safety. Furniture should be considered at the common kitchen to create a small dining area.

Common Kitchen

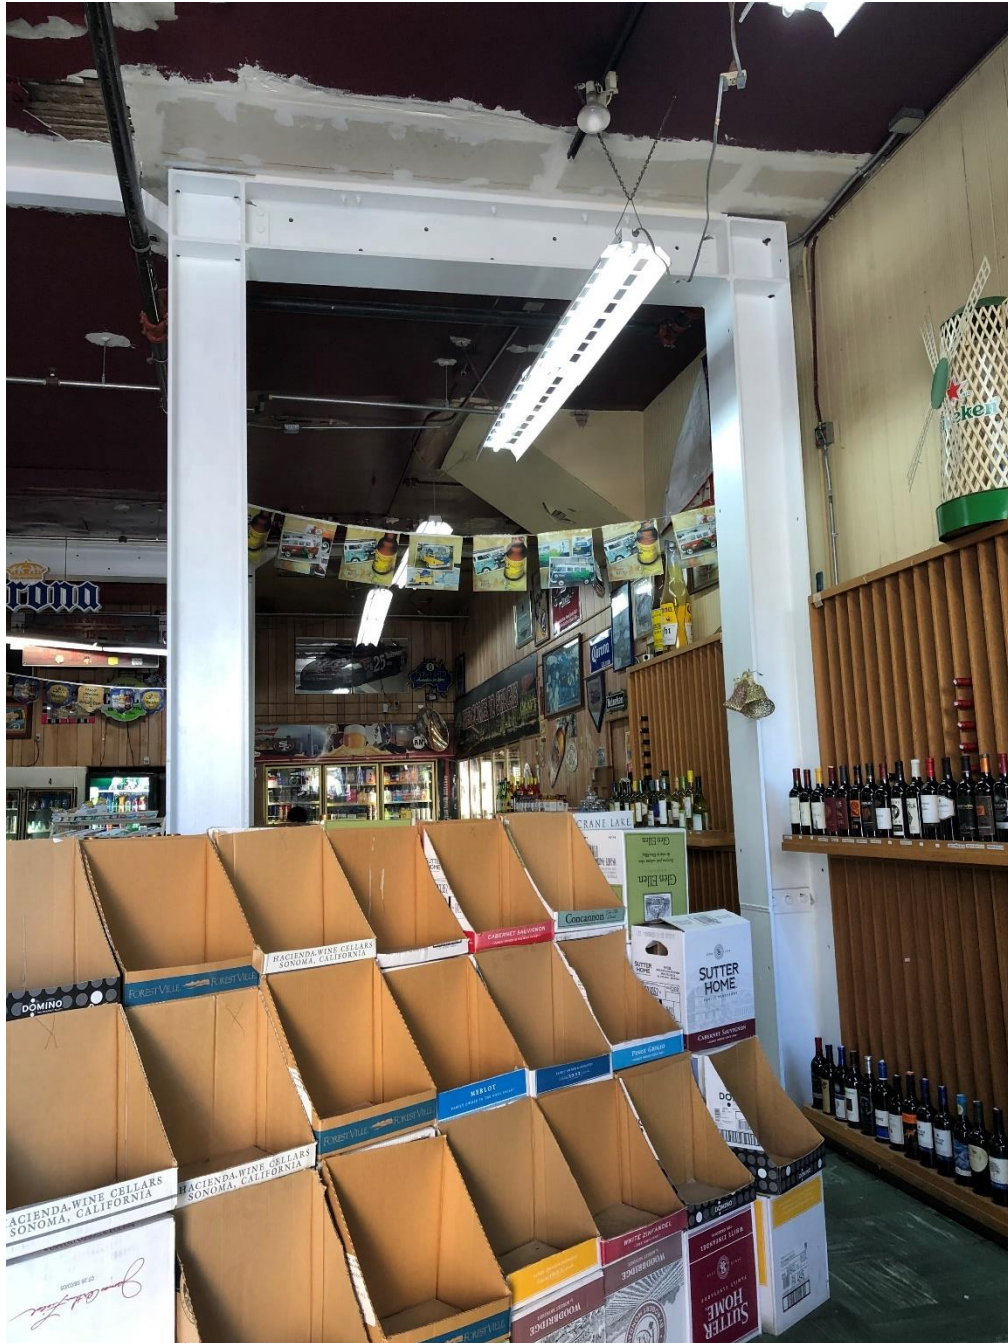
Photo 2. Moment frame in the ground floor commercial space

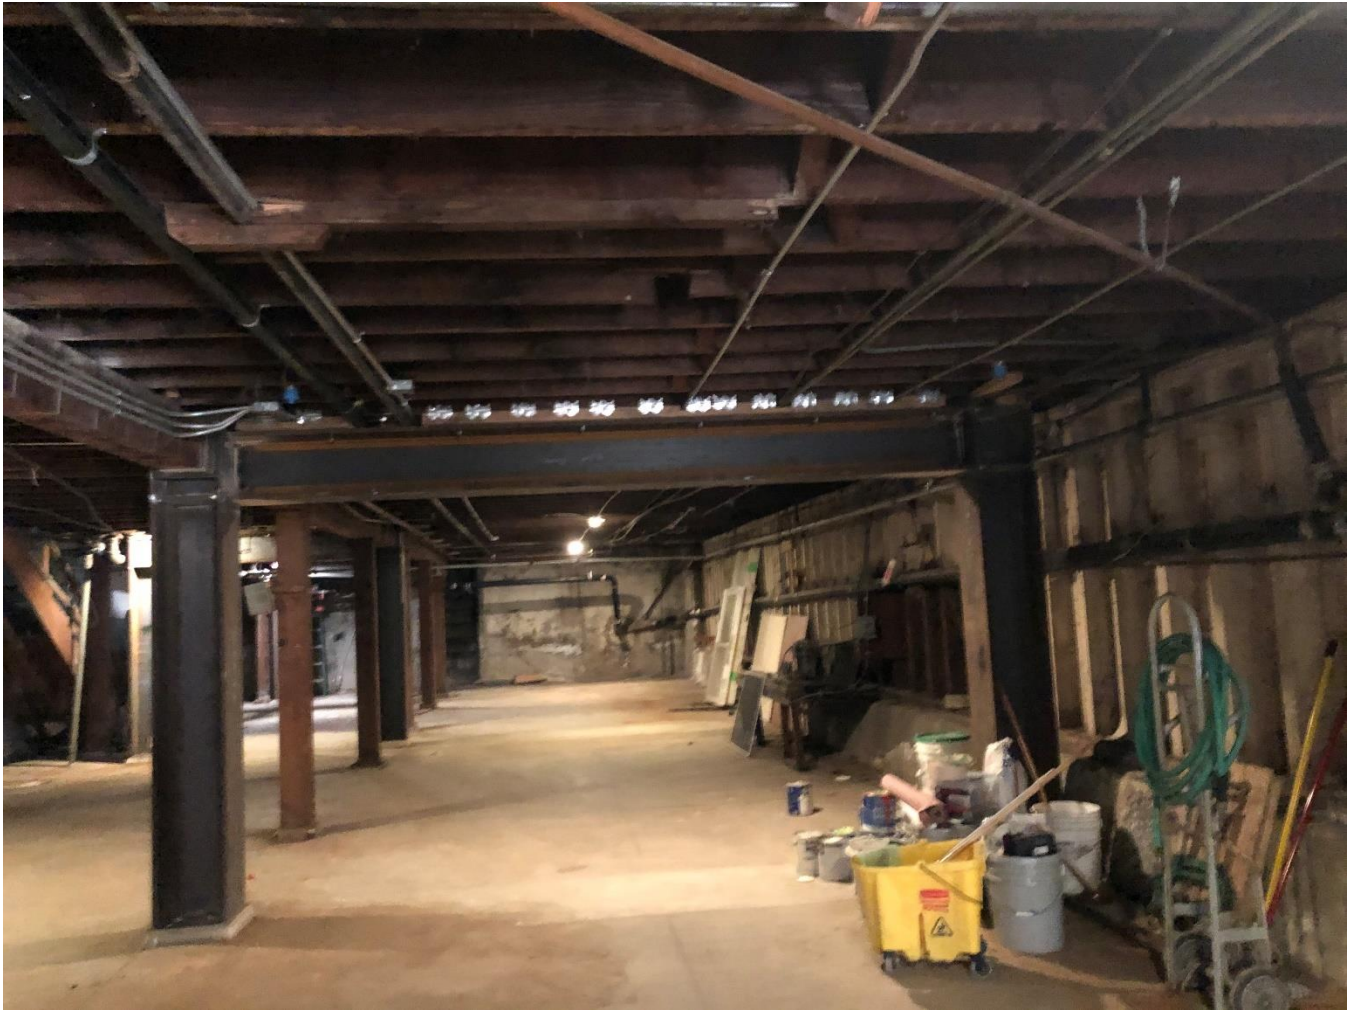
Photo 3. Moment frame in the basement

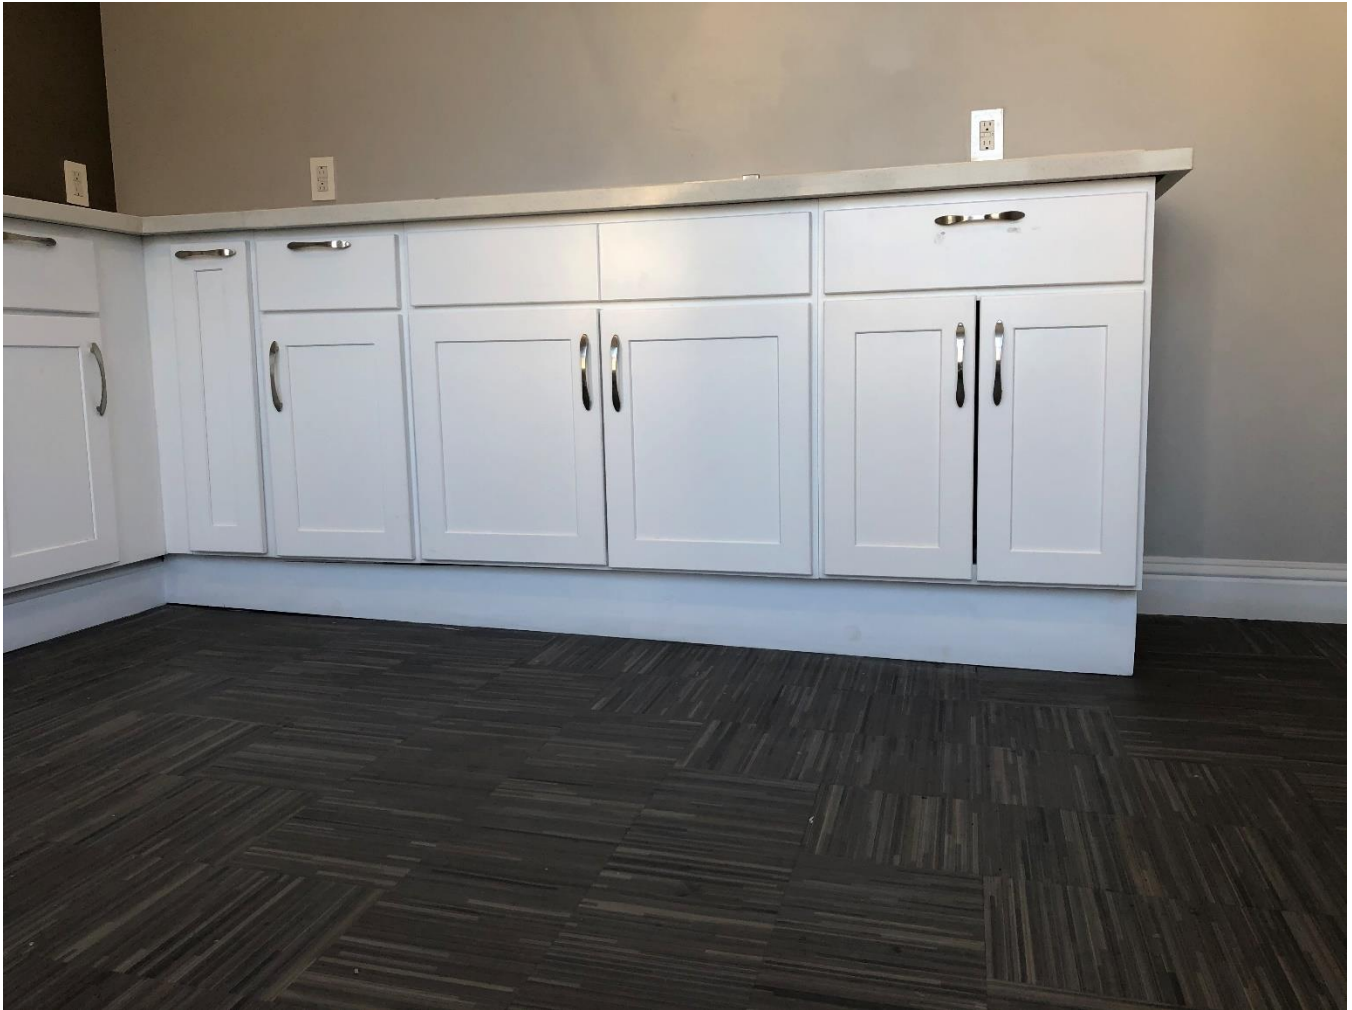
Based on visual observations of the visible areas of the building, the structure generally appears to be in good structural condition. The interior of the building has been extensively renovated. No systemic cracking was observed in the wall finishes. However, foundation settlement is assumed to have occurred over the years as evidenced by noticeable sloping of the floors (Photo 4). This condition does not represent a structural concern. Some surficial spalling of concrete in the basement footings was observed (Photo 5), but it does not appear to be structurally significant. Although not a structural issue, the fire escape ladder latch at the second floor was observed to be tied off and did not appear to be functional (Photo 6).

Photo 4. Sloped floor at kitchen counter

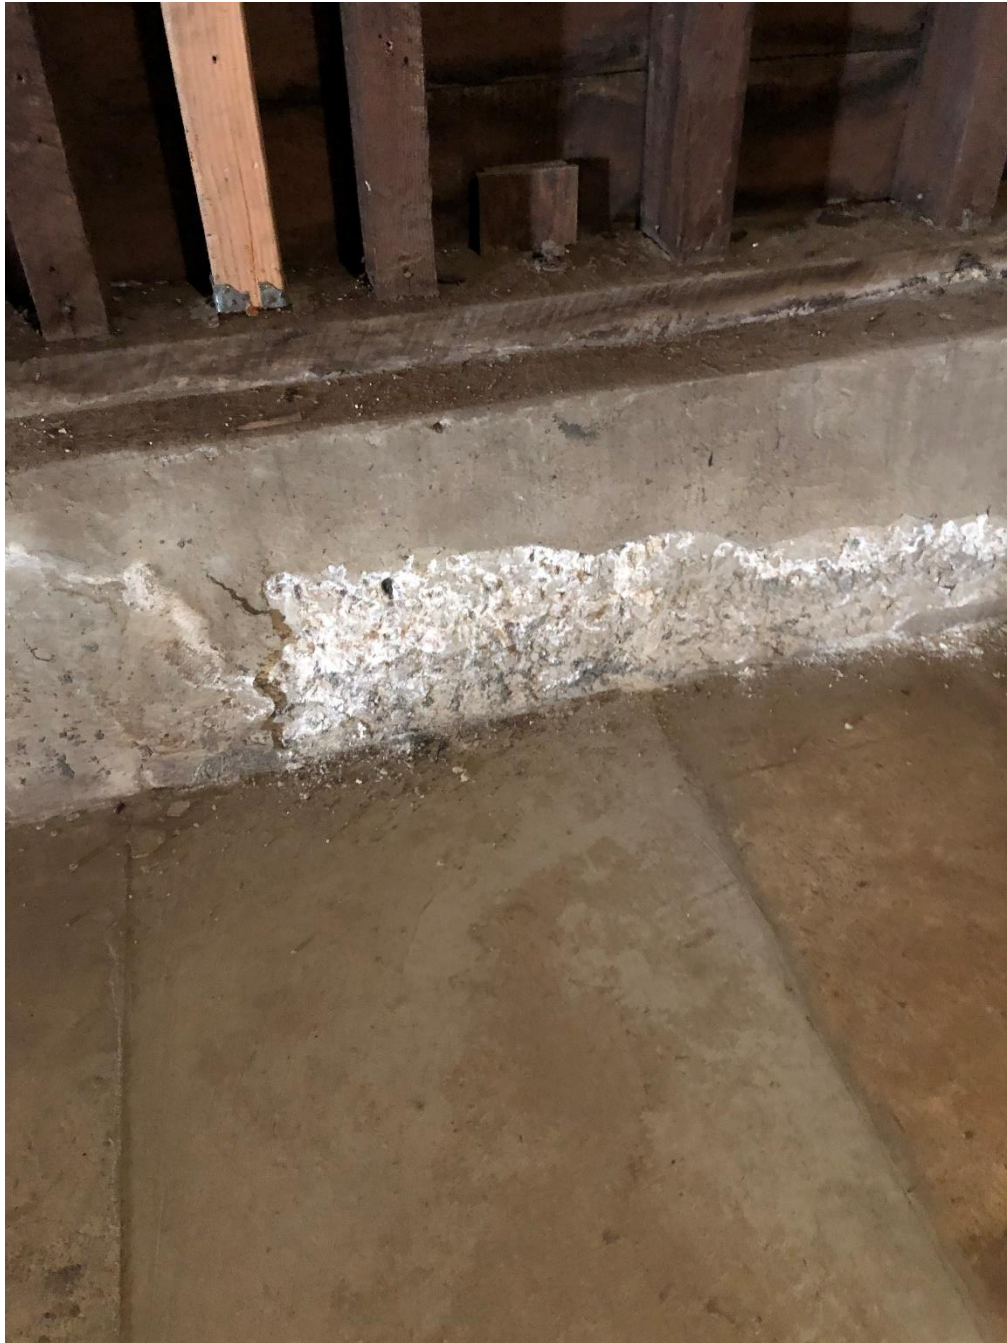
Photo 5. Deteriorated concrete in the basement footing

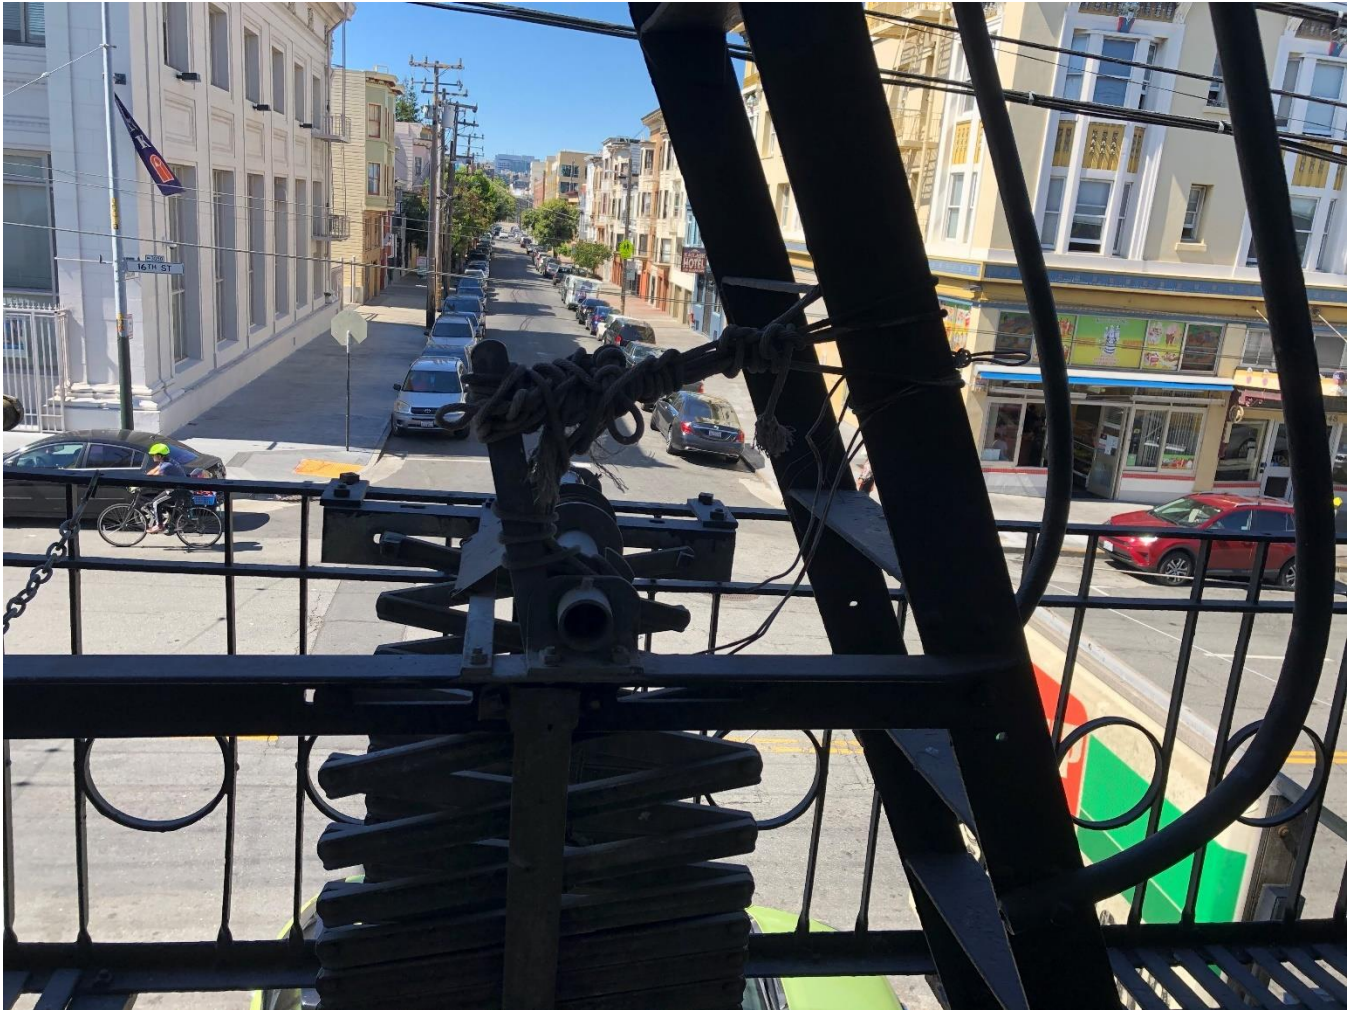
Photo 6. Nonfunctioning fire escape

We recommend that the fire escape be inspected and repaired as necessary to be functional prior to building occupancy.
