MISSION INN
5630 Mission Street
San Francisco, CA

Observation and Assessment Report

July 7, 2021

Saida + Sullivan Design Partners, Inc
ZFA Structural Engineers

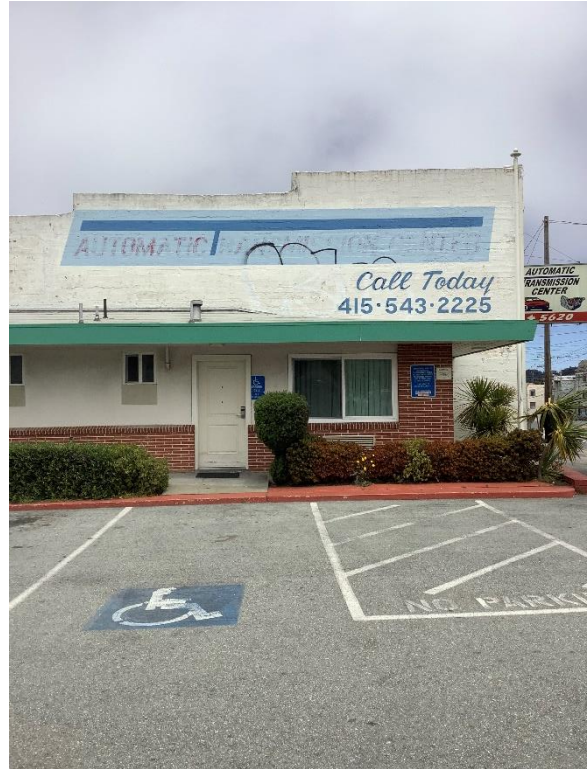
Designated Accessible Van Parking with Signage

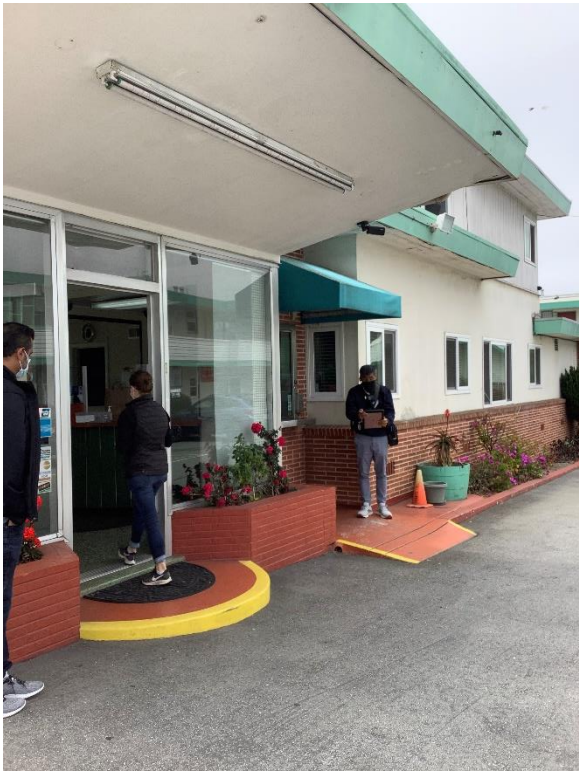
Reception/Lobby Entrance, Service Window with Ramp

Access to the reception/lobby is located at the front of the project site. Access to reception/lobby does not meet either ADA or current California Building Code accessibility requirements due to an existing step at the entrance. A service window next to the reception/lobby entrance was observed which is also not ADA or CBC compliant for accessibility.

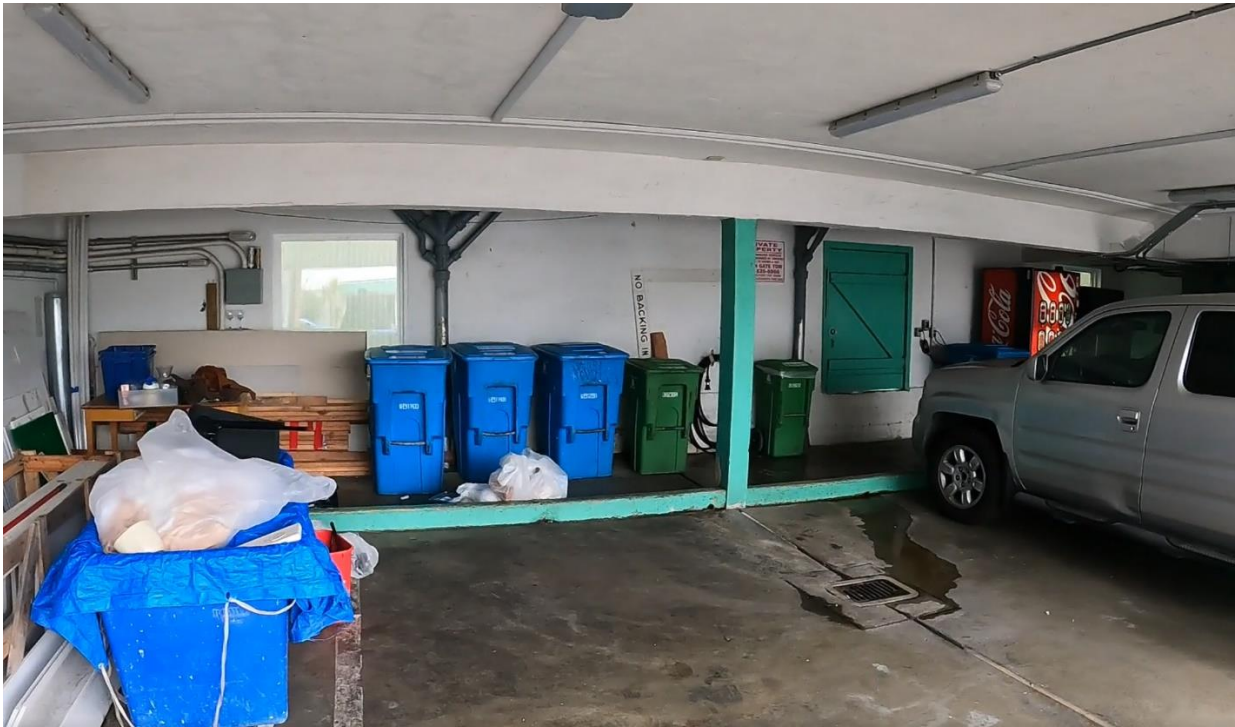
Comments: Currently, the house keeping team members are collecting trash from the motel rooms. Recycling and composting bins are piling up on the ground floor and in the carport spaces. Adding dedicated trash collection areas on each floor and a designated central trash collection area with an enclosure on-site is recommended. Trash pick up frequency would need to be reviewed with the collection agency.

Utility Area, Carport, Trash Collection Area

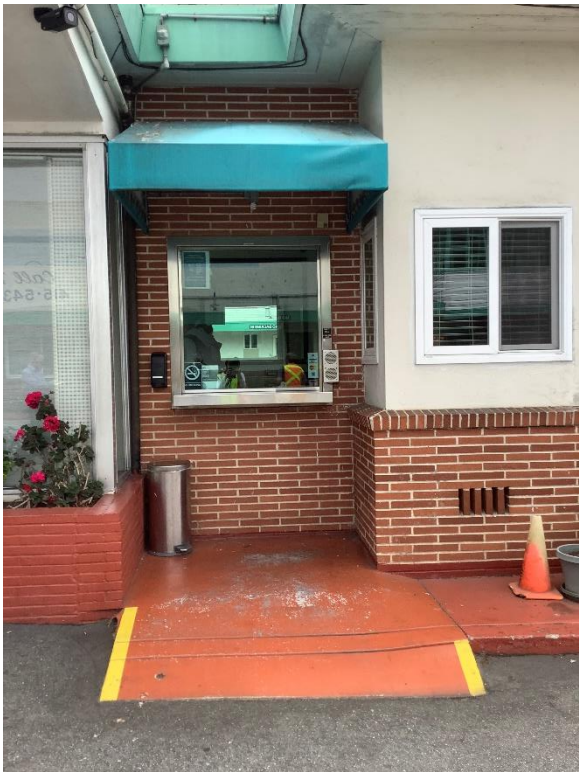
Reception Service Window

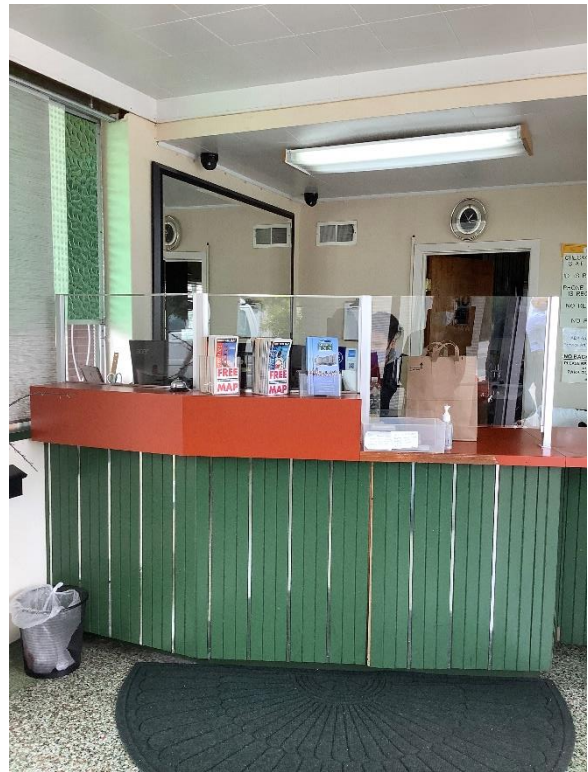
Comments: The reception/lobby interior finishes appear to in poor to fair condition. With the alteration in the building layout to accommodate the new program, all the fixtures and finishes would be replaced.

Reception/Lobby Interior

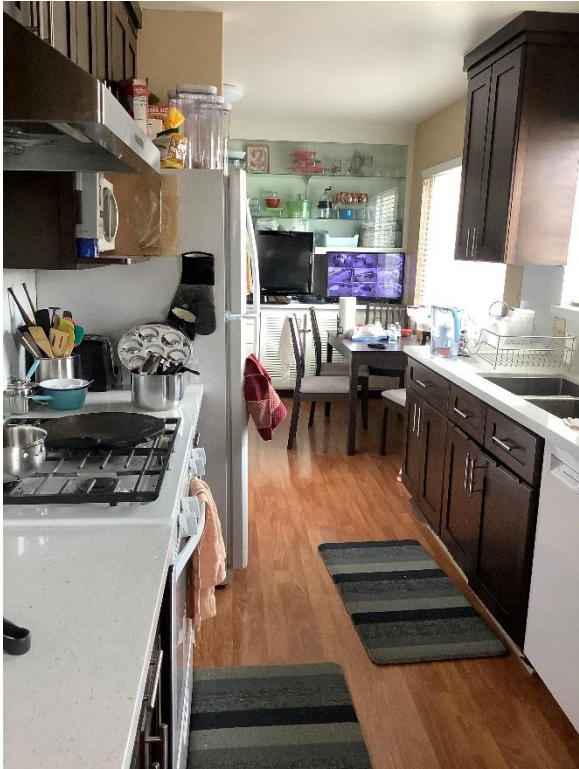
Comments: The Manager's Office and full kitchen do not meet either ADA or current California Building Code accessibility requirements. The interior finishes at the Management Office and private residence appeared to be in good condition.

Kitchen in the Manager's Office/Private Residence

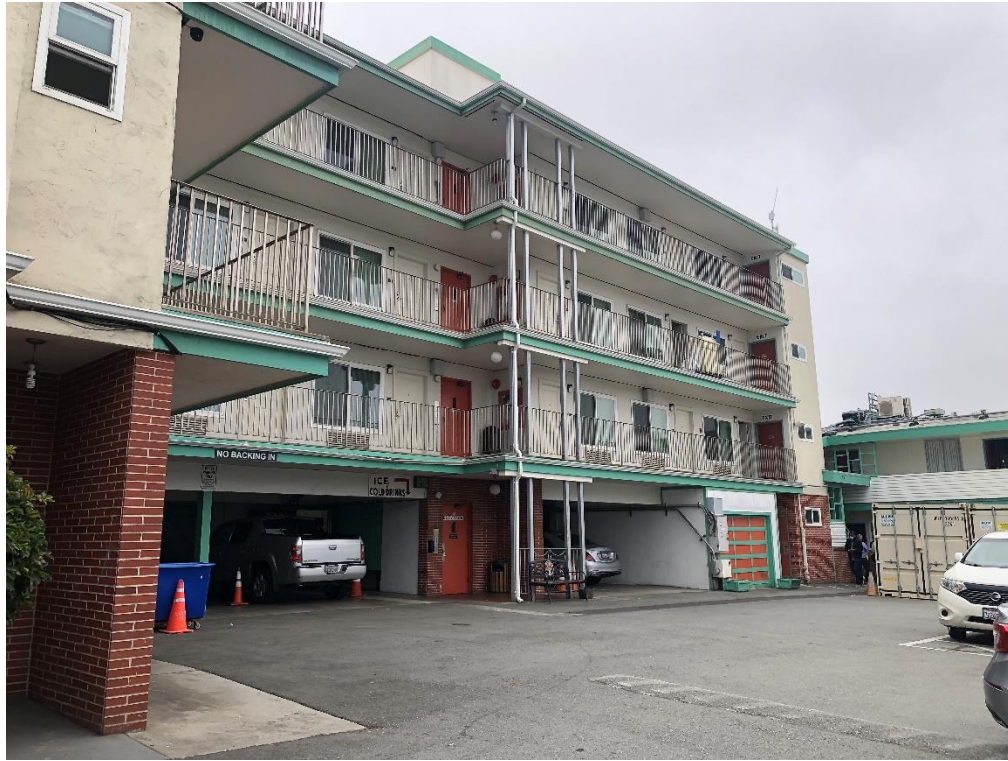
Building A has an obvious soft story condition with limited structural elements to provide lateral resistance at the tuck under parking of the ground floor. Based on the size and construction type, the building appears to be subject to San Francisco's Mandatory Soft Story Retrofit Program (MSSP). According to online records, an MSSP retrofit design was submitted and approved by the building department, but then withdrawn by the owner in 2018 (Application # 201608225613). Another MSSP retrofit design (Application # 201804257385) was submitted the same date as the previous application was withdrawn. This permit has not been approved. The Soft Story Status Report (<https://sfdbi.org/file/8747>) lists the status of the property as "Exempt from program". It does not appear that any seismic retrofit work has been performed on the building.

Photo 1. Exterior of Building A

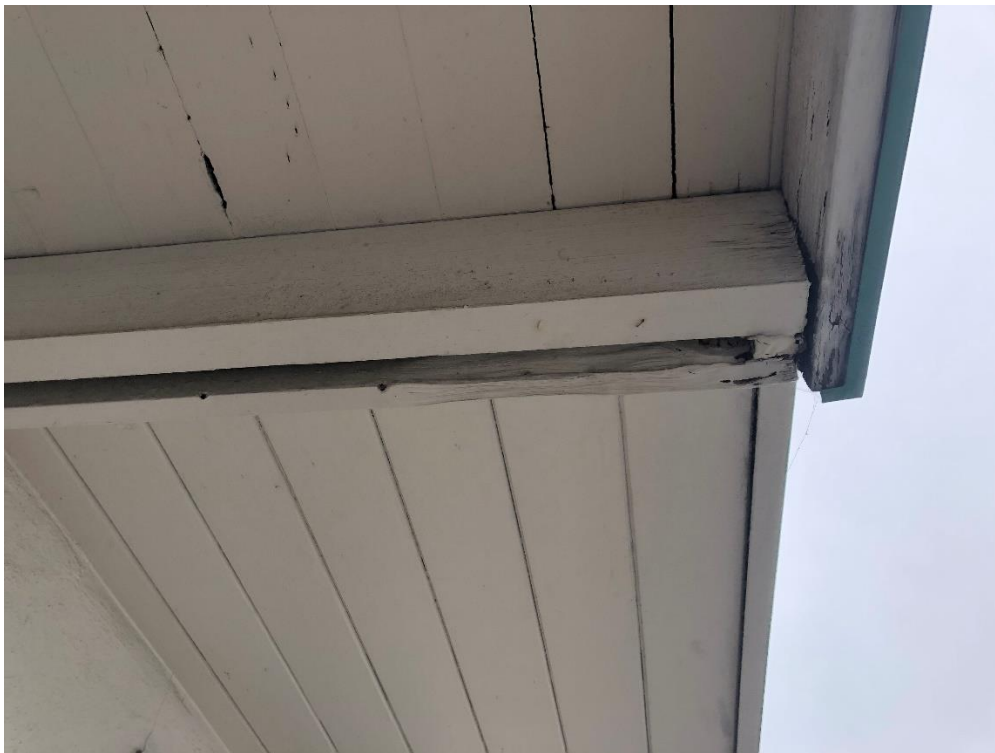
- The ends of the cantilevered wood beams supporting the exterior second floor walkway at Building B are noticeably deteriorated due to water damage and dry rot (Photo 4). Previous repairs were observed in some locations (Photo 5). The extent of damage could not be determined from visual observations.
- The guardrail at the exterior second floor walkway of the east leg of Building B is loose and deteriorated due to the water damage mentioned above (Photo 6 and Photo 7).
- Cracking was observed in the concrete topping slab at the exterior walkways of Building A, particularly at locations where steel railings and posts are embedded in the concrete (Photo 8 and Photo 9). These cracks are likely nonstructural, although they could pose a waterproofing issue to the structure below depending on the waterproofing details from the original construction.

Photo 4. Damaged beam at Building B exterior walkway

- Exterior walkway framing at Building B
 - Remove finishes on walkway surface to expose decking.
 - Perform exploratory investigation to determine the extent of damage.
 - Provide new exterior-grade framing as required to repair damaged framing.
- Guardrail at exterior walkway of Building B
 - Remove damaged and loose portions of the guard rail.

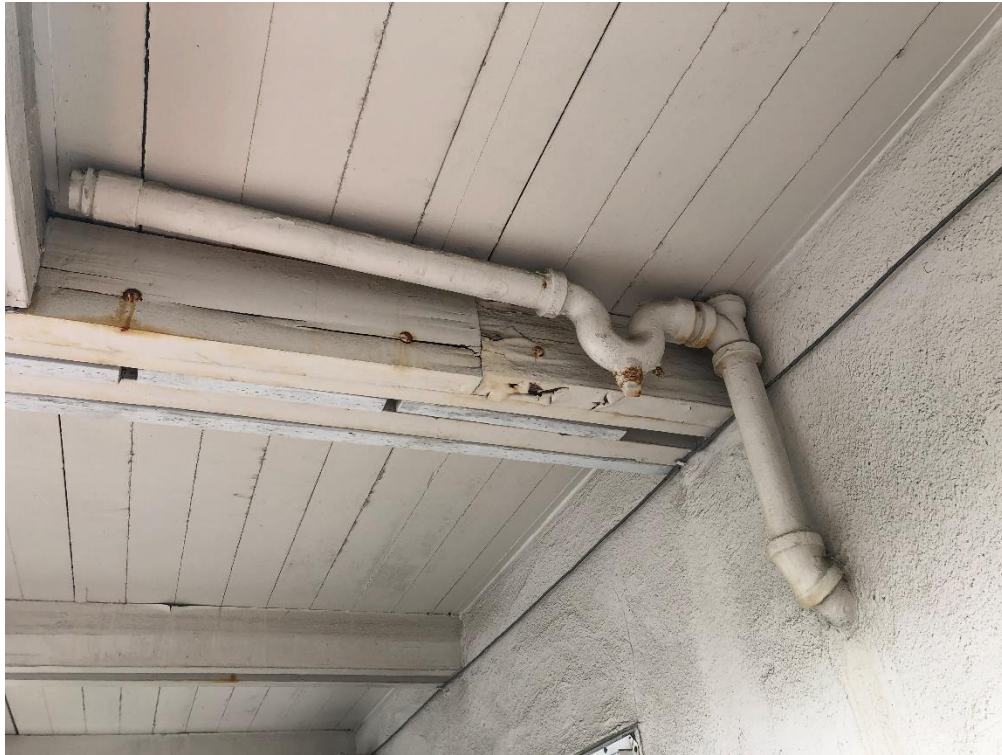
Photo 5. Previous repair at damaged beam at Building B exterior walkway

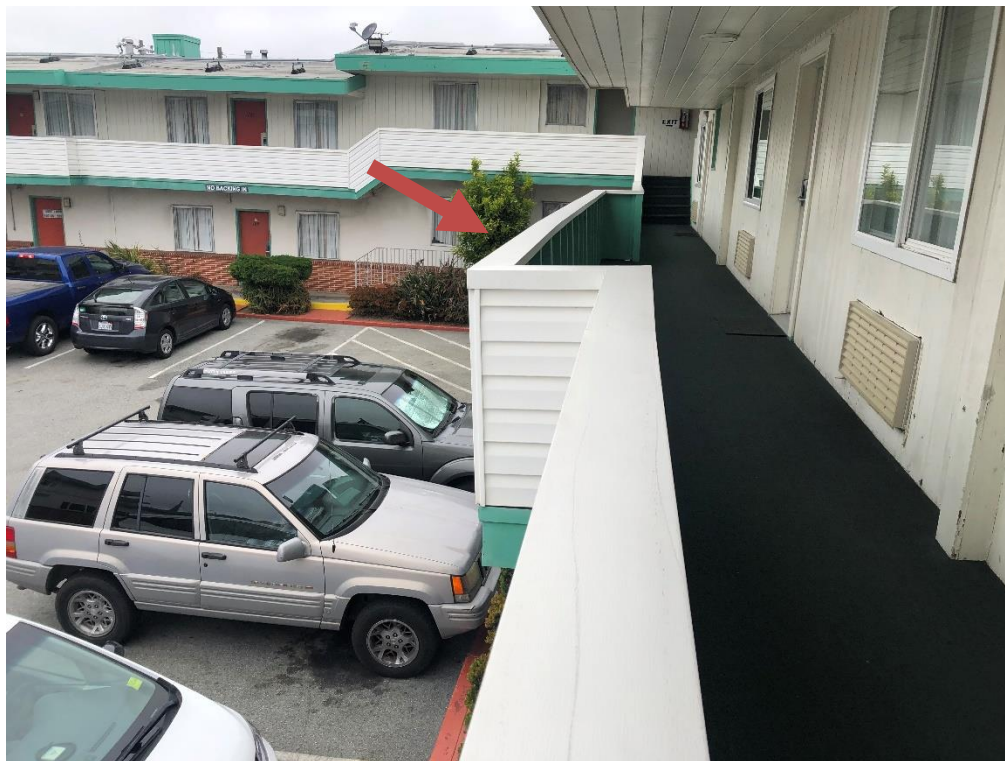
Photo 6. Damaged/loose guard rail at Building B

- Install a new code-compliant railing system.
- Cracking of concrete topping slab at Building A
 - The cracking does not appear to be structurally significant. The walkways are vented below the framing, so we assume that water damage has not occurred as signs of it would be evident from below if significant deterioration had occurred. However, the cracks should be sealed to prevent water ingress to the framing below. We recommend that the cracks be periodically monitored to ensure further damage does not occur.

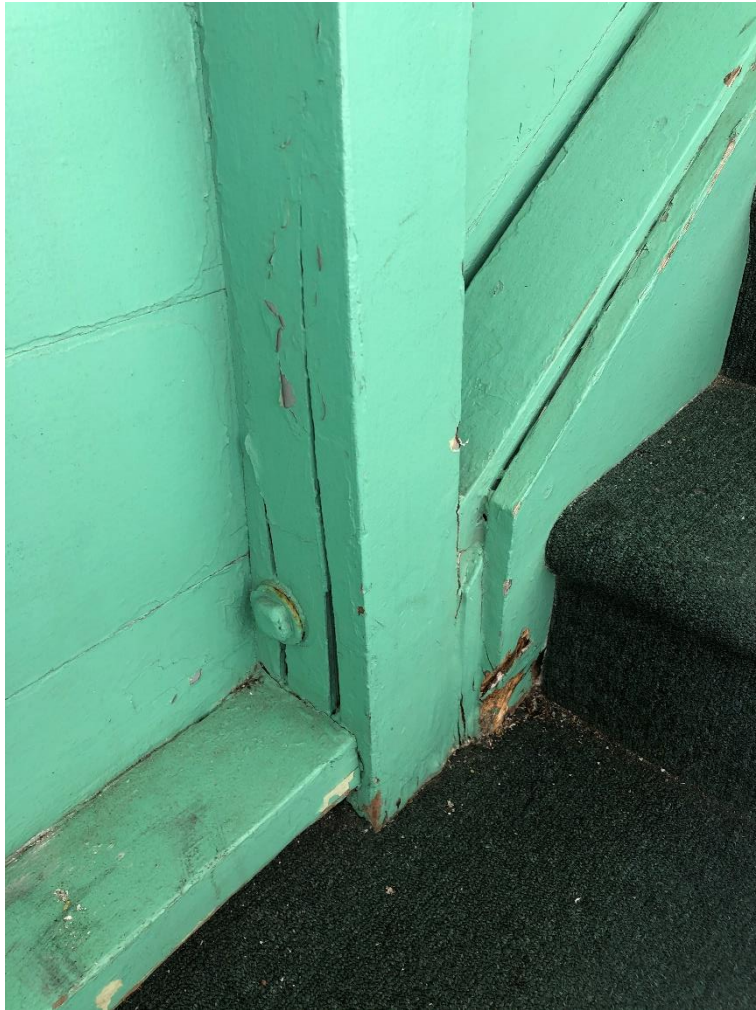
Photo 7. Damaged post at Building B guard rail

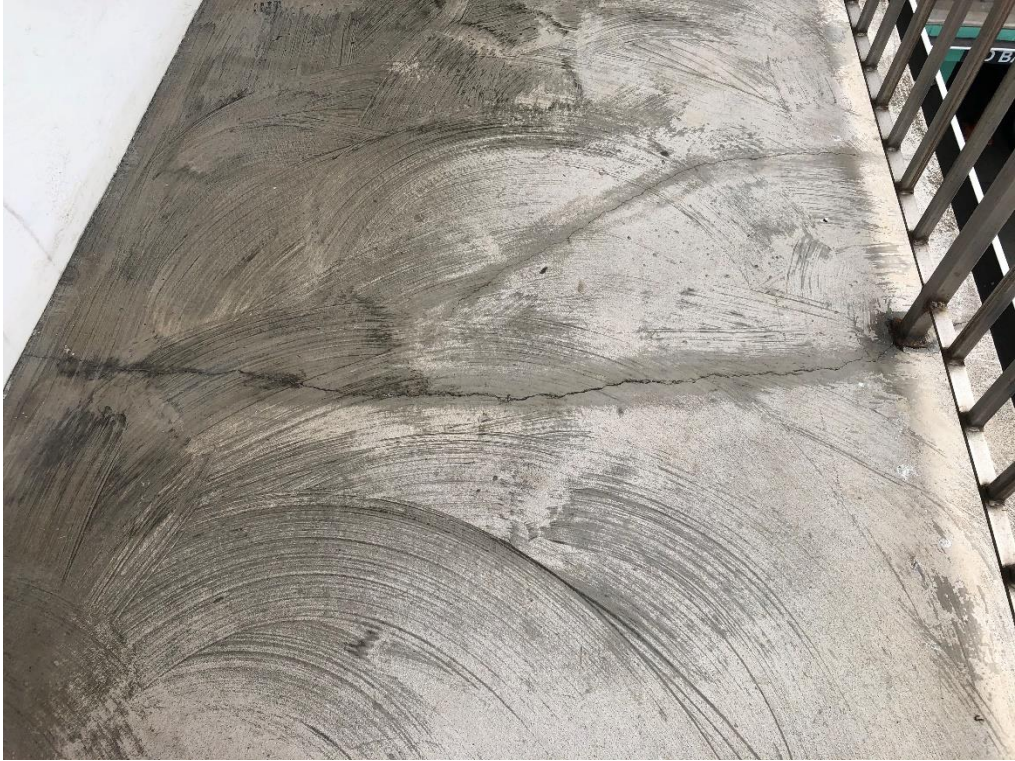
Photo 8. Cracked topping slab at Building A

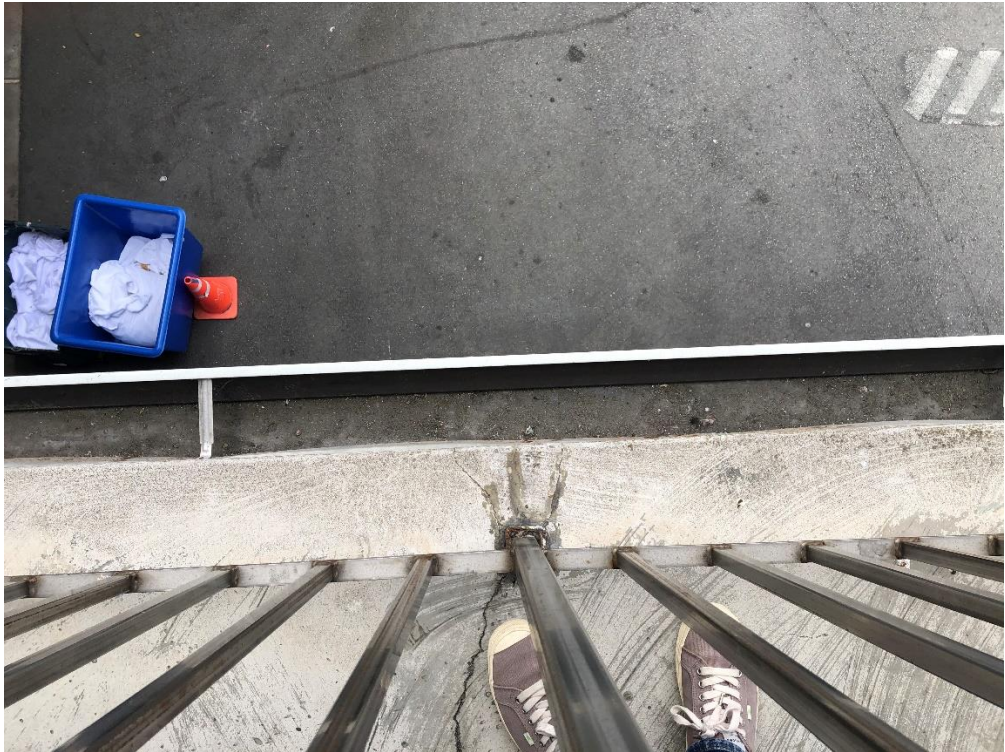
Photo 9. Cracked topping slab at Building A
