PHYSICAL NEEDS ASSESSMENT

THE GOTHAM
835 TURK STREET
SAN FRANCISCO, CA 94102

NOVEMBER 16, 2021

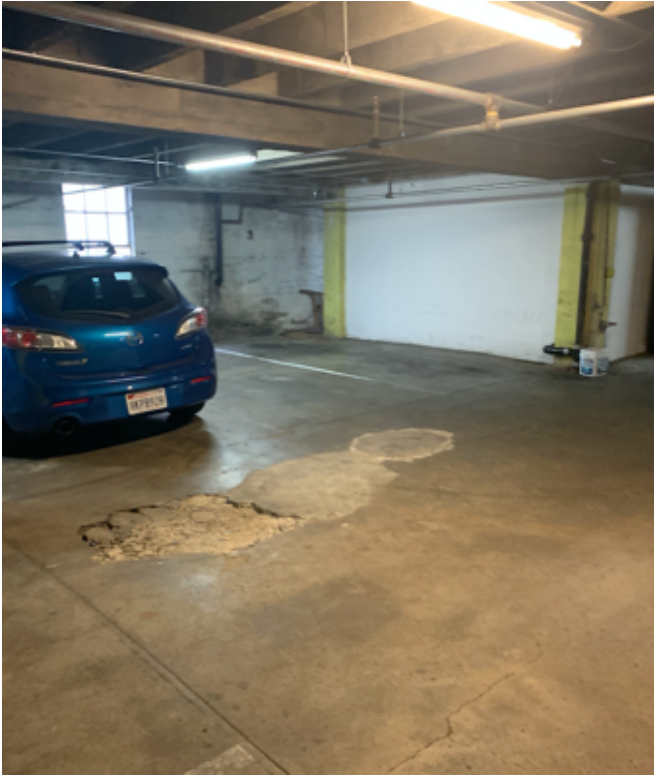
Upper garage

There are two levels of parking at the property. Parking for the upper (main level) of the building is accessed via the automatic garage door on Turk Street. The entry driveway leads to the main level parking. There are approximately 7 parking spaces in the upper garage. The lower garage is accessed via garage doors on Elm Street, at the rear of the building. That parking area is used for parking and storage. The condition of both parking garages is poor. Extensive wear and deterioration of the concrete surfaces was noted. The walls of the garages are worn and in need of repairs. Rehabilitation work for both garages is assumed to be included in the seismic retrofit work.

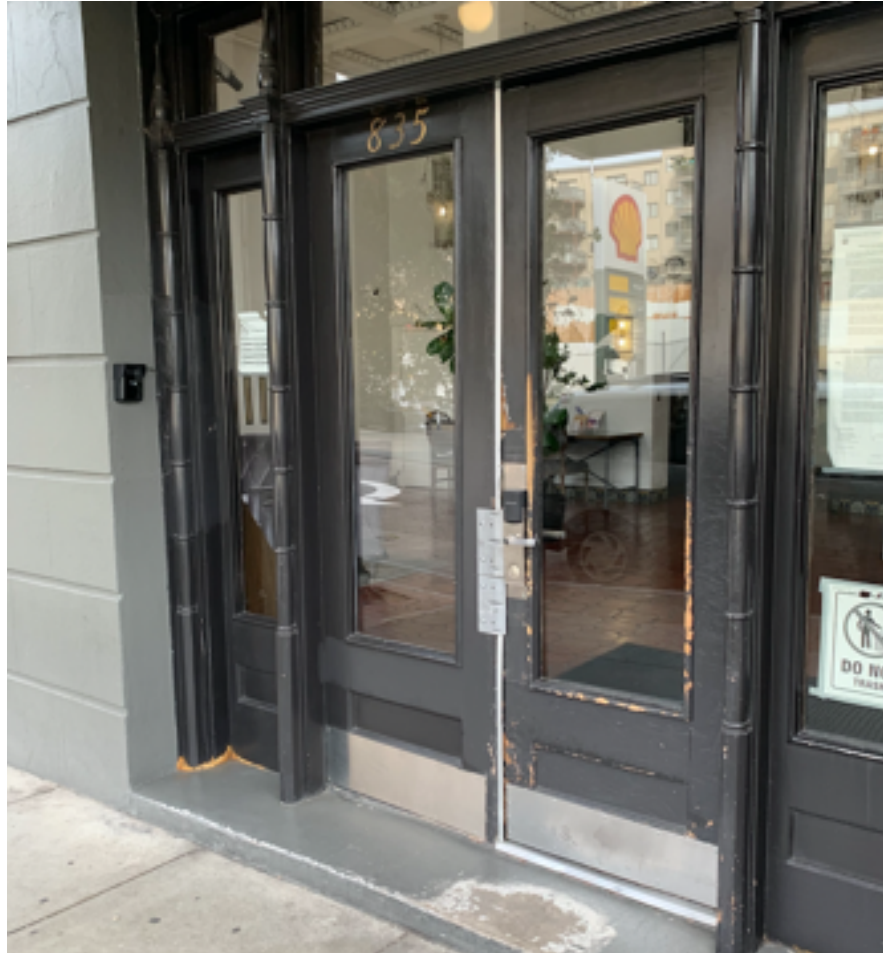
Entry doors

- Entry to the building is not barrier free. There is a step-up to the entry which may exceed the required limits described by the ADA guidelines.
- Entry door to the building requires grasping a non-ADA compliant door handle and action to pull the door outward. The door hardware is not compliant, and the swing-action of the door is not compliant.
- There is no automatic entry mechanism into the building.
- Clearances in the lobby may be accessible as the lobby area is large and spacious.
- At least one of the elevators may be accessible given that they were recently replaced. If not, it is assumed that an exemption was granted or is possible.
- Access to and maneuverability to the garages and within the garages are not barrier free.

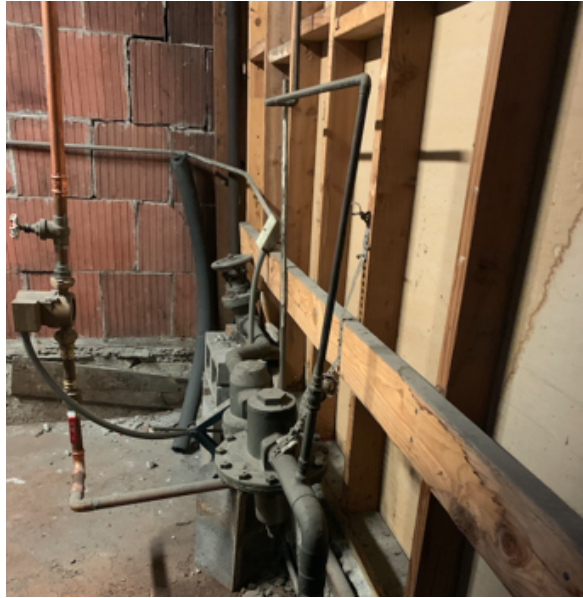
The observed conditions of the building interiors were good since the common areas and rooms were recently renovated. The building structural conditions, however, are in need of upgrades. A structural report was provided for review. The findings and recommendations in that report should be carried out in the immediate scope of work. Corresponding costs, based on that report, are shown on Appendix A.

Terra cotta wall and crumbling footing wall – observed at boiler room – upper garage

damaged and worn. Repair/remove and replace terra cotta tiles currently installed in the basement (lower parking) stairwell and other locations throughout as those materials are damaged or missing in many locations.

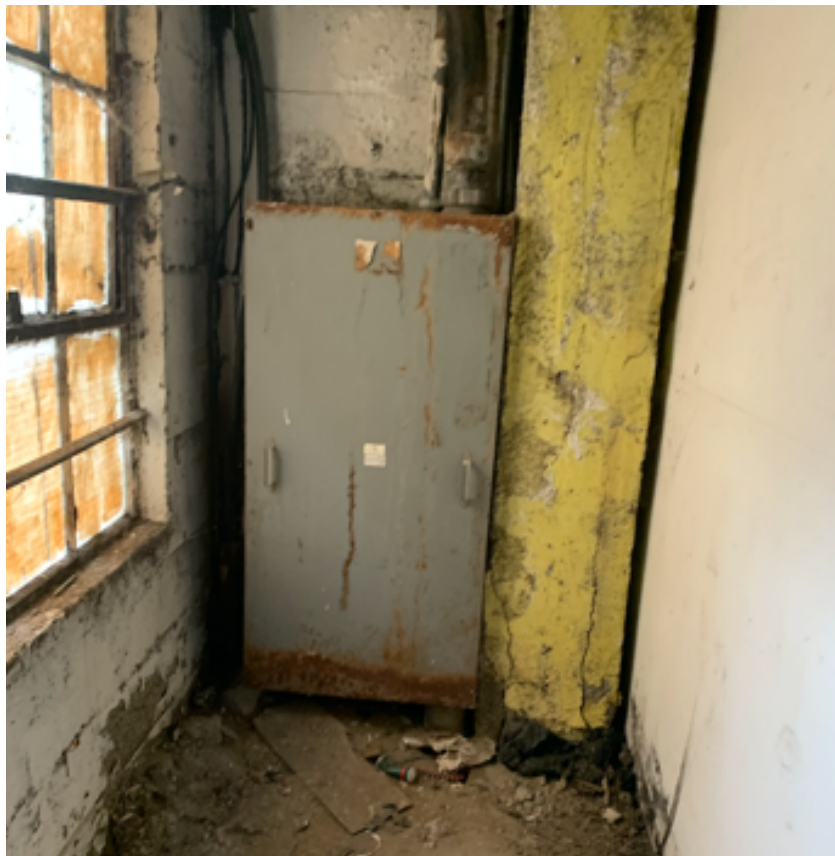
Stressed concrete post at upper garage (east side) near electrical switchgear

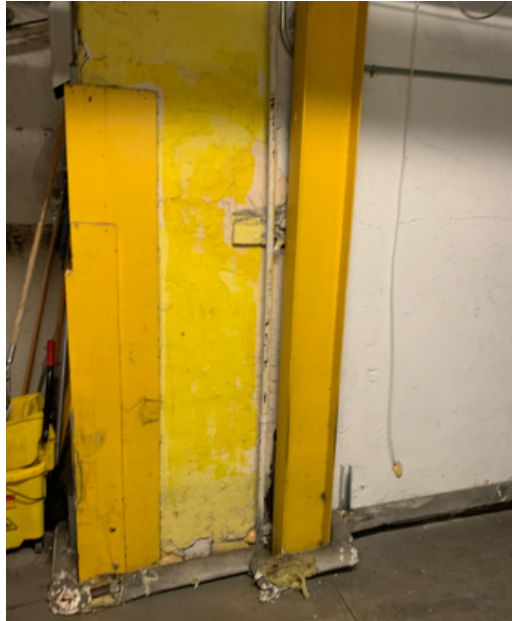
Structural steel at driveway entrance

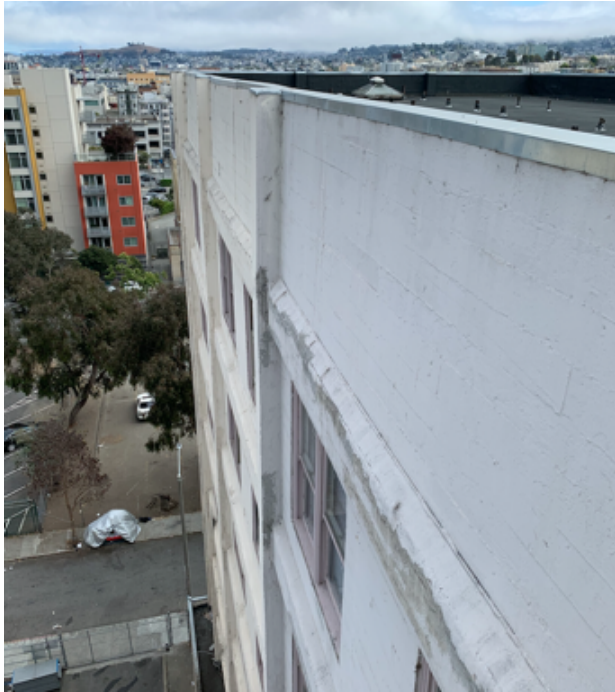
The exterior siding materials are original to the building. The overall condition of the siding is fair. At 100+ years old, it should be expected that moderate wear would occur. Wear was noted at the exterior siding. Repairs, as needed, and exterior paint, should be done in the immediate scope of work. Care should be given to maintaining the historical elements of the building exterior.

Concrete wall siding at east side of building

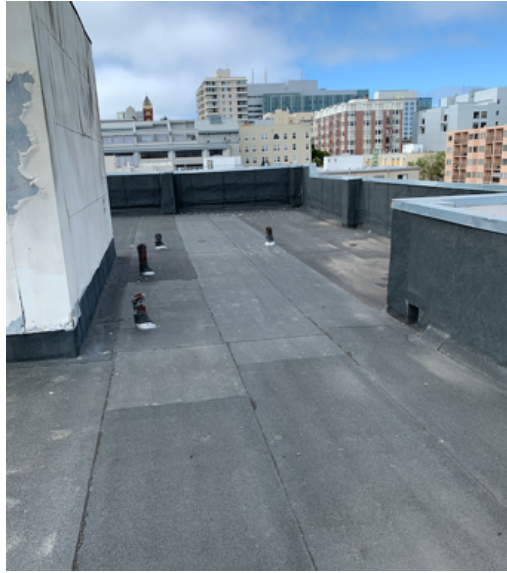
Roof surfaces

The roofing is in good condition and should be expected to last another 5-7 years.

When roof surfaces are replaced in the future, the contractor should provide a minimum 30 year guarantee on the materials and an acceptable minimum term guarantee on installation. Consideration should be given to using a “cool” roof finish material to maximize energy efficiency.

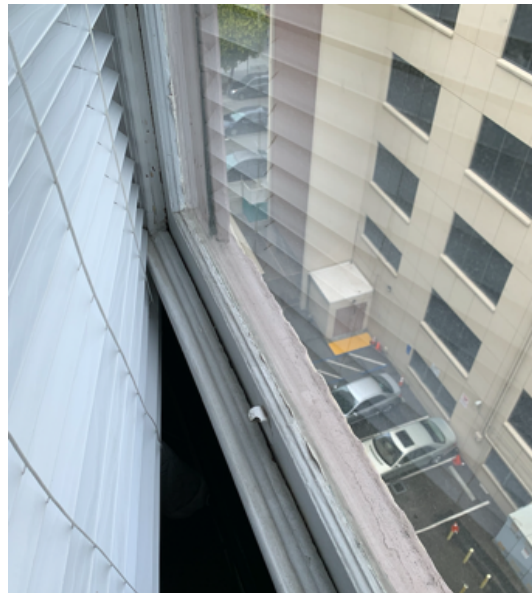
Unit window

The window openings are original, wood framed sections. Windows are wood framed and are either original or moderately repaired/replaced. The windows are single paned, double hung units. No issues were found. Historic windows of these kinds are typically very inefficient when it comes to heat gain and loss for the interior spaces. Since they are old and single paned, they don't have high insulation qualities.

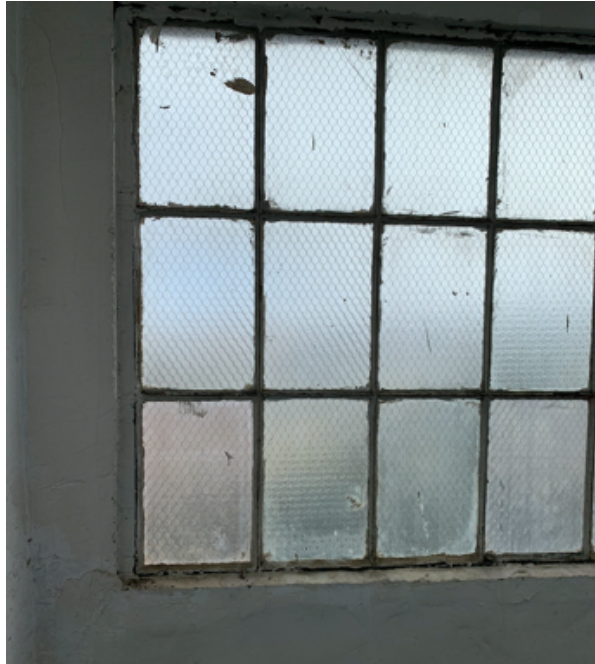
Stairwell window

The rear stairwell windows are metal framed units with wired glass panes. These windows are in poor condition and should be replaced.

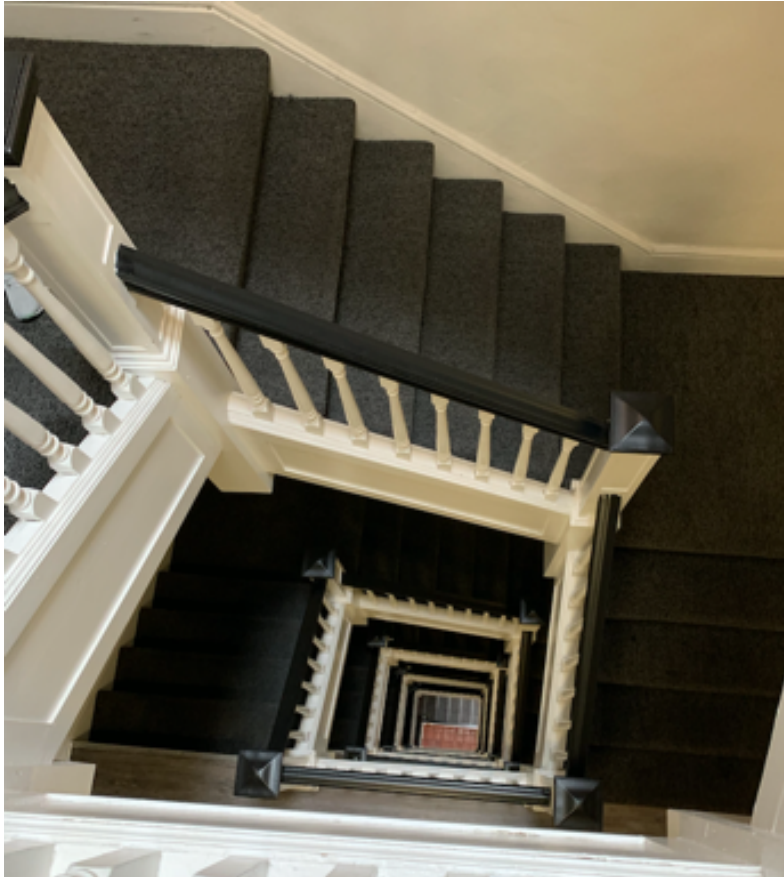
Main stairs

Upper units are accessed via the elevators and via a central stairway located in the middle of the building. The stairs are wood framed and enclosed. Stair railings are wood dowel type railings. Stair treads are coated with carpet. Stairs, railings and carpeting are in good condition.

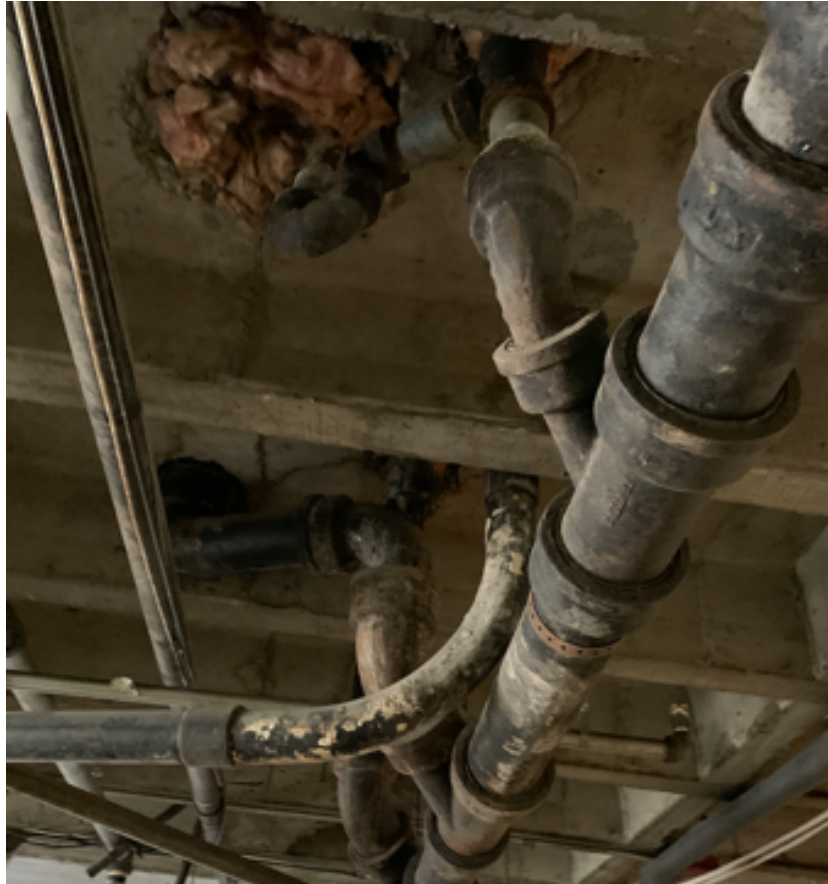
Garage ceiling

Ages of plumbing materials appeared to vary greatly. Some well-aged waste piping was observed, older supply piping was observed. Evidence of historic water leaks were noted in the basement.

Since the plumbing systems are a hodge-podge of materials, it is recommended that the plumbing: supply, waste and vent systems be evaluated by a licensed plumbing contractor or engineer.

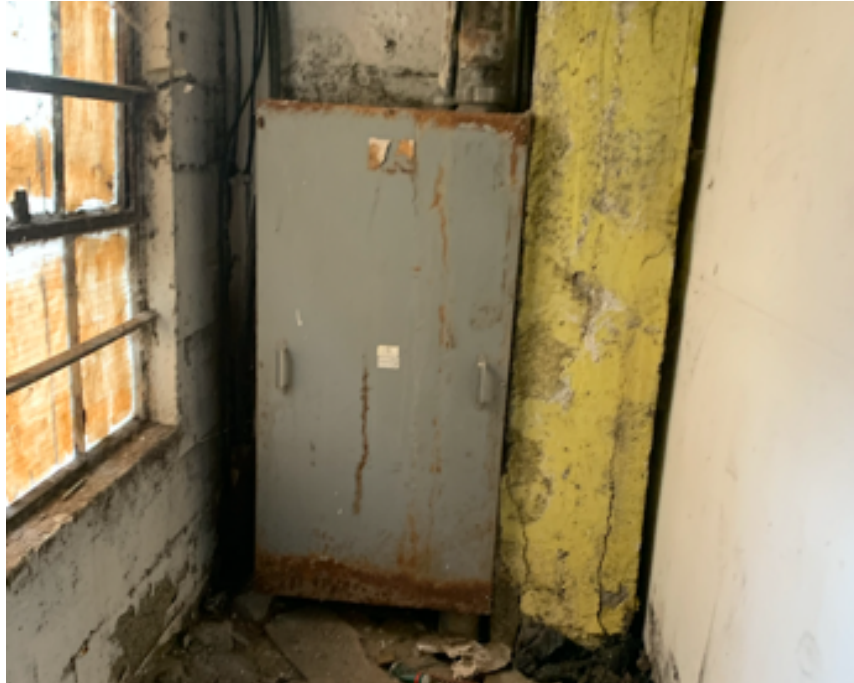
Transformer / service entry container at electrical switchgear area. No information as to whether this is online or not was ascertained. The tag was worn off.

It is strongly recommended that an electrical engineer evaluate the existing systems, conduct a load calculation and make recommendations for electrical work at the building. Removal of the original and aged electrical systems should occur in the immediate scope of work. Install new or upgraded electrical service, main switchboard, panels, conduct, wiring.

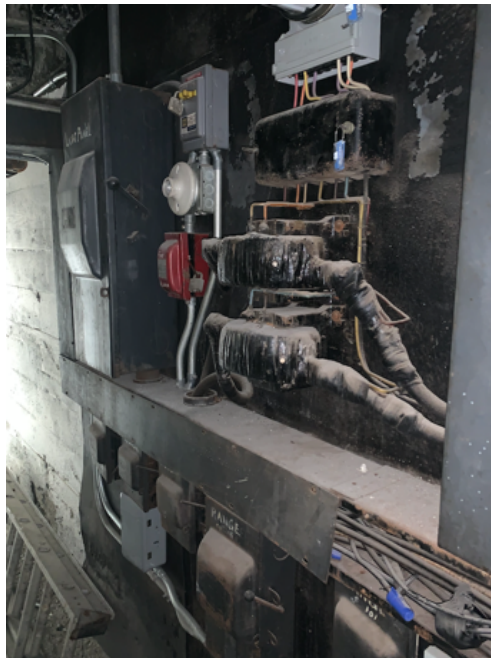
The building is serviced by a 400 amp main which, by all accounts, is original. Numerous newer subpanels and presumably additional service have been added over the years. It is assumed that some additional power service has been added to electrify the newer elevators at the building and for other purposes. No logic could be adhered to the electrical systems for the building. No electrical permit data could be located on the SF DBI website.

Main and various subpanels. Newer meter above.

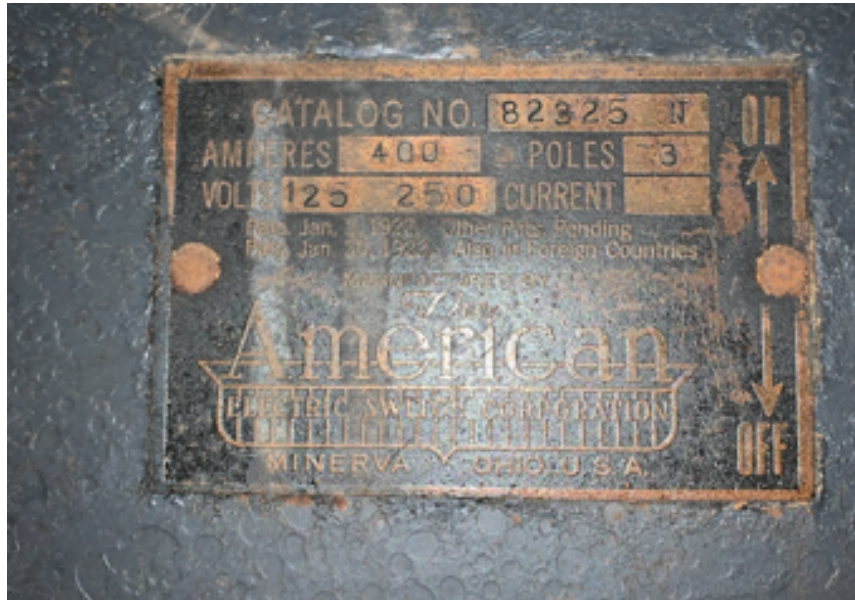
Original tag on breaker cover
