**City Gardens 333, LLC**  
San Francisco, California

**Property Condition  
Assessment Report**

**March 26<sup>th</sup>, 2020**

**LJP Project #20-4482**

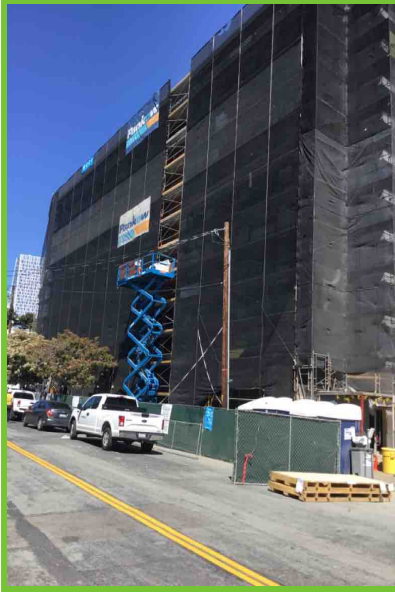
1

Note: 12th street elevation

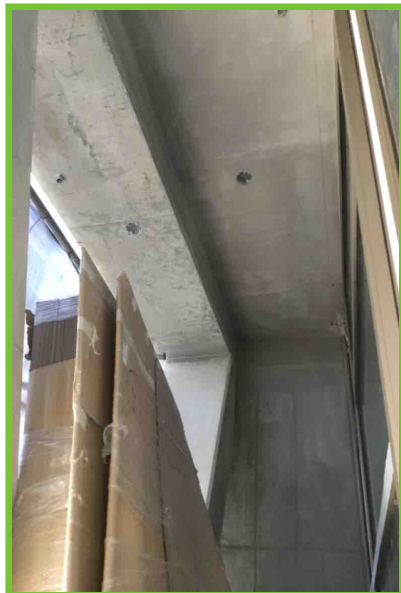
12

Note: Entry west promenade

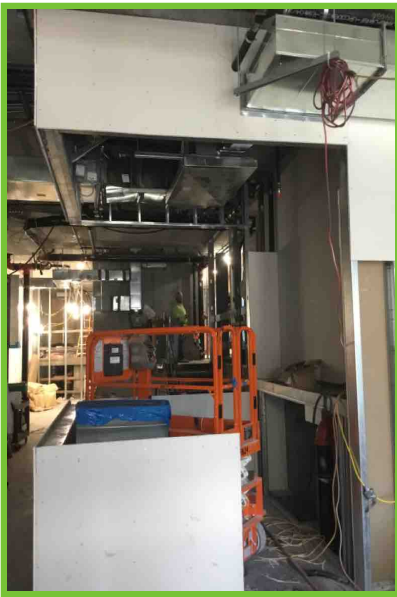
15

Note: Lobby

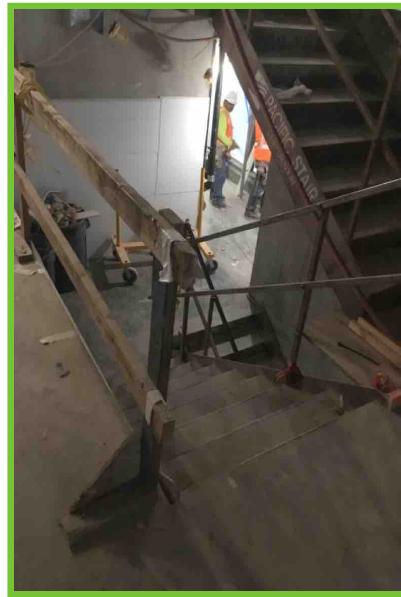
16

Note: Garden level stairway

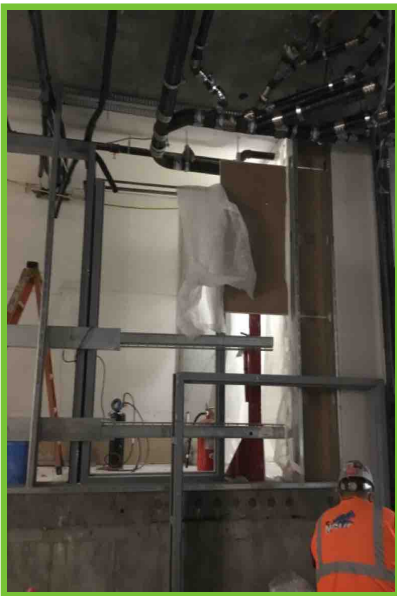
17

Note: Lobby

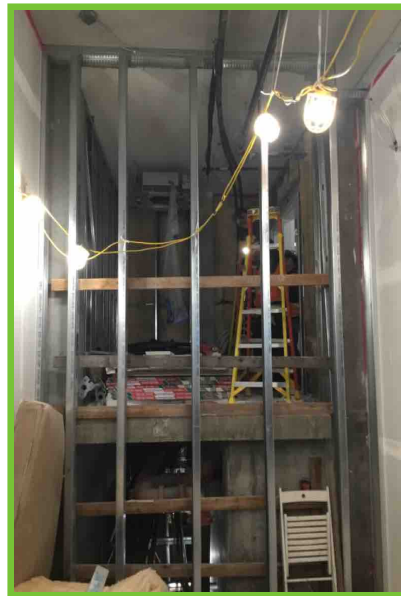
18

Note: Lobby

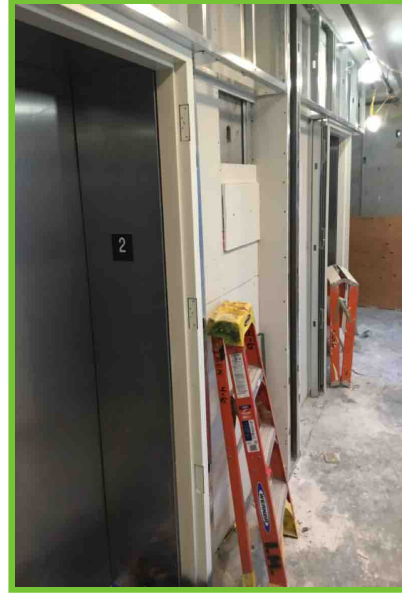
20

Note: Elevators facing East courtyard

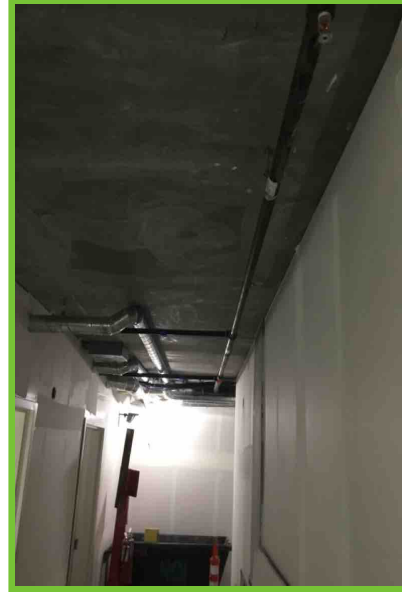
22

Note: Office mechanicals

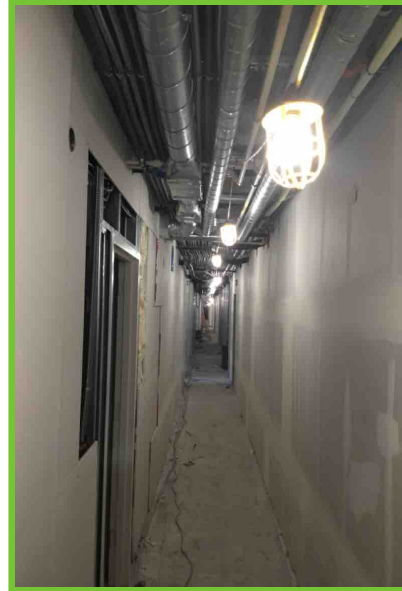
24

Note: Level 2 corridor

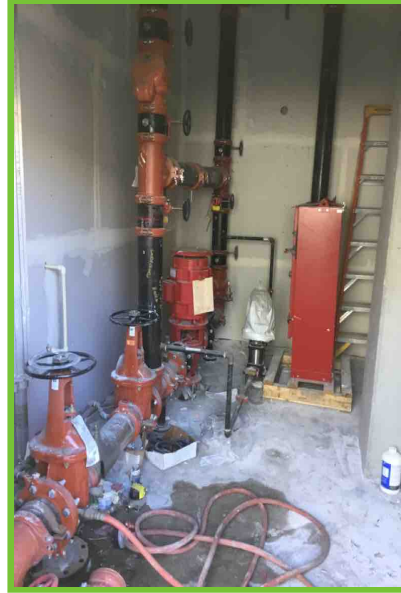
26

Note: Fire pump room

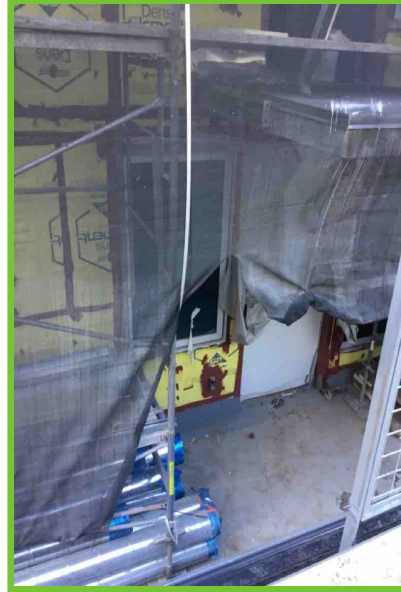
28

Note: Norfolk stairwell

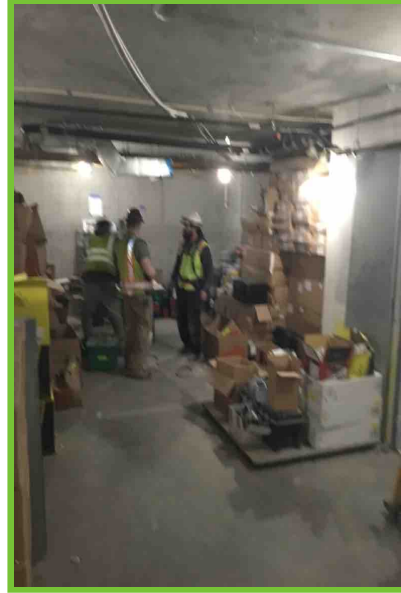
38

Note: Basement bike room

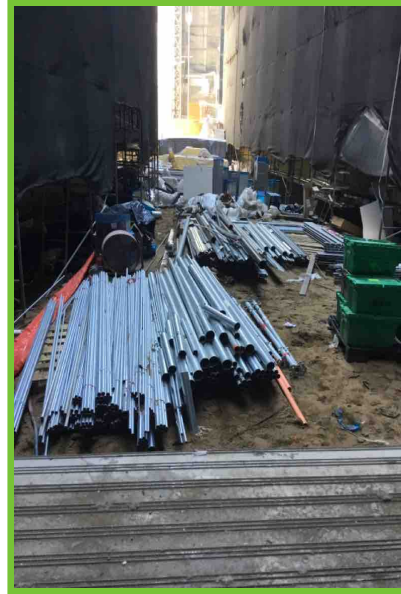
40

Note: Courtyard

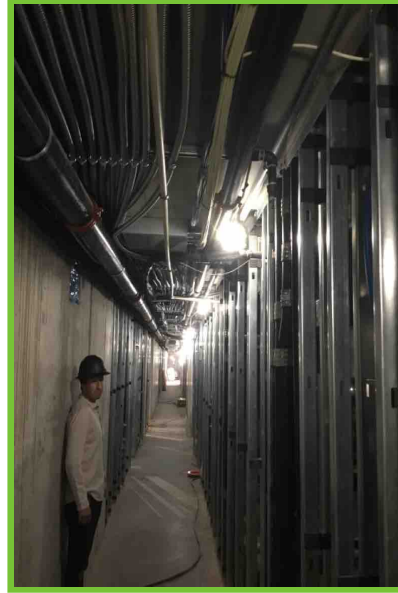
44

Note: Level G corridor

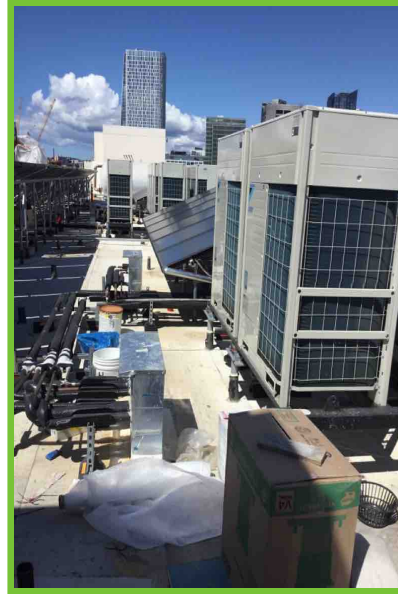
46

Note: Roof level

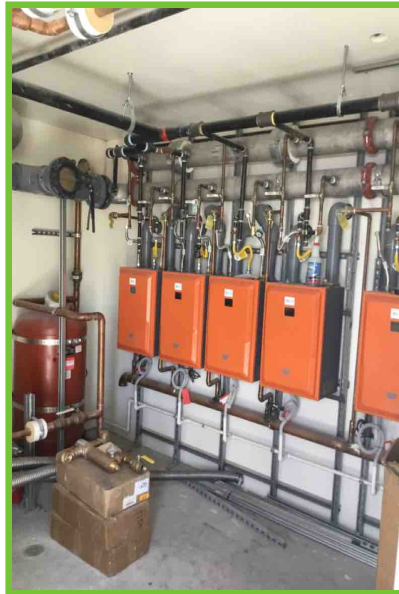
66

Note: Rooftop mechanical room

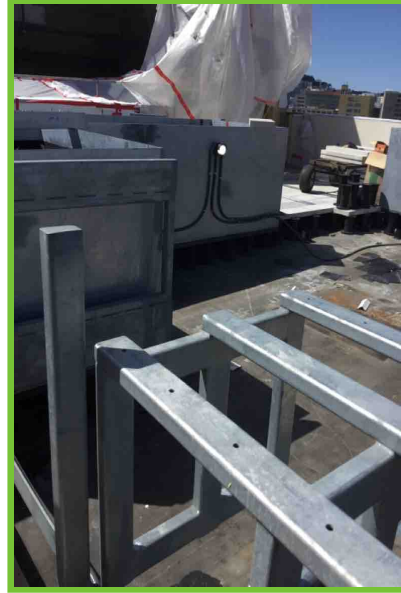
68

Note: Rooftop planters & patio

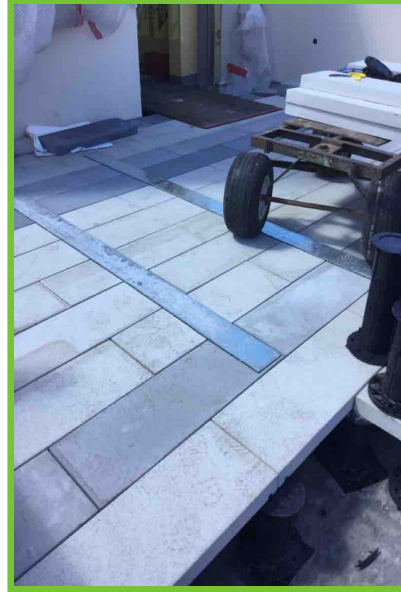
70

Note: Rooftop patio pavers

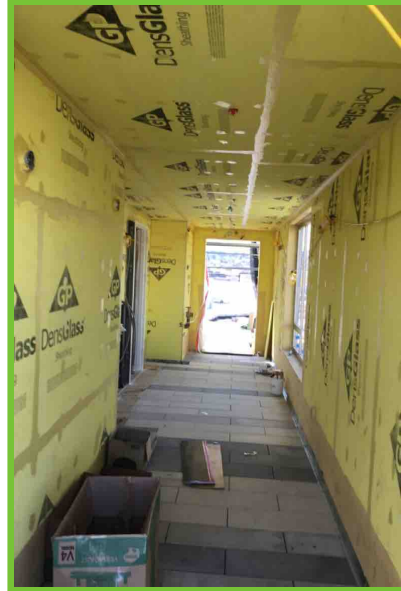
72

Note: Rooftop elevator lobby

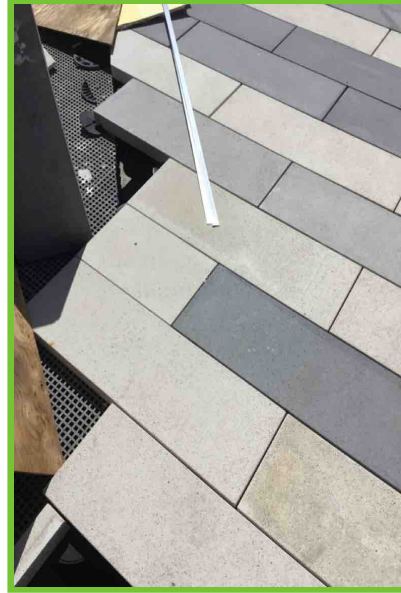
74

Note: Rooftop patio

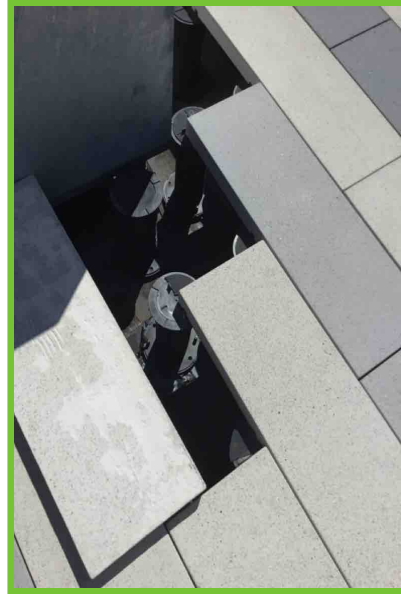
76

Note: Rooftop patio stations

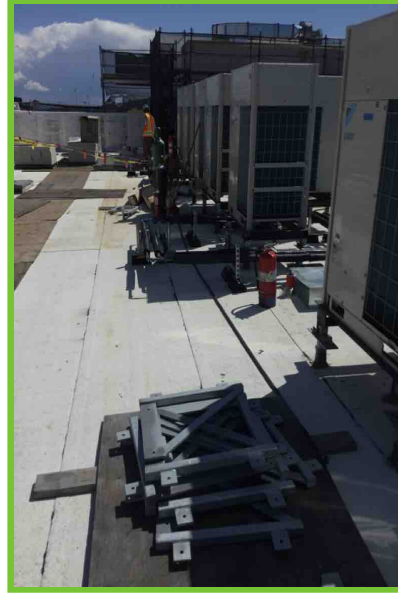
80

Note: Rooftop heat pumps

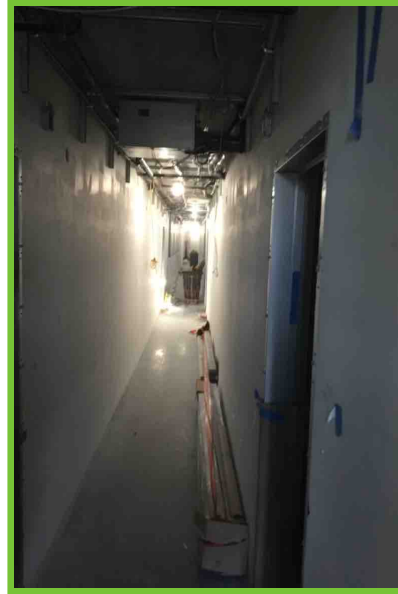
82

Note: 7th floor corridor B

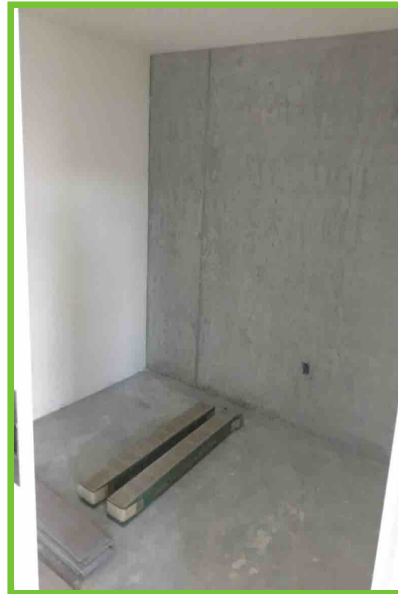
84

Note: 702 bedroom

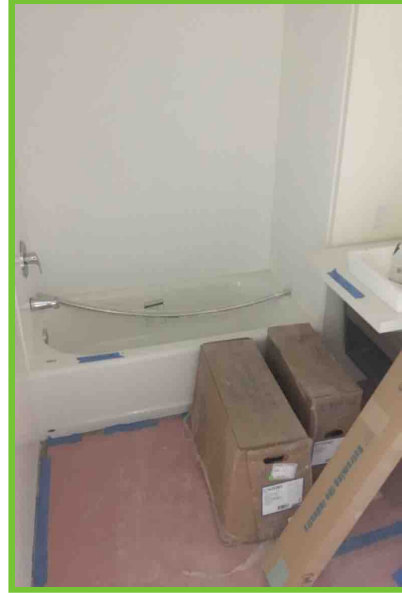
86

Note: 702 bathroom

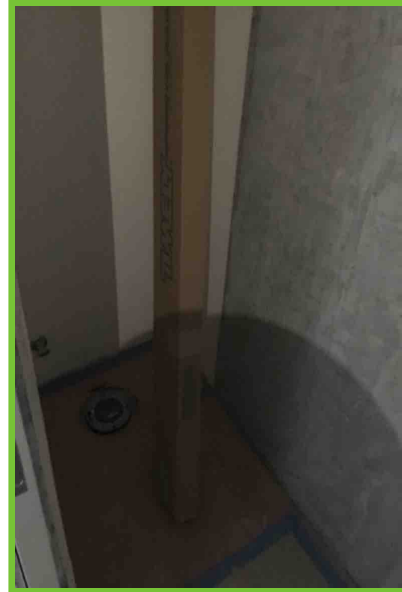
88

Note: 702 powder room

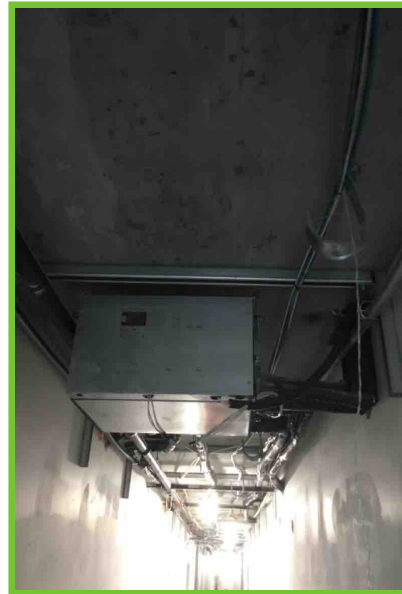
90

Note: Corridor 7 B

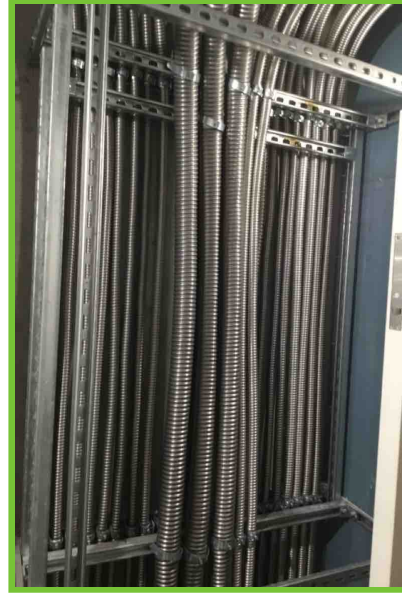
92

Note: 7th floor electrical

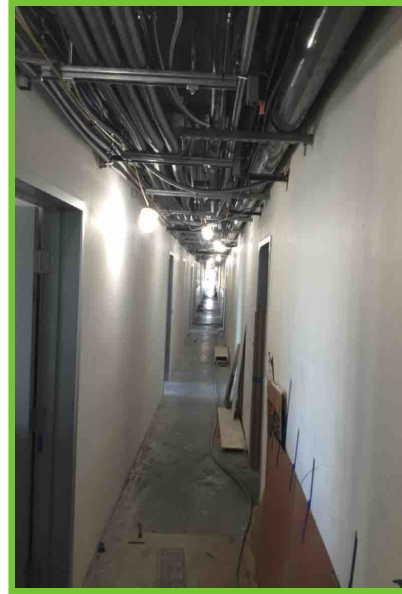
94

Note: Corridor 7 A

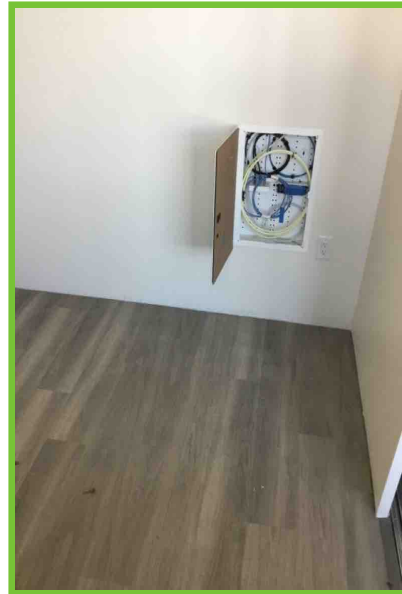
96

Note: 711 B2 Bedroom & Smart cabinet

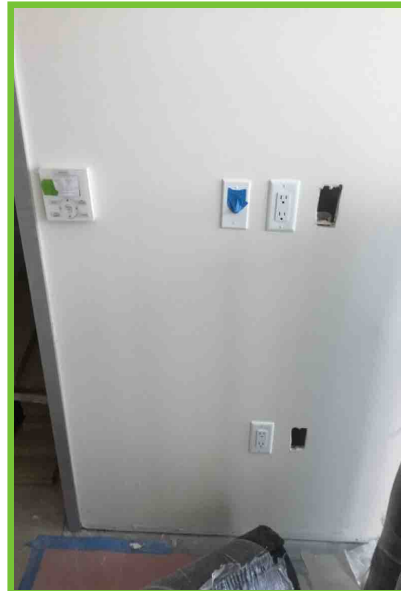
102

Note: 720 B3

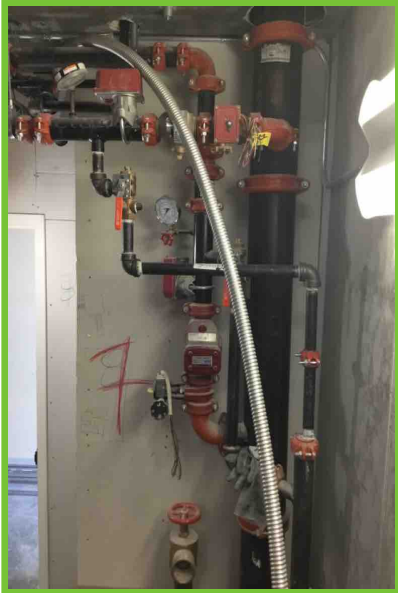
103

Note: 7th floor Fire controls

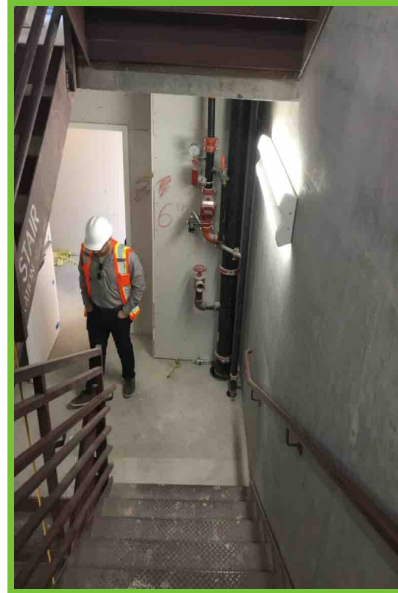
104

Note: 6 A stairwell

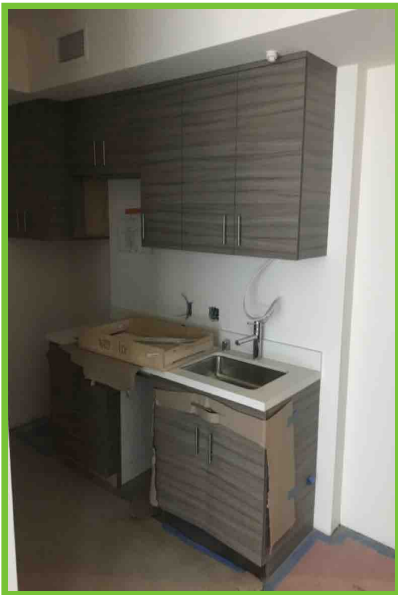
105

Note: 624 B3

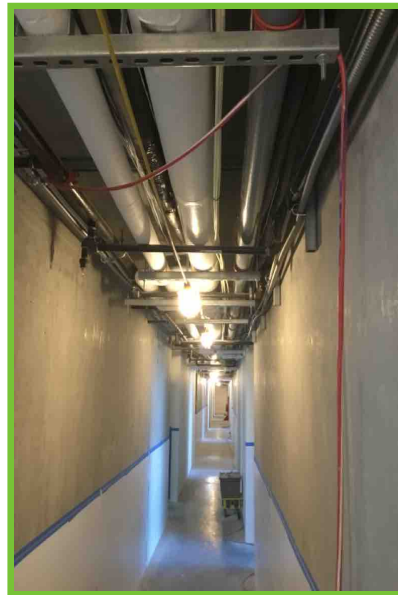
106

Note: 6 B corridor

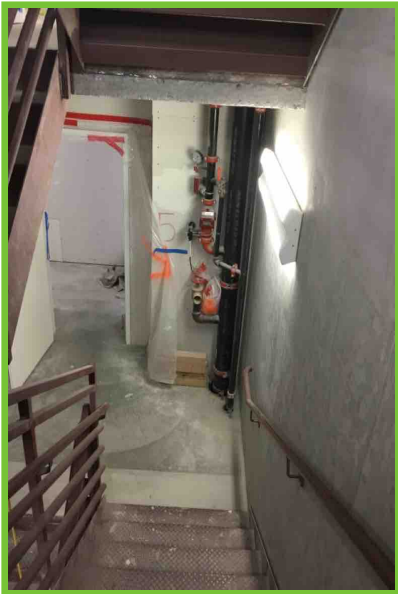
107

Note: Corridor stairwell 5B

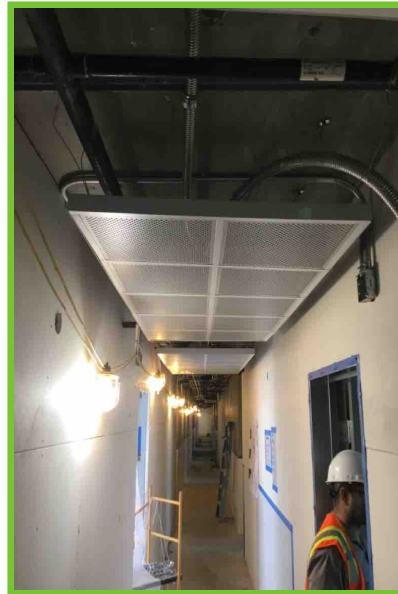
108

Note: 5B corridor

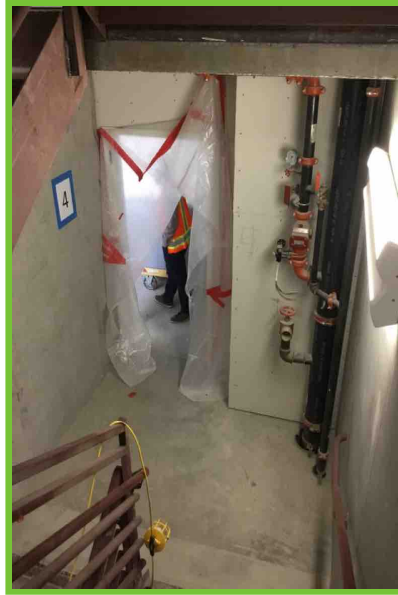
110

Note: 4B corridor

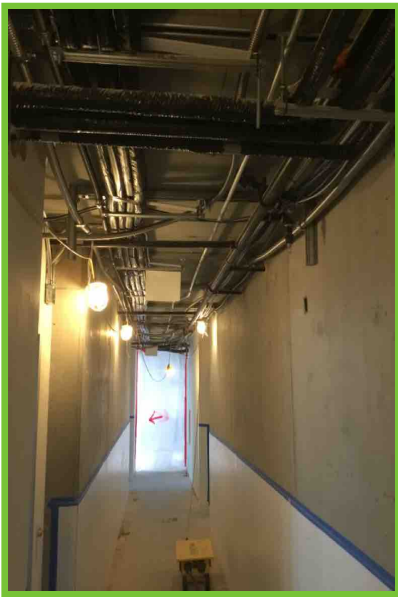
111

Note: 4B corridor

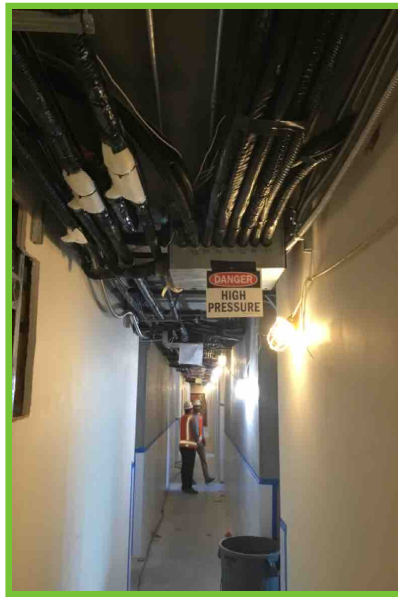
112

Note: 4B corridor

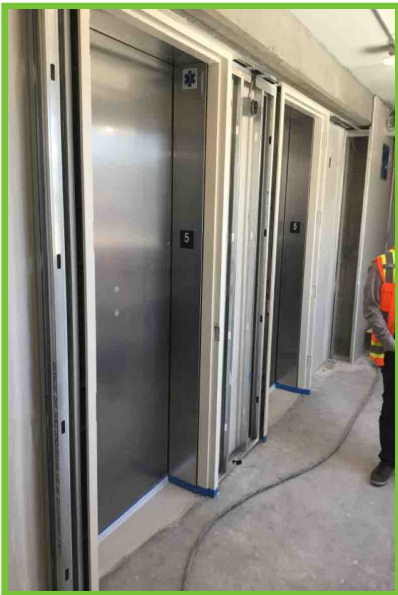
117

Note: 4th floor west elevators

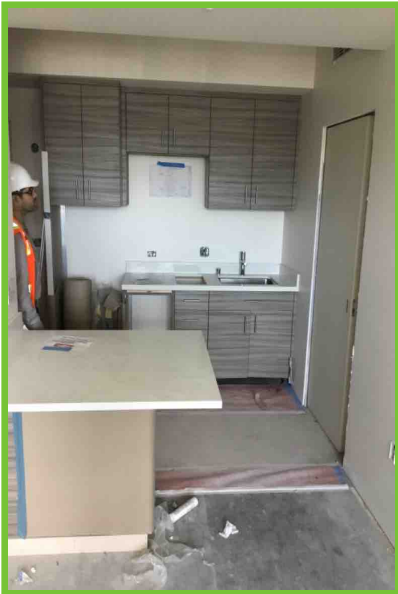
119

Note: 412 B6 Kitchen

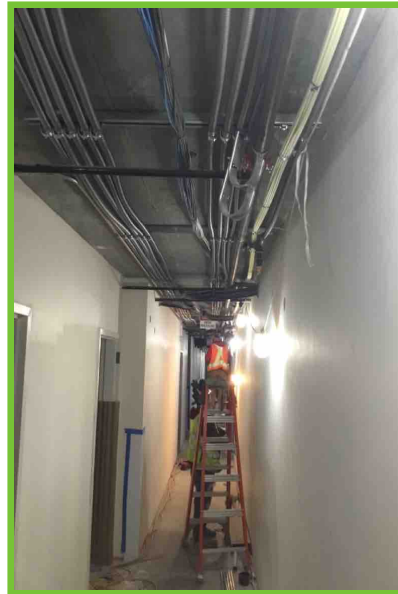
120

Note: 4th floor Corridor A
