# **PHYSICAL NEEDS ASSESSMENT**

**42 OTIS STREET**  
**SAN FRANCISCO, CA 94103**

MARCH 20, 2023

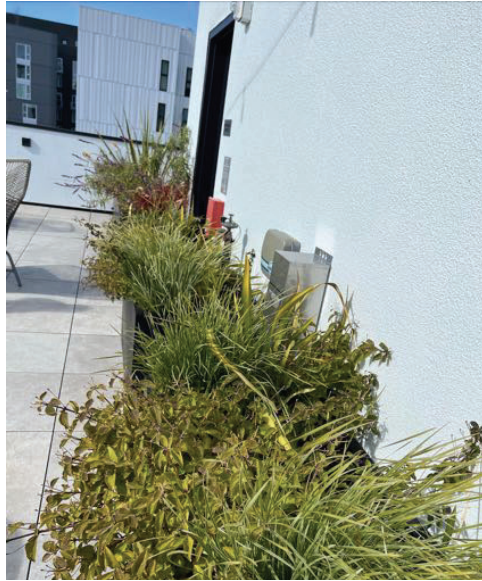
The roof deck contains a walking surface (raised wood/trex decking), seating, planted areas, and amenities. The roof deck is in good condition.

*Roof deck planter*

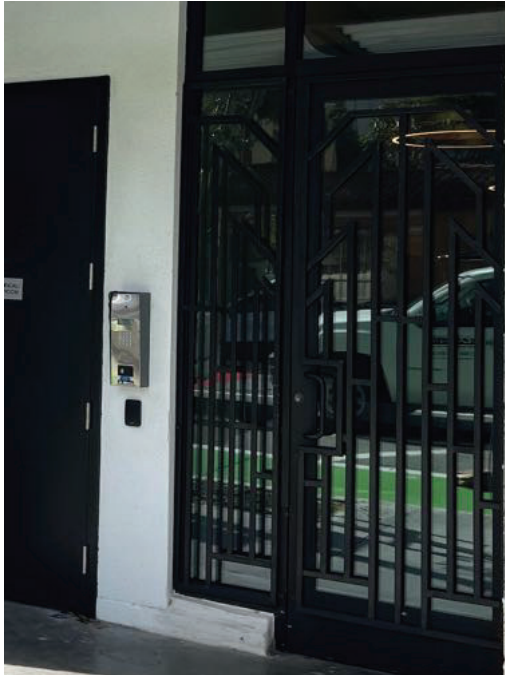
*Entry door*

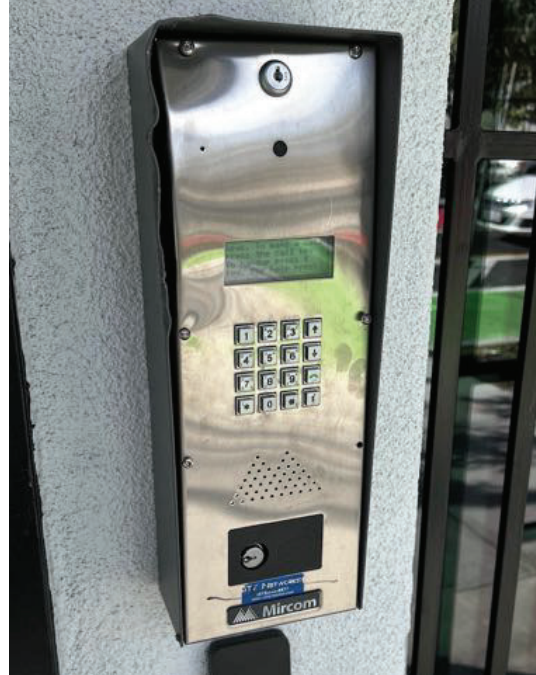
The main entrance to the residential building is located on Otis Street. Residents can enter the building via the wall mounted keypad by entering a code or by using a key fob. The keypad controls box was damaged at the time of the site visit. It should be repaired in the immediate scope of work.

*Damaged keypad*

PNA Ref Page	Area/Item	EUL*	H&S? NOTES	Priority	Unit Cost	QTY	Totals	Description
6	Entry call box	10	y	1	\$ 7,500	1	\$7,500	Replace damaged call box
6	Sofft vents	30	y	1	n/c	1		Re-engage painter to clean soffit vents. Remove paint.
	Graffiti removal							Can be done via maintenance company.
<b>TOTAL IMMEDIATE NEEDS</b>							<b>\$7,500</b>

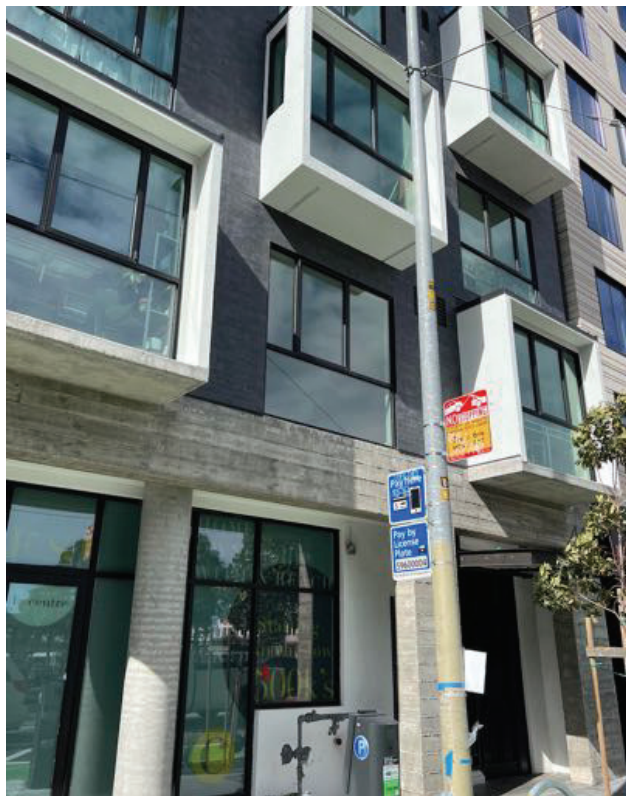
The siding is in good condition in all locations. From a maintenance perspective, the exterior siding should be maintained in terms of finishes – prevent any wood sections from rotting, paint painted metal at regular intervals, maintain concrete sections by removing any harmful elements and resealing.

*Exterior siding*

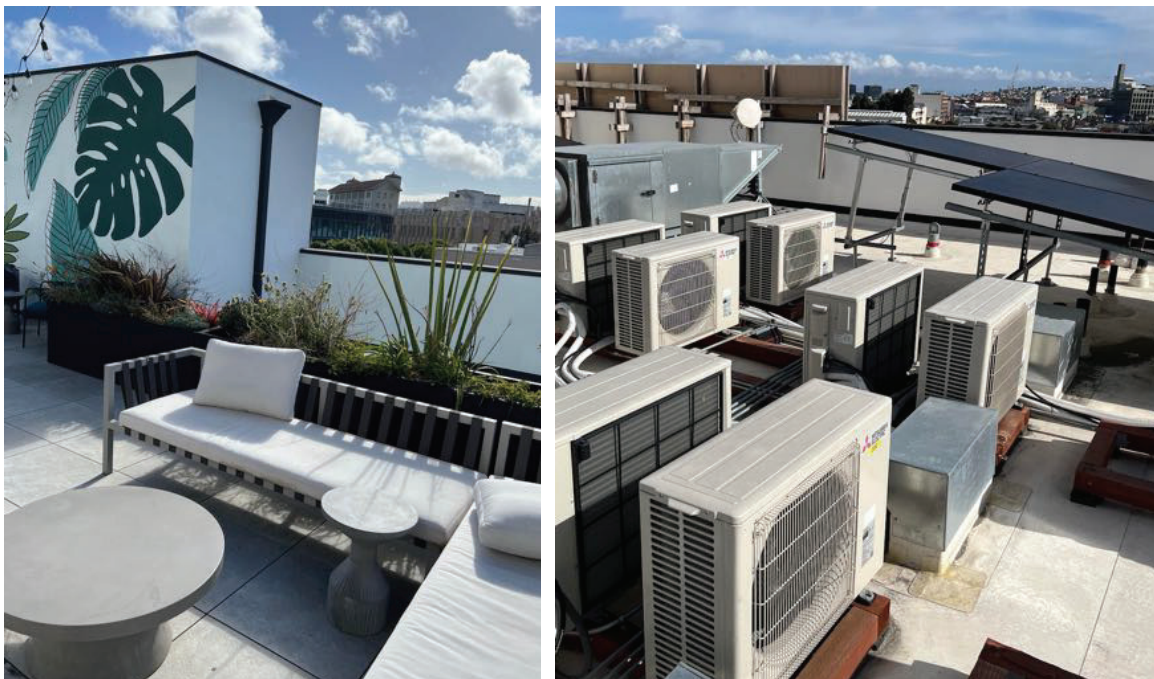
The roof surfaces and the roof deck appear to be in good condition.

*Roof surfaces*

When roof surfaces are replaced in the future, the contractor should provide a minimum 30 year guarantee on the materials and an acceptable minimum term guarantee on installation.

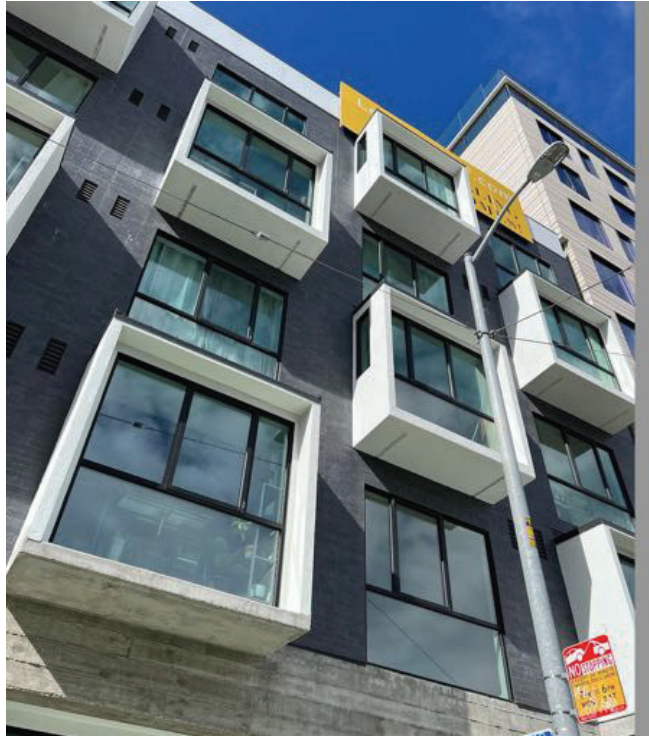
All windows at the building are original. All storefronts are original. All windows are dual paned with metal framing and are in varying fixed and operable configurations. No issues were noted or reported with windows or windows/storefront systems.

*Unit fixed and sliding windows*

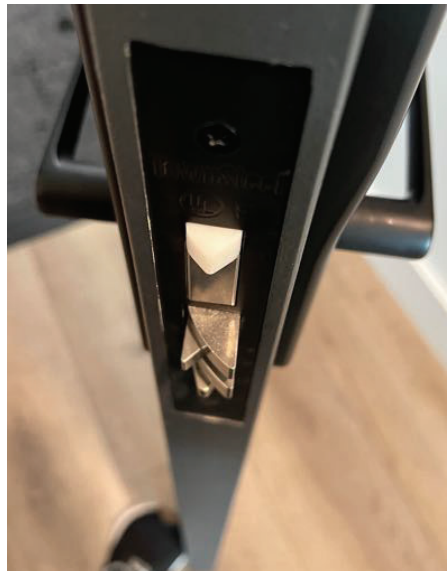
Unit entry doors are solid core metal with peepholes. The locksets are electronic and contain a deadbolt lock. All doors and door hardware were observed to be in good condition.

*Entry door lock*

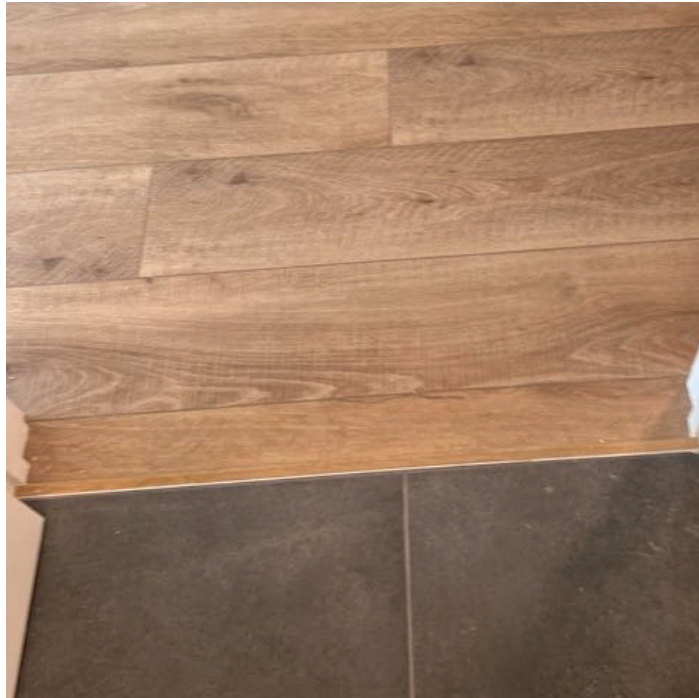
All living area flooring in the observed units is vinyl plank. Bathroom has ceramic tile flooring. All of the observed flooring was in good condition.

*Flooring - typical*

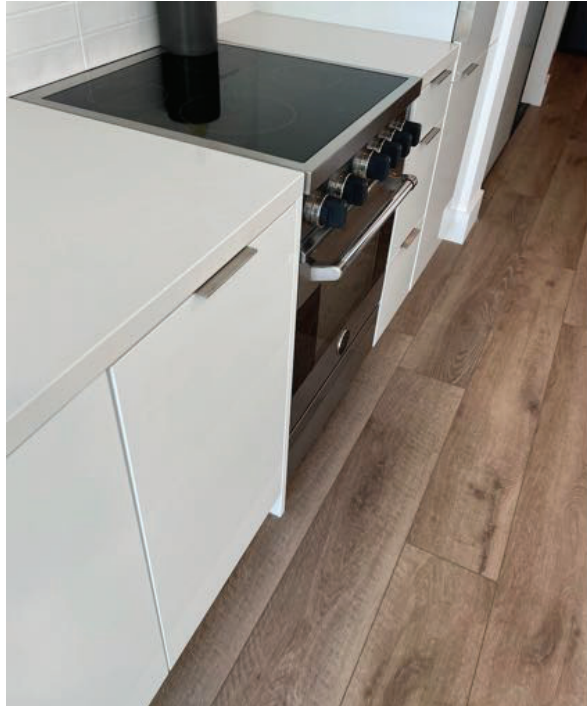
Cabinet are laminated wood the doors and frames. Shelving is laminated wood. The observed cabinets were in good condition. Bathroom cabinets are also laminated and *woodgrain* appearance.

Countertops are solid surface and all observed counters were in good condition.

*Cabinets and counters*

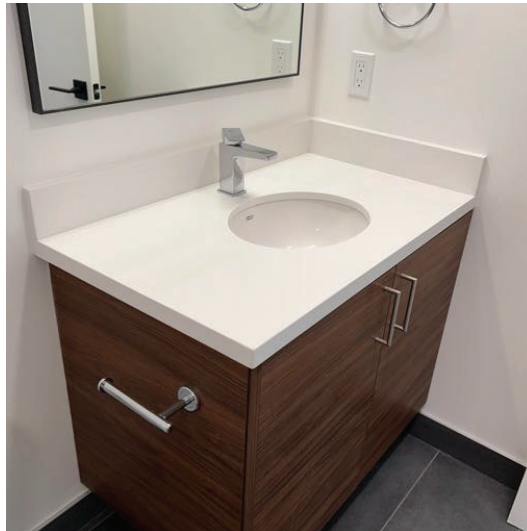
The bathroom sinks are typically single bowl sink set into a solid surface countertop, over a vanity cabinet. Sinks and vanity cabinets were found to be in good condition.

*Vanity cabinet, sink and faucet*

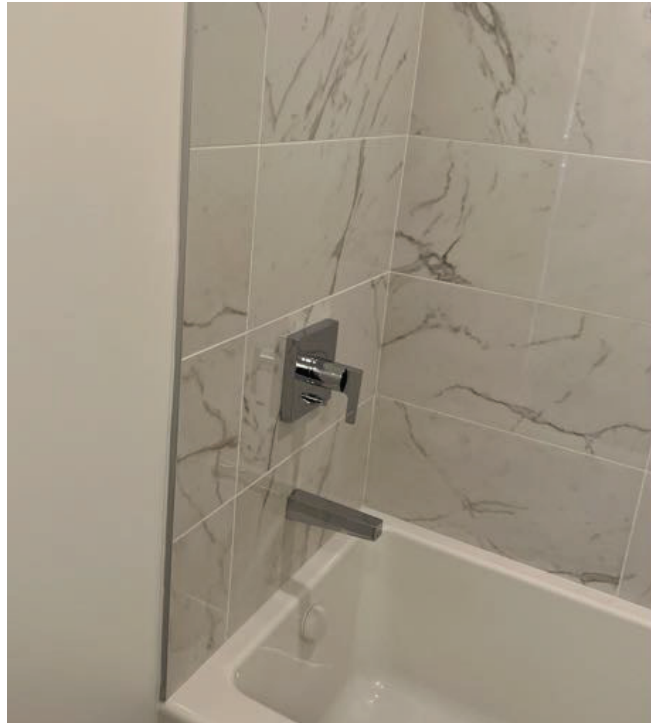
Tub surrounds are single piece fiberglass. Tubs and surrounds are original, and the observed units were in good condition.

*Tile tub surround and fiberglass tub*

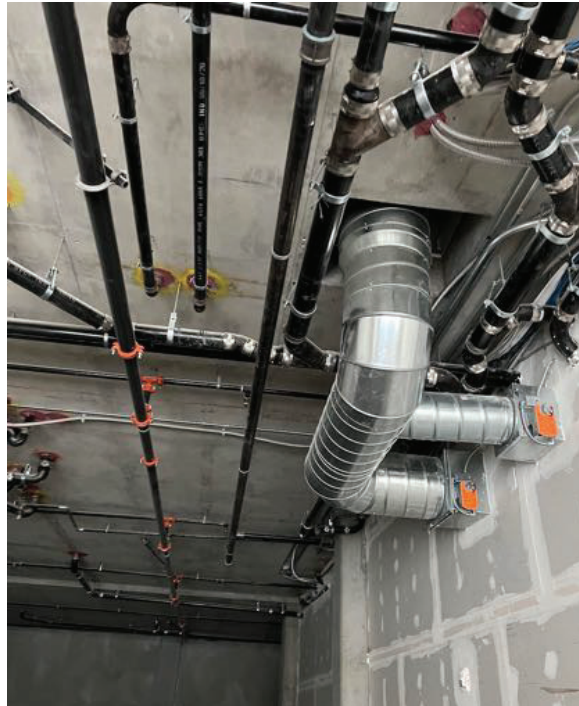
No active leaks were observed or reported at the time of the inspections.

*Waste and fire piping and venting at ground floor commercial space*

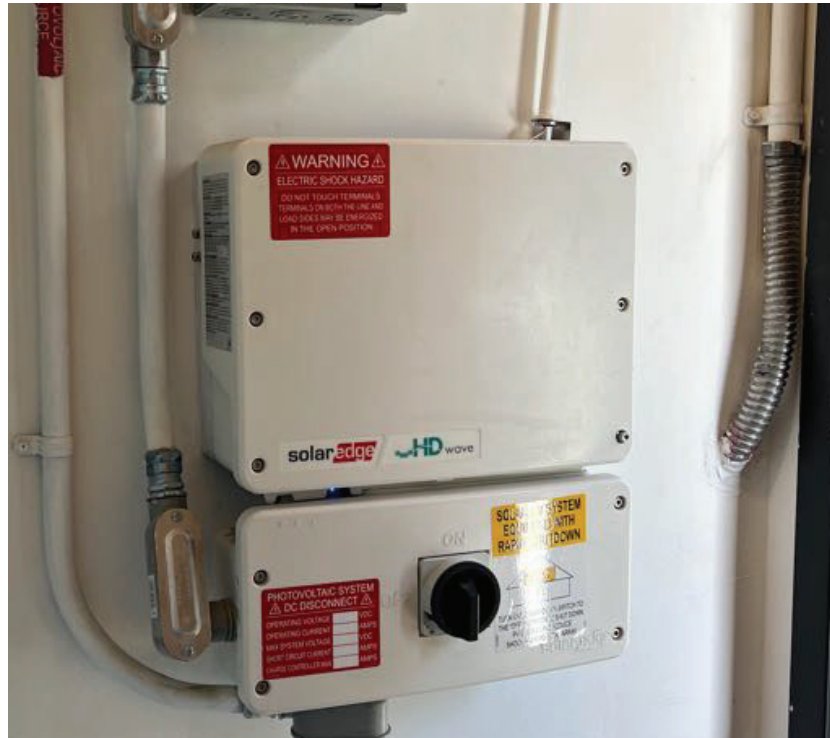
There is a small array of solar panels at the roof. No details were shown on either the electrical or plumbing drawings. They are presumed to be for solar voltaic collection to battery backups located the ground floor battery and electrical room. A solar inverter was noted at the battery room.

*Solar inverter and disconnect*
