# **42 Otis Condominiums**

42 Otis Street  
San Francisco, CA

## **Observation and Assessment Report**

March 27, 2023

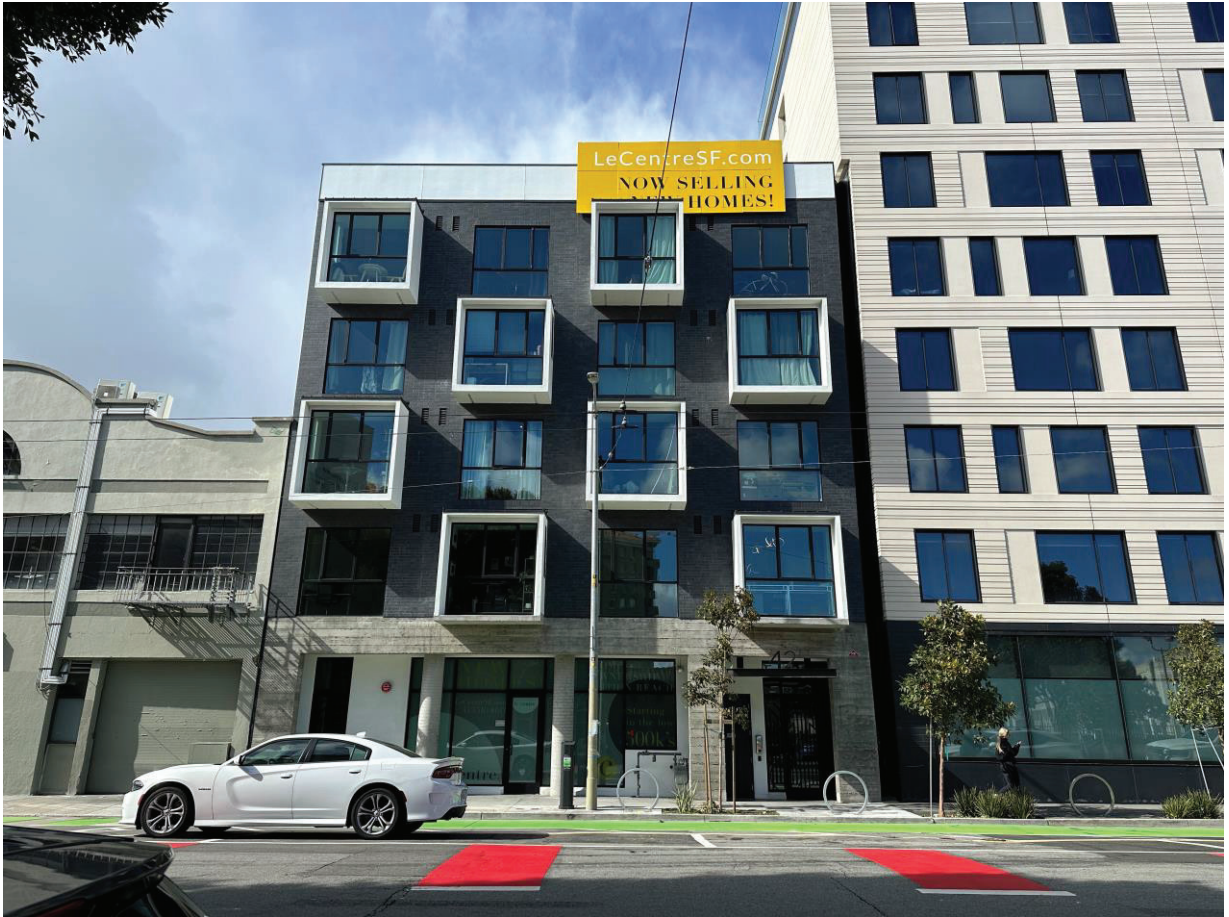
Building Exterior facing Otis Street

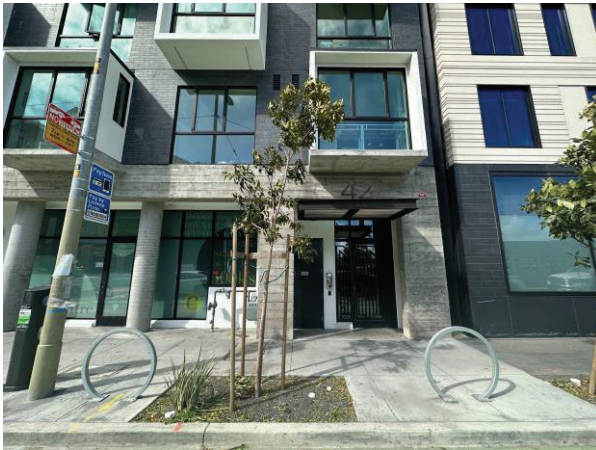
42 Otis Address Number, Residential Front Entrance

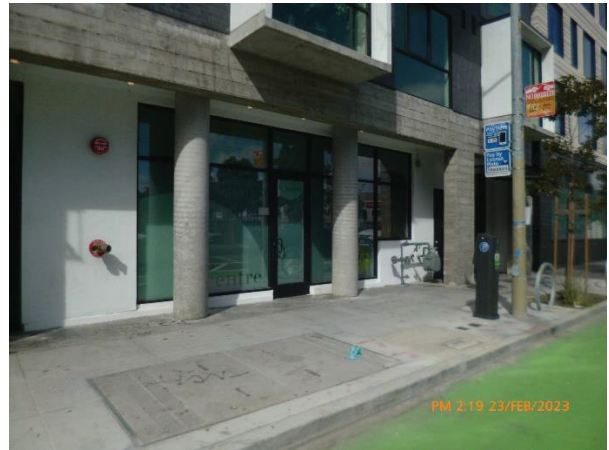
Commercial Space Entrance and FDC

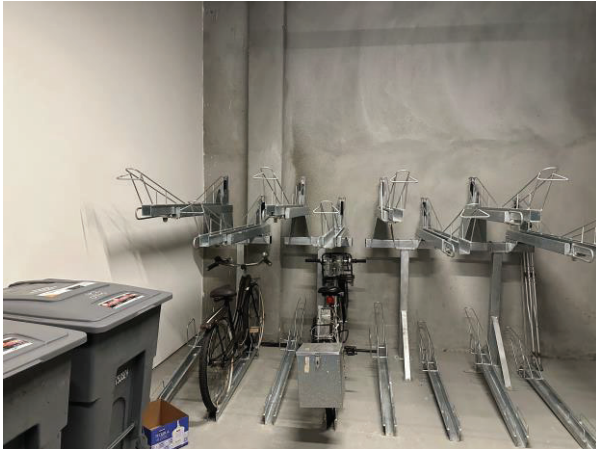
Bicycle Parking

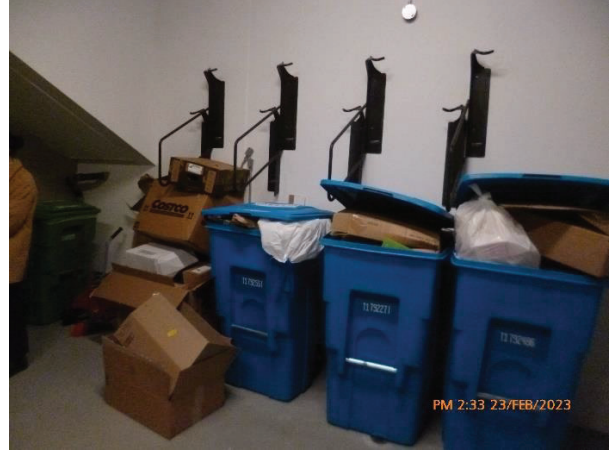
Trash, Recycle, Compost Bins in Bicycle Parking

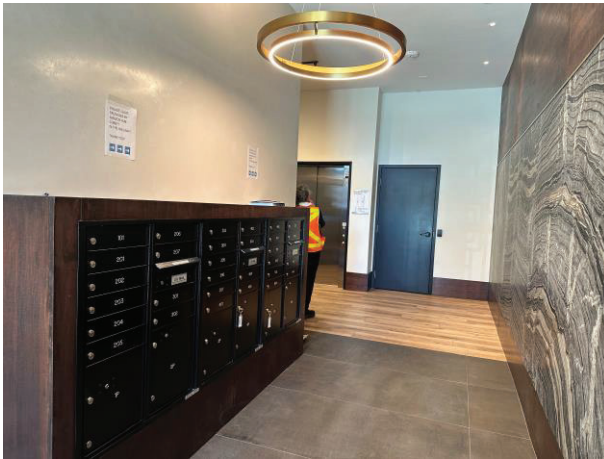
Lobby Interior, Mail and Parcel Boxes

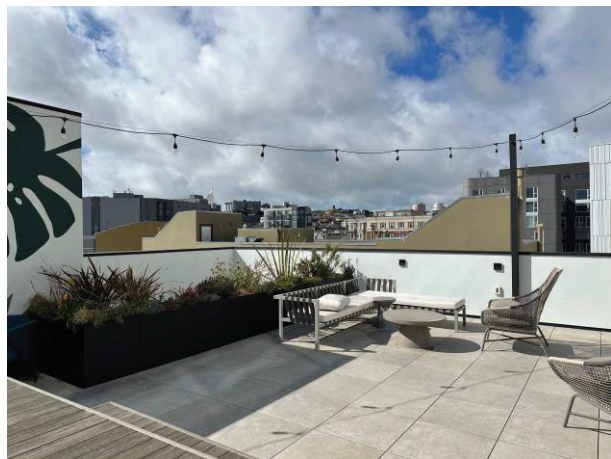
Roof Deck: Outdoor Gathering and Planter boxes

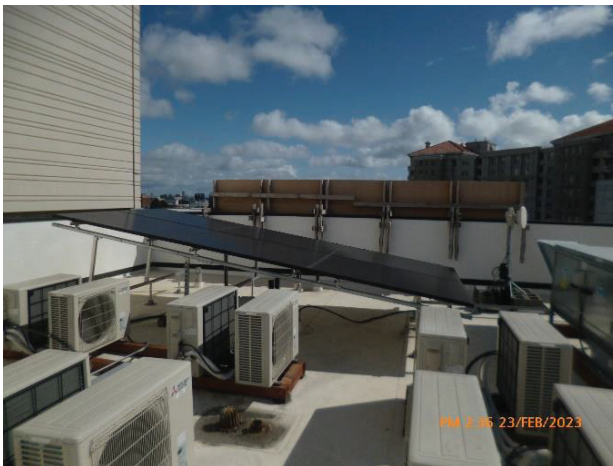
Solar PV Panel on Roof

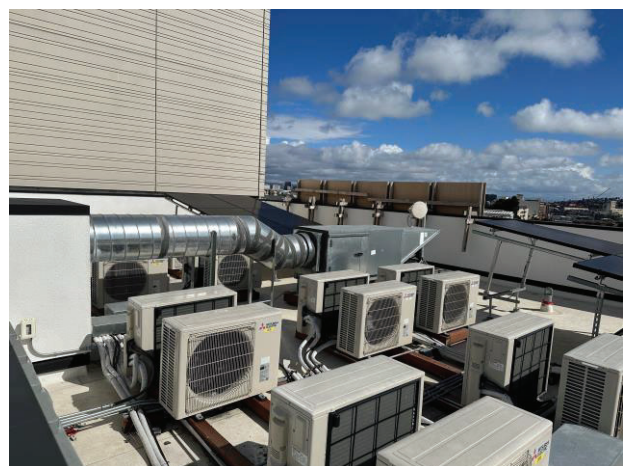
Mechanical Equipment on Roof

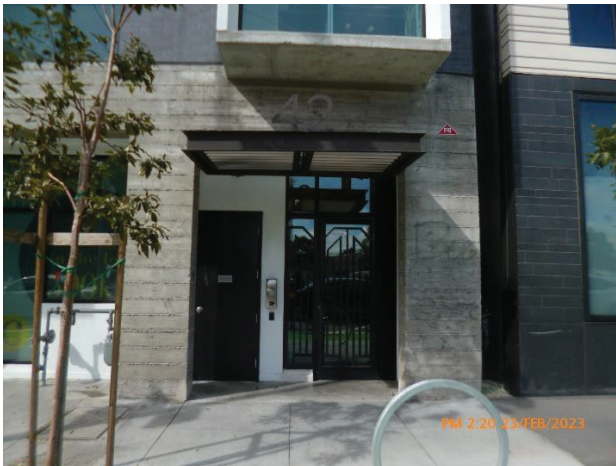
Electrical/FACP Door and Residential Building Entry Door

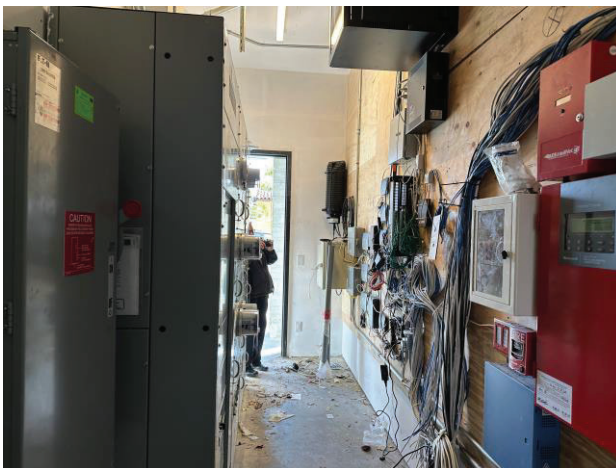
Interior of Electrical and FACP room

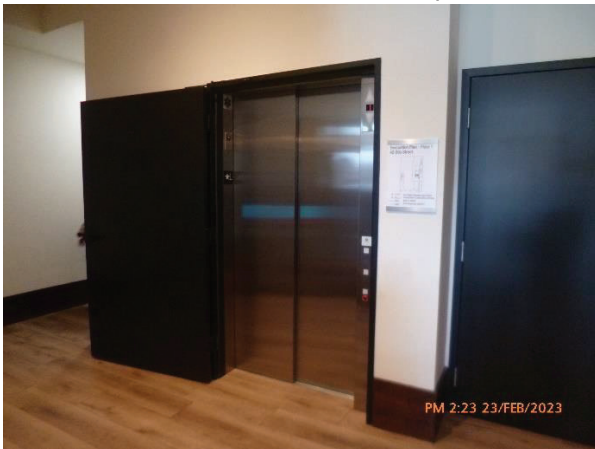
Elevator at the Lobby

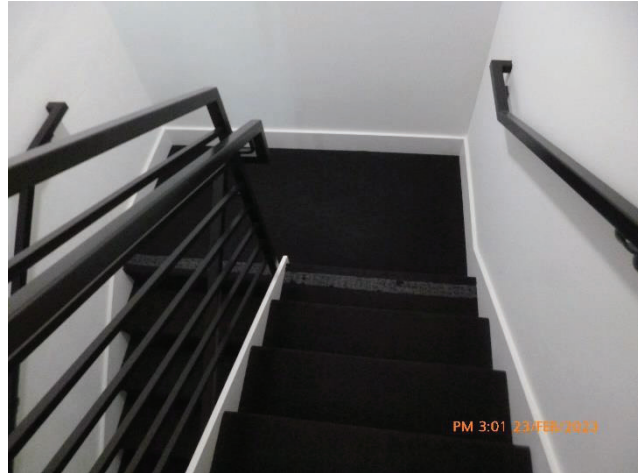
Exit Stairs with Carpet

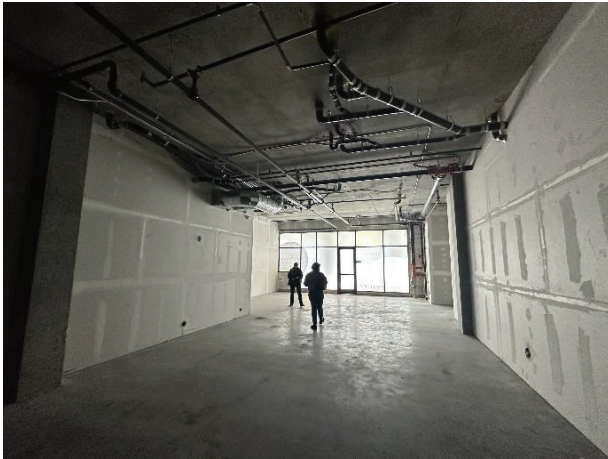
Unoccupied Commercial Space facing Otis

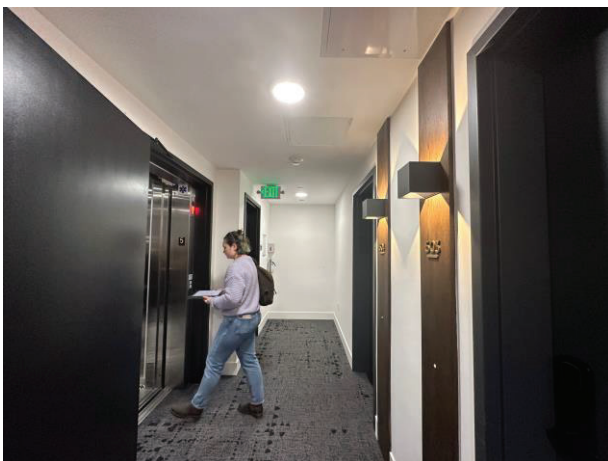
Residential Corridor, Interior Finishes

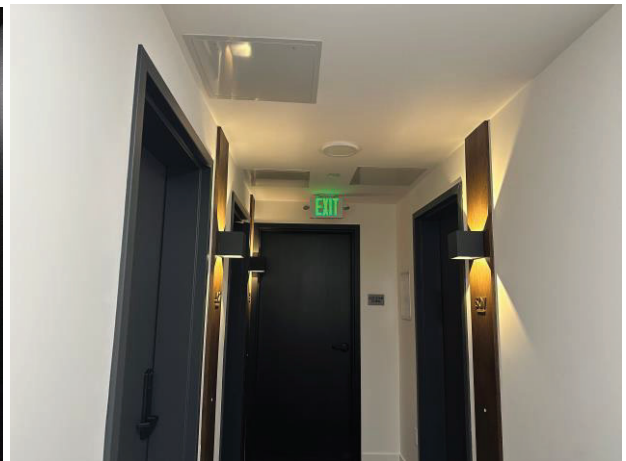
Residential Corridor, Exit Signage to Exit Stair

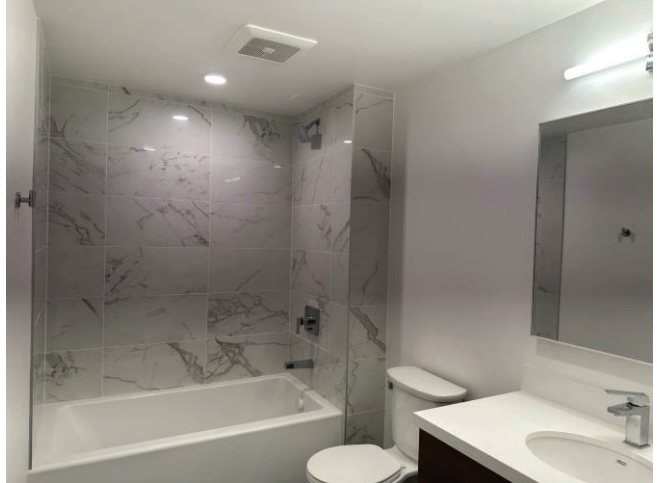
Bathroom Interior

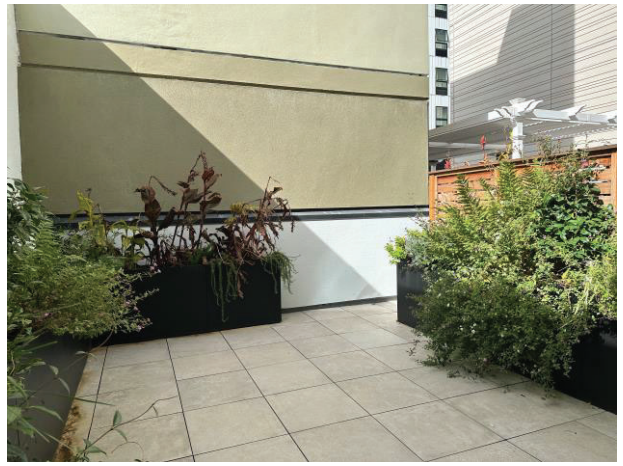
Smaller Unit Type: Private Open Space

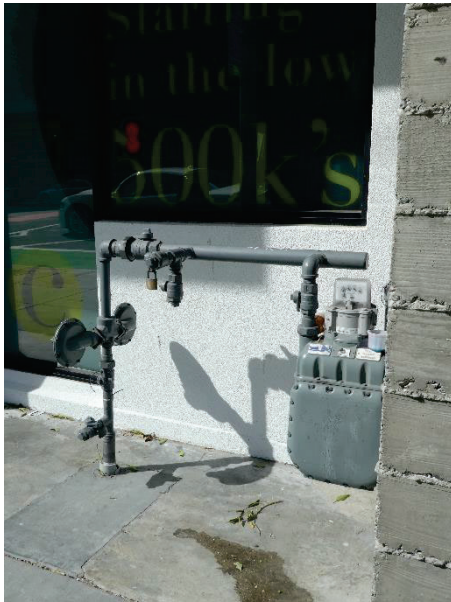
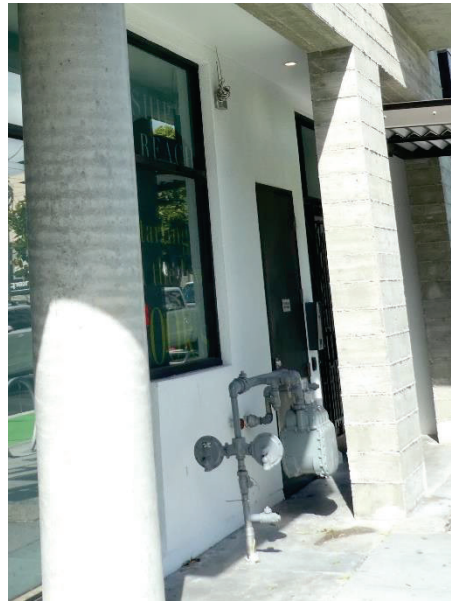
**Note:** Contrary to what is shown on the as-built plans, the central laundry room does not have gas dryers at the second floor. At the site it was observed that all appliances in the units were electric.

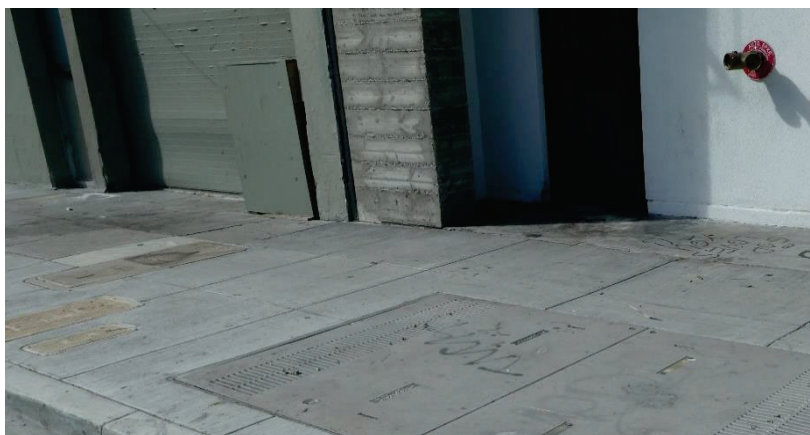
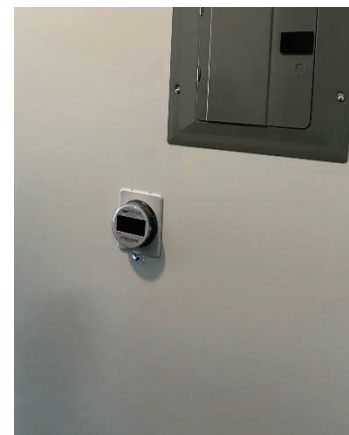
SFPUC water meters are located within boxes in the sidewalk at the front of building left side entrance next to underground transformer. We did not observe the separate commercial tenant space meter indicated on the as-built drawings. The level 2 retail/professional services units and residential units were observed to have the code required submeter with a read-out accessible to the tenant located on a wall in each apartment.

The plumbing plans showed separate water main connections to the building and stub out for the commercial tenant space. However, the civil plans showed only one water line.

**Recommended:** Confirm water metering actually installed on site. We recommend reviewing any available tenant or owner's SFPUC water bills to confirm the separate metering for the ground floor commercial space.

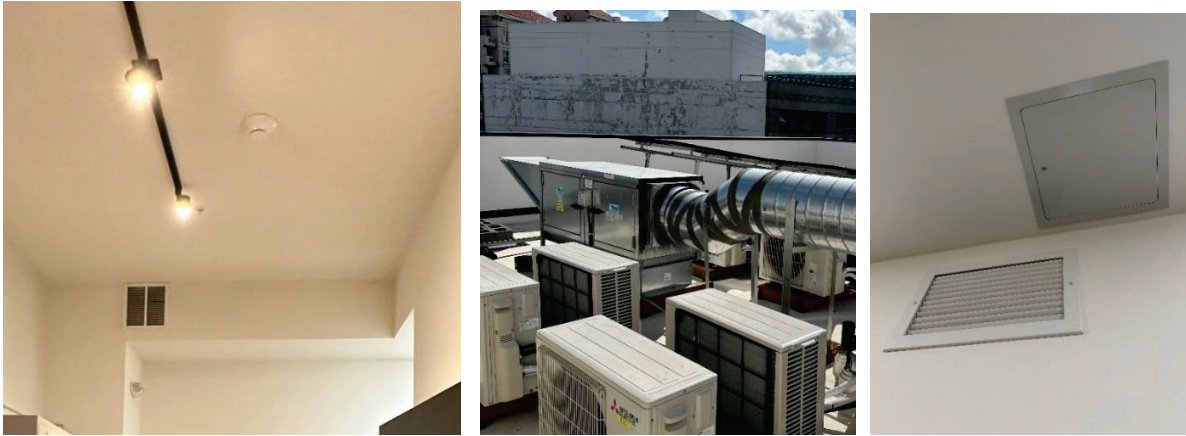
One rooftop filter/fan supply unit serves the entire building: The residential ground floor common entry space, trash room, electrical room, and bicycle room, the residential corridors, as well as the retail/professional services units and residential units.

**Recommended:** Confirm fire/smoke damper testing is current for all dampers noted in the approved plans. They are code required at duct shaft exits, and at duct penetration of smoke barrier rated walls and partitions.

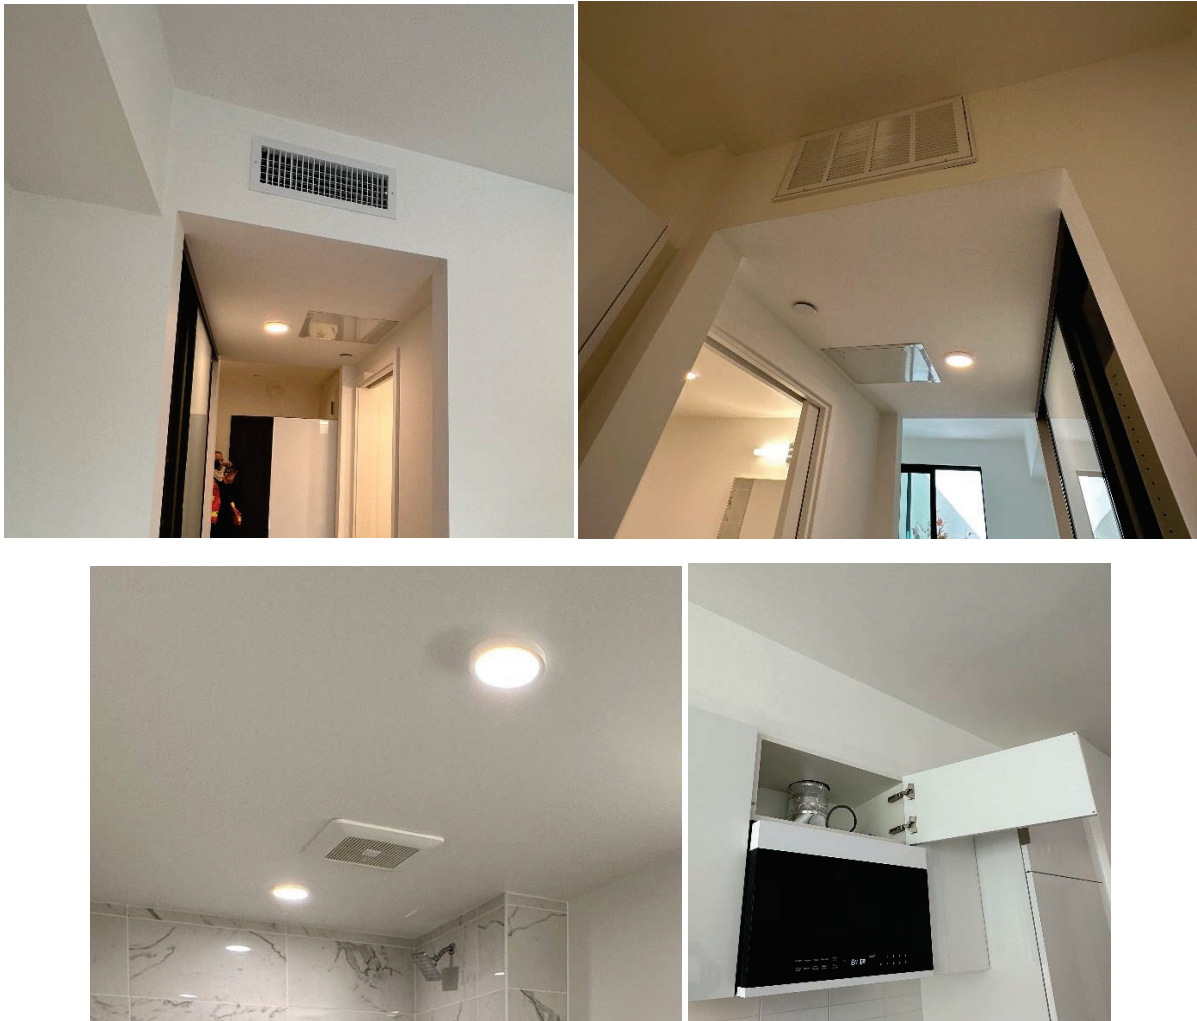
There are ceiling mounted bathroom exhaust fans. It was observed that the exhaust fan serving the bathroom is turned on and off by a wall switch. A humidistat control is noted to also be installed for the bath exhaust fan control.

**Recommended:** Recommend testing humidistat is operational to meet current T24 requirements that improve indoor air quality and prevent mold.

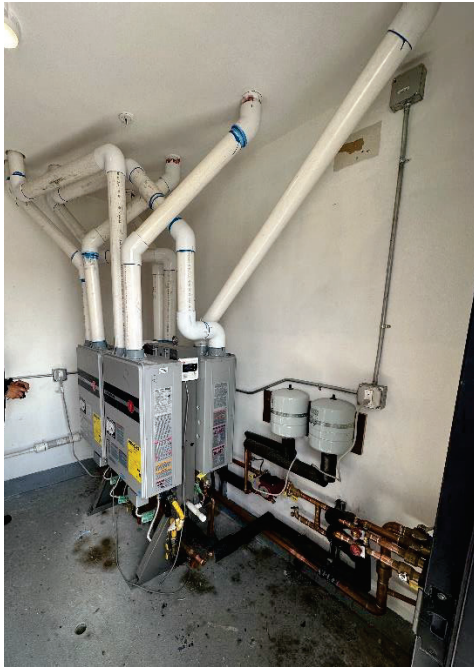
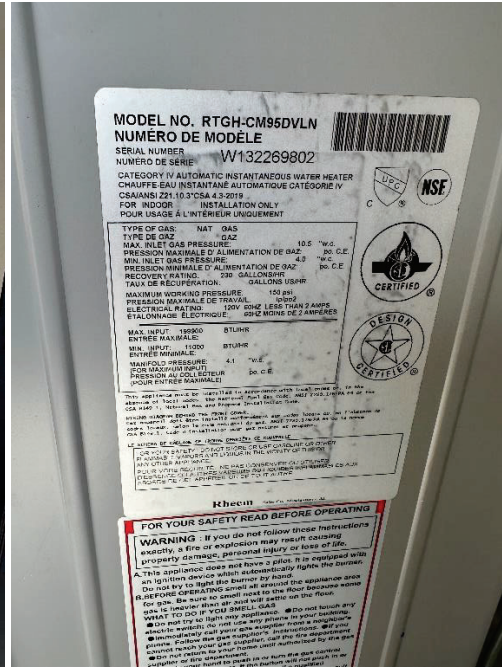
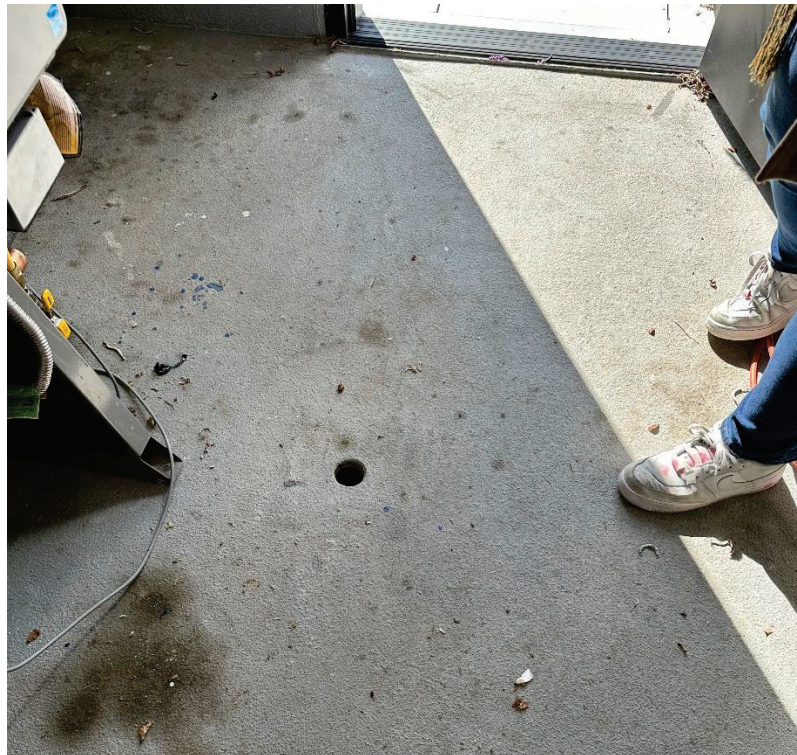
The four instantaneous water heaters are installed on a manufacturer-provided floor mounting rack. It was observed that the clearance for the back 2 water heater units that face the wall is not sufficient to provide clear maintenance access. 24" between the water heater and the wall is the recommended minimum for service clearance.

We observed a hole in the floor apparently, apparently a floor drain, with no cover.

**Recommended:** Complete the hot water pipe insulation, with 1" thick insulation on pipes 1" diameter and under, and 1-1/2" thick insulation on pipes larger than 1" diameter. Be sure all insulation joints are tight and fastened.

Regular tankless water heater maintenance includes descaling the heaters with acid solution. Follow manufacturers instructions and recommended intervals, plan and schedule descaling the heaters.

Contract a full maintenance and retro-commissioning of the hot water and preheat system. Test the delivery time for hot water to apartments that are the most remote connections to the system. Hot water should reach 105F to 115F within 20seconds of turning on any hot water faucet.

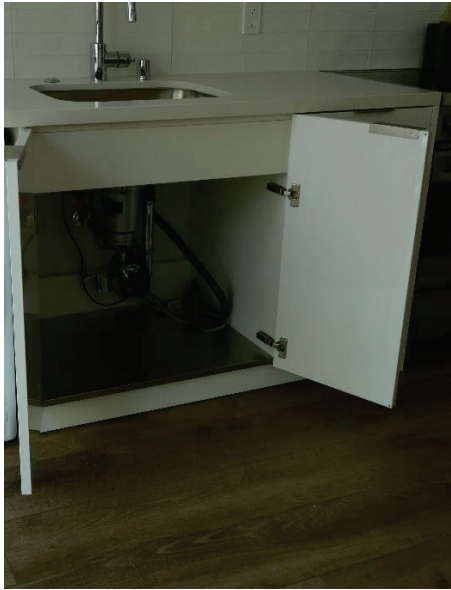
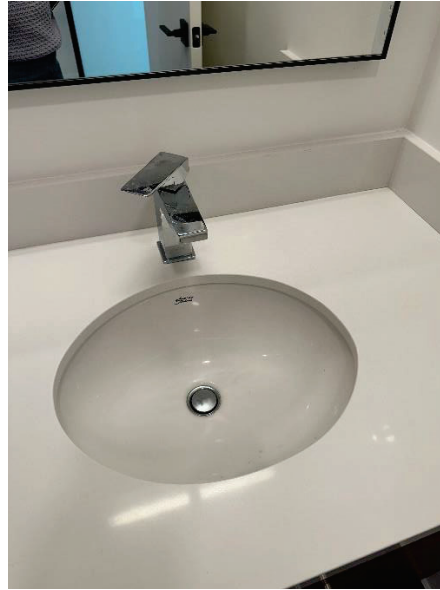
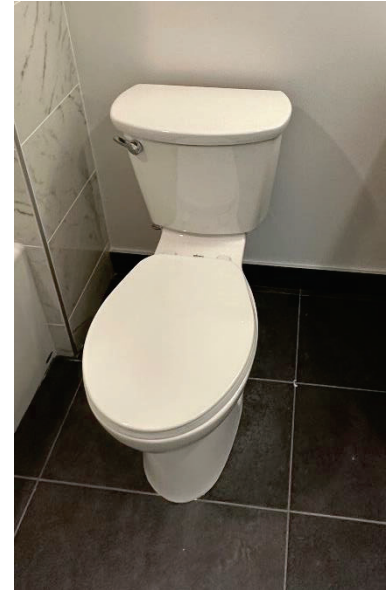
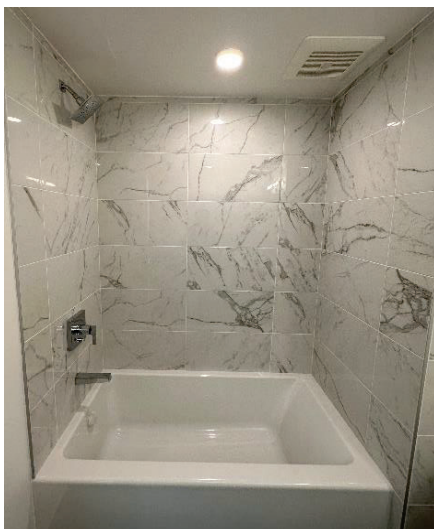
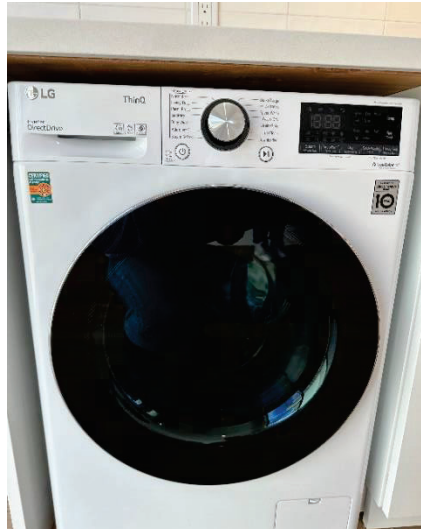
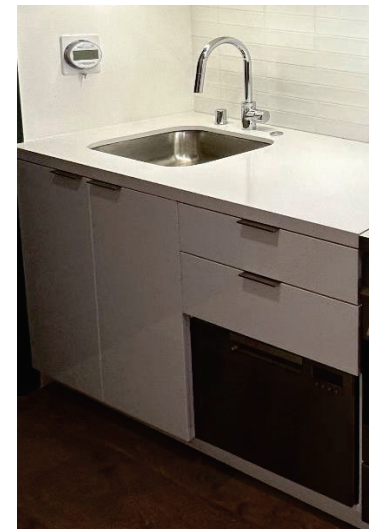
Each apartment had a kitchen sink with garbage disposal, a drop-in vanity lavatory, tank-type toilet, bathtub/shower, and in-unit washer/dryer combo. The ones we observed operate correctly. One residential unit we observed during the site walk had a dishwasher, but the drawings show dishwashers were planned for all residential units.

**Recommended:** No plumbing fixtures scheduled on drawings, confirm that the installed plumbing fixtures meet or exceed code required low flow rates. Check which apartments do not have a dishwasher installed.
