**City Gardens 333, LLC**  
San Francisco, California

**Property Condition  
Assessment Report**

**March 26<sup>th</sup>, 2020**

**LJP Project #20-4482**

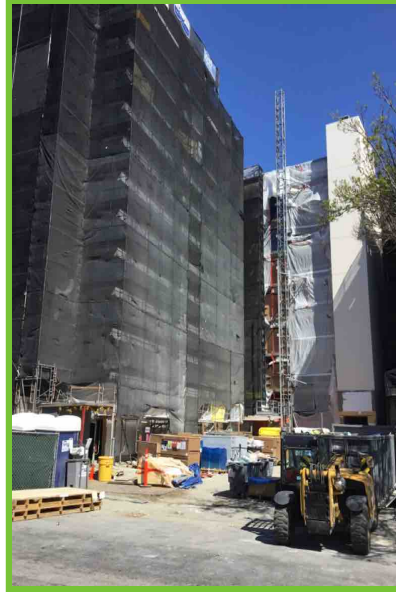
3

Note: East Facade

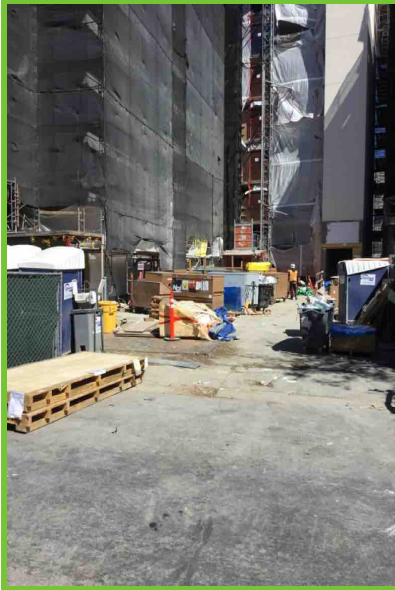
4

Note: East facade

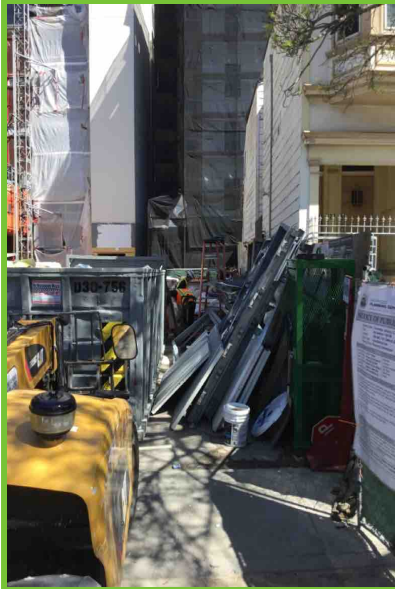
6

Note: East Facade

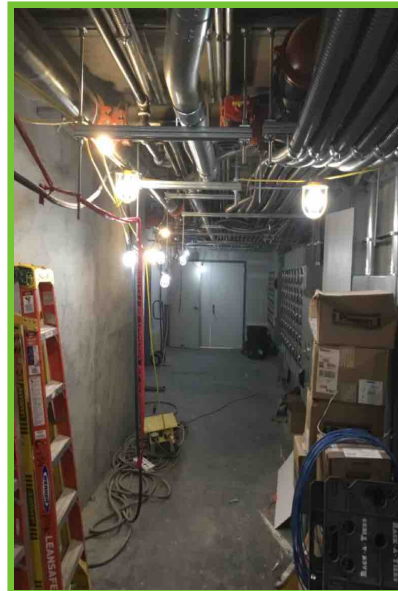
37

Note: Basement entrance into switch room

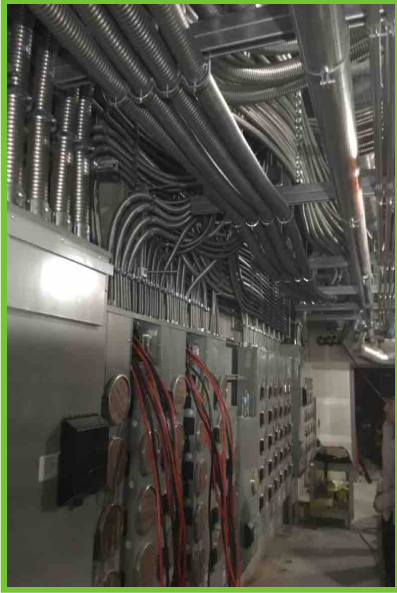
38

Note: Electrical meter room 2

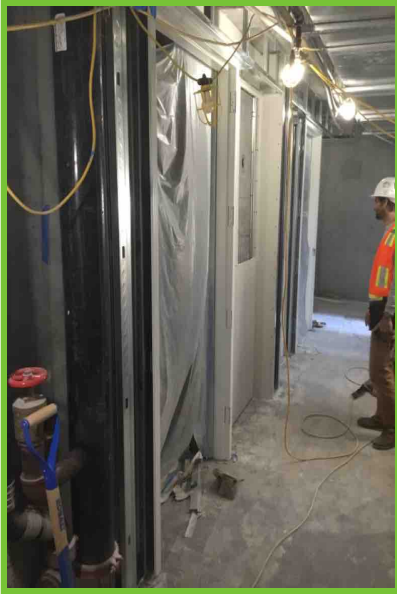
40

Note: Garden level elevators

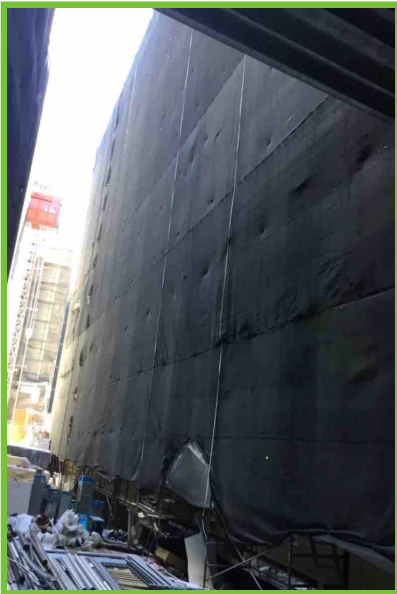
42

Note: Courtyard covered scaffolding

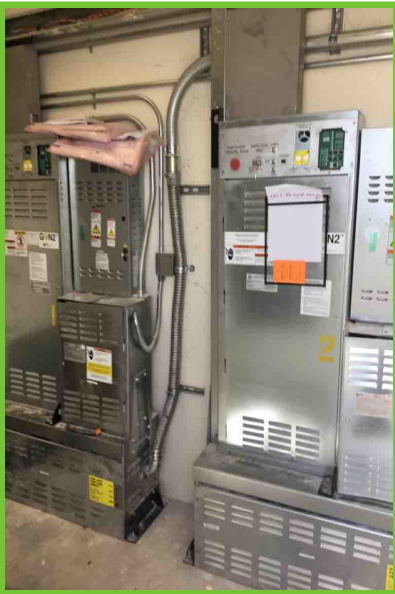
66

Note: Elevator control room

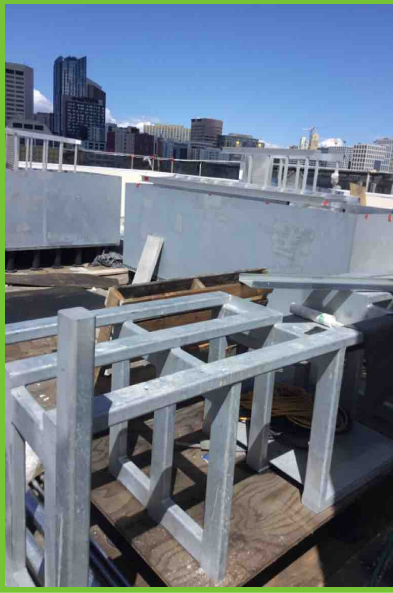
68

Note: Rooftop planters

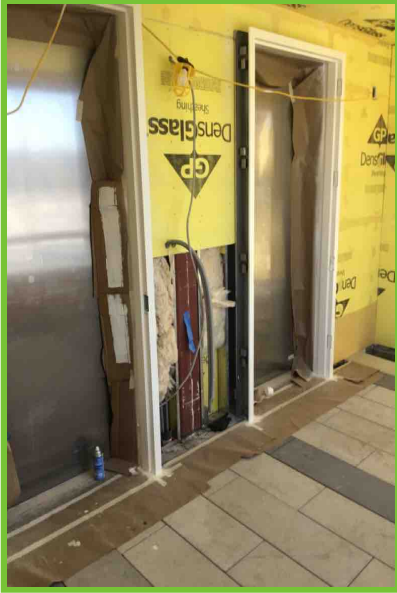
74

Note: Rooftop elevators

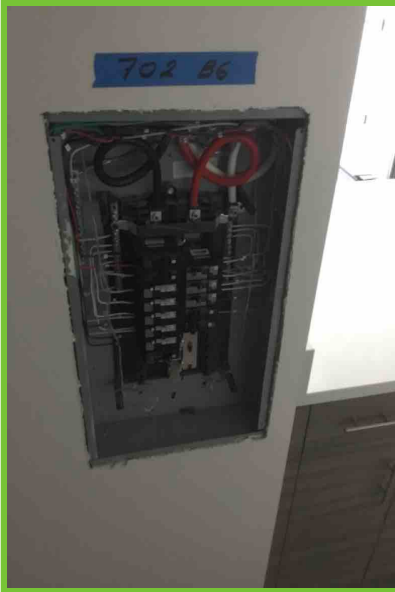
88

Note: 792 electrical panel
