**City Gardens 333, LLC**  
San Francisco, California

**Property Condition  
Assessment Report**

**March 26<sup>th</sup>, 2020**

**LJP Project #20-4482**

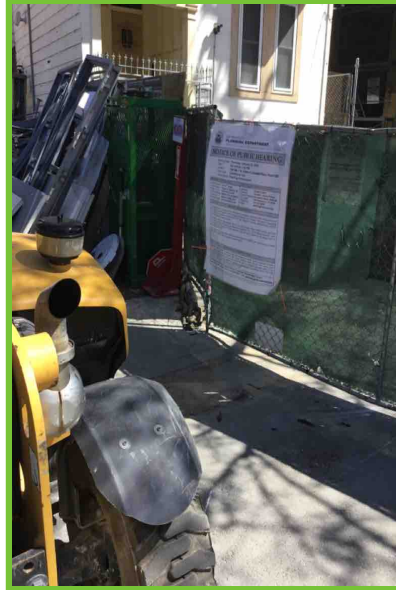
5

Note: 12th street

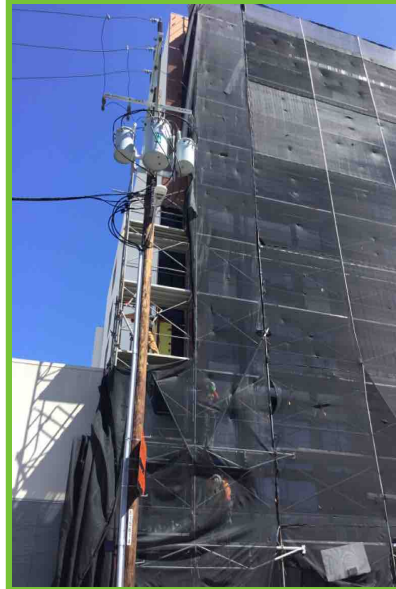
7

Note: 12th street/  
 Folsom elevation

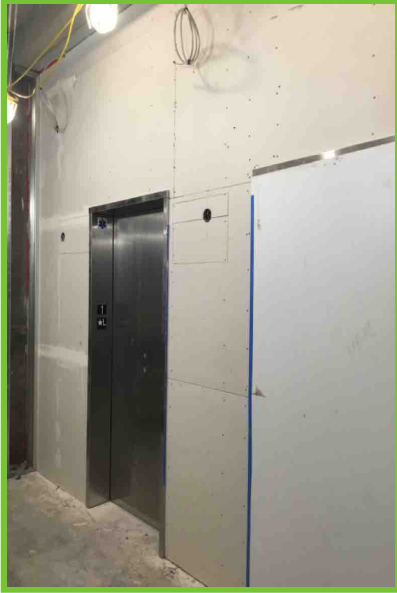
20

Note: Lobby Elevators

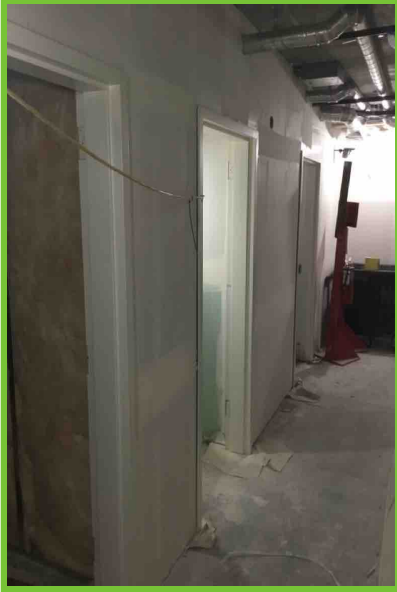
22

Note: Offices

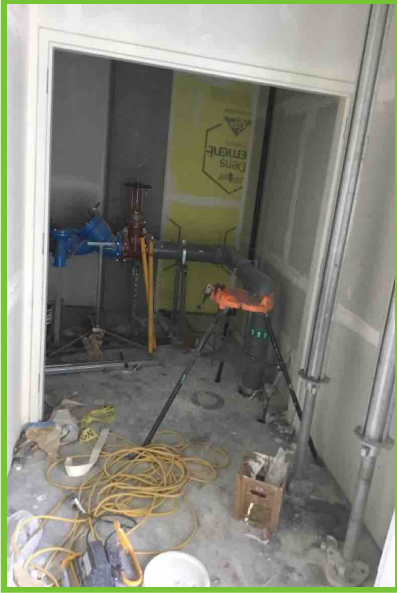
26

Note: Norfolk entrance

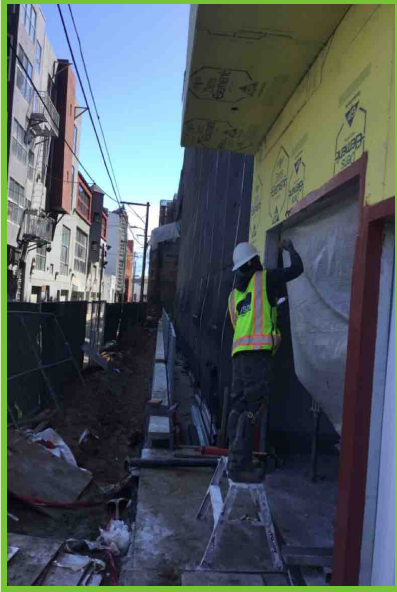
28

Note: Norfolk facade & stoops

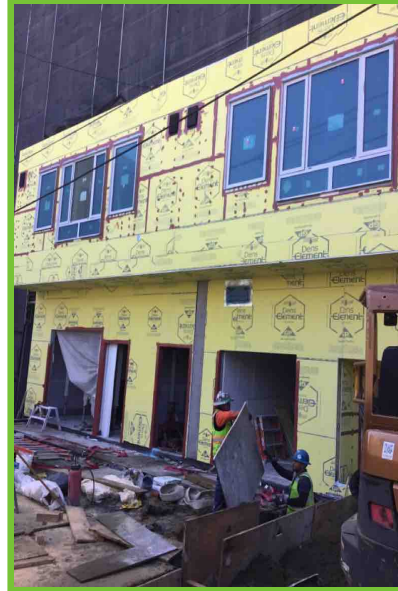
33

Note: Norfolk facade

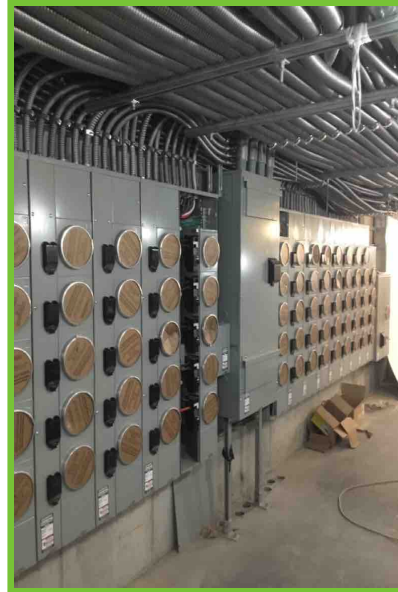
35

Note: Meter bank 1

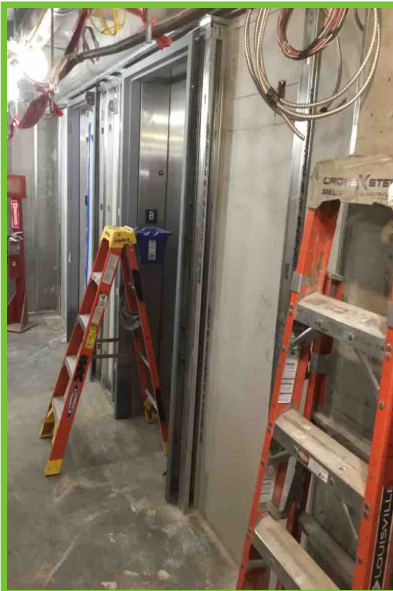
36

Note: Basement elevator

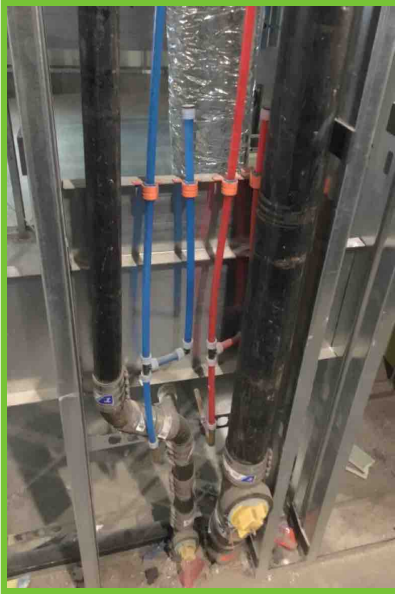
46

Note: Level G corridor

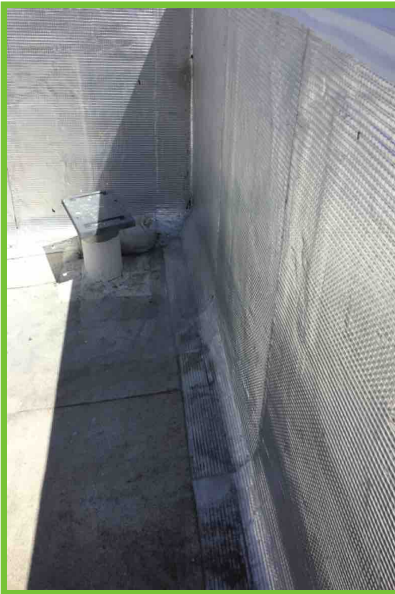
48

Note: Roof level

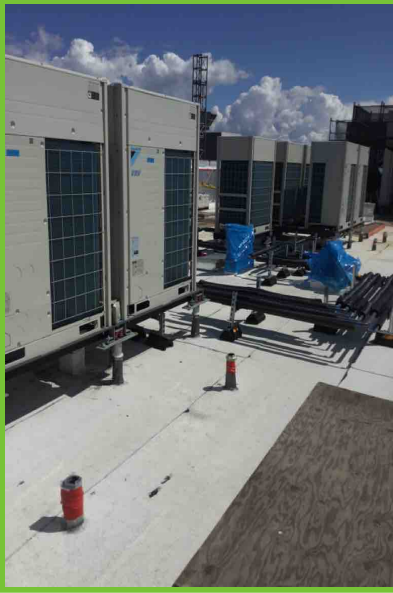
80

Note: Rooftop heat pumps

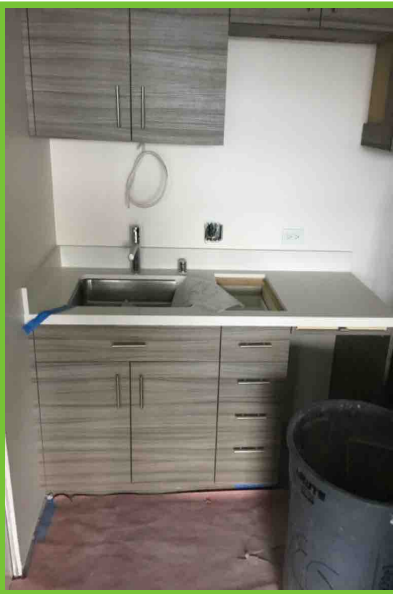
84

Note: Unit 702 B6

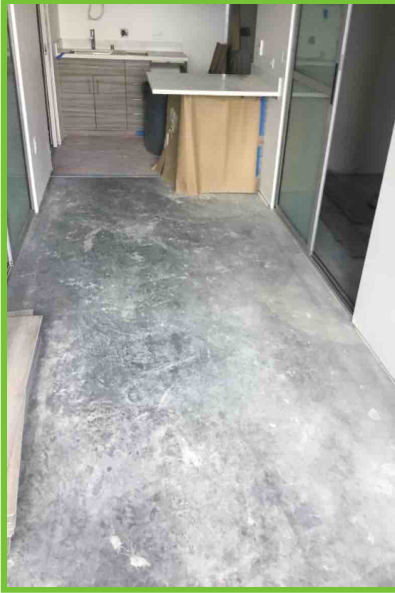
86

Note: 702 living room

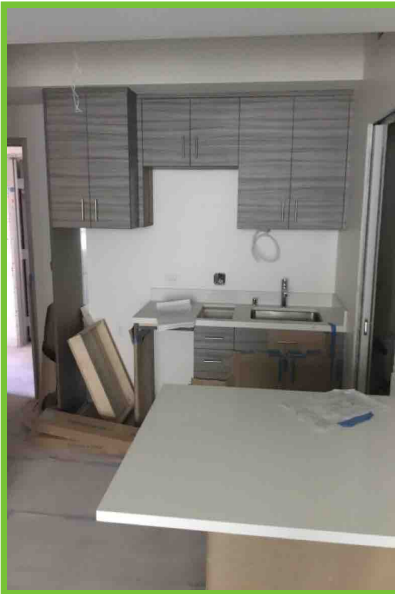
90

Note: Unit 701 C1. Kitchen

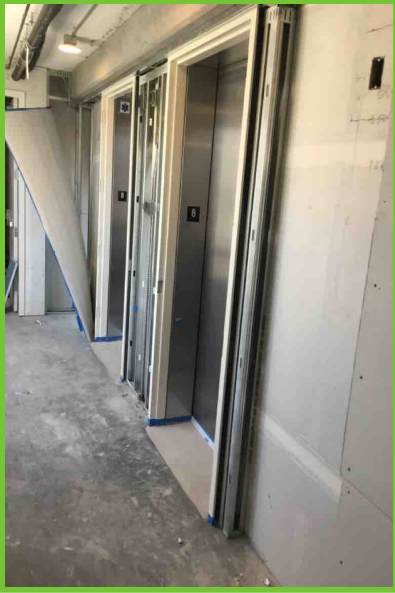
92

Note: Elevators level 7; bank 8

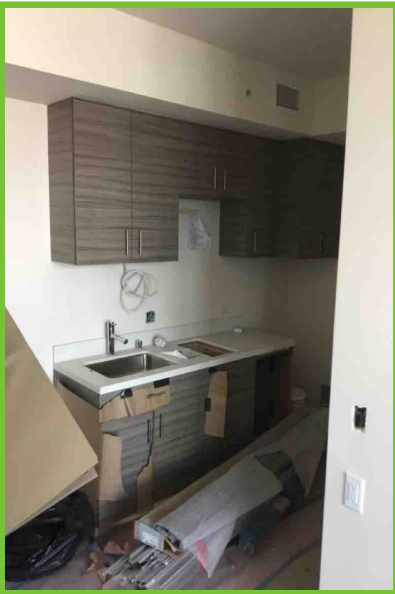
96

Note: 711 B2 Kitchen

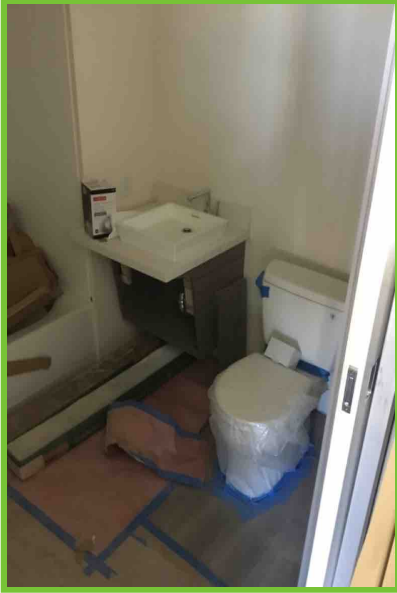
98

Note: 711 B2 Bathroom

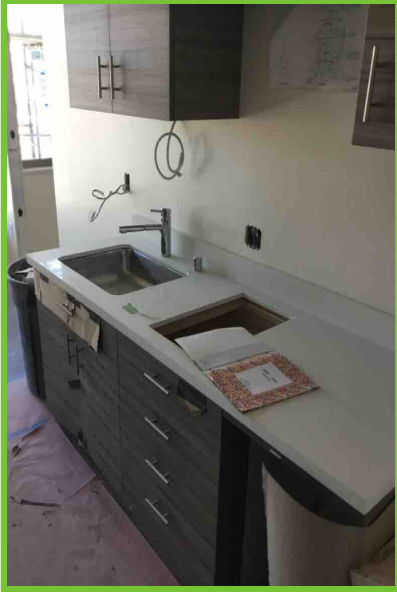
100

Note: 713 B1 Kitchen

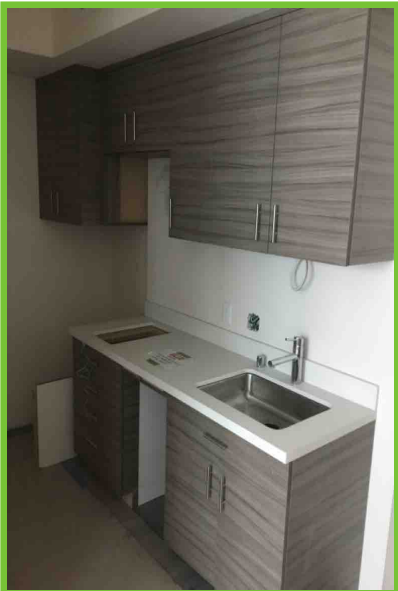
102

Note: 730 B 3 Kitchen

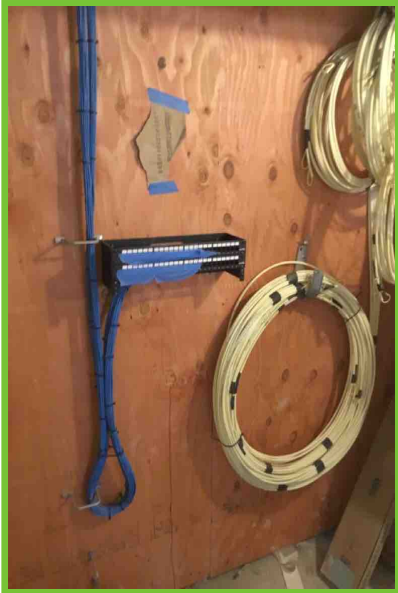
116

Note: 4th floor IIBF room
